Stream Crossing Survey of the Scarborough Marsh Watershed

**Friends of Scarborough Marsh (FOSM)
Scarborough, Maine**

Steve Pinette, FOSM Board Member

Final submitted October 2017

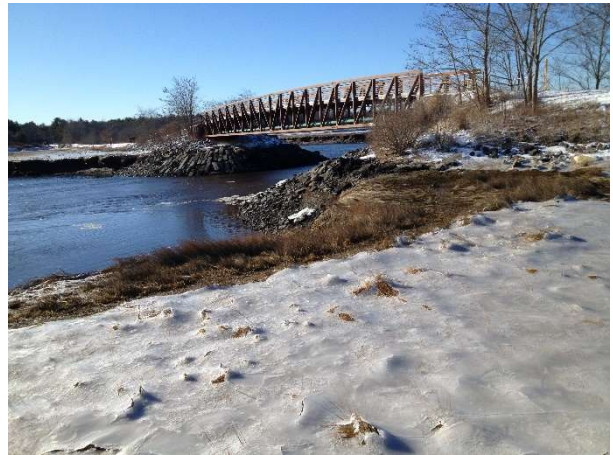
Photo 12 (7B-DR: single-span steel bridge)

Dunstan River	7B-DR	60484	bridge	bridge with armored rip-rap banks	5	evidence of constriction from aerial photo	at Eastern Trail	na	na		na	1/9/2017	evidence of constriction from aerial photo and modeling (Normandeau and WHO, 2002)	
Finnerd Brook	2-FB	not surveyed	round culvert	24" ID corrugated metal pipe culvert	1		at Glenard Road	inaccessible	@grade		0.67	1/6/2017		
Finnerd Brook	3a-FB (a)	56179	round culvert	concrete pipe culvert (Photo only--no measurements)	not noted	not noted	at Turnpike	not noted	not noted		not noted	10/1/2015		
Finnerd Brook	3b-FB (a)	60204	round culvert	concrete pipe culvert (Photo only--no measurements)	not noted	not noted	at Turnpike	not noted	not noted		not noted	10/1/2015		
Finnerd Brook	4-FB	56185	round culverts	two 60" ID corrugated metal pipe culverts	4	cobble raceway upstream	at Payne Rd.	@grade	@grade		0.33	12/21/2016	cobble raceway from upstream pond likely restricts fish passage. ***strong diesel/sewerage odor

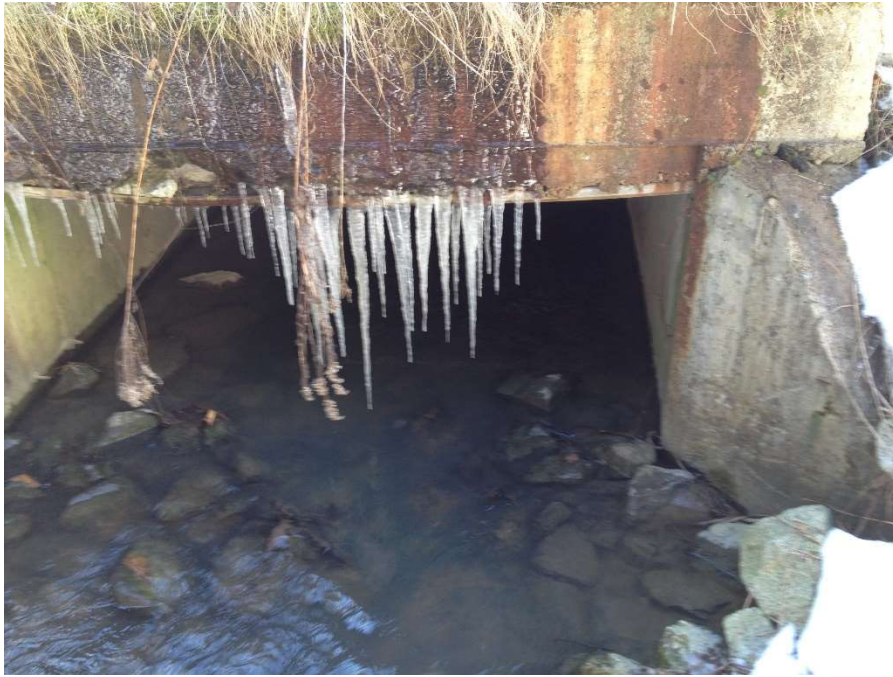
Sites with other features (e.g., cobble/gravel mound or rip-rap piles, upstream or downstream) that *may* restrict fish passage under low-flow conditions are assigned Restriction = '4' in Appendix C. Sites on Cascade Brook (3-CB, 4-CB, 1-CB-trib [**Photo 13**]), Dunstan River (1-DR, 4-DR), Finnerd Brook (4-FB) and Mill Brook-west (4-MB-west) are in this category.

Photo 13 (1-CB trib: cobble mound [potential low-flow fish restriction] at outlet)

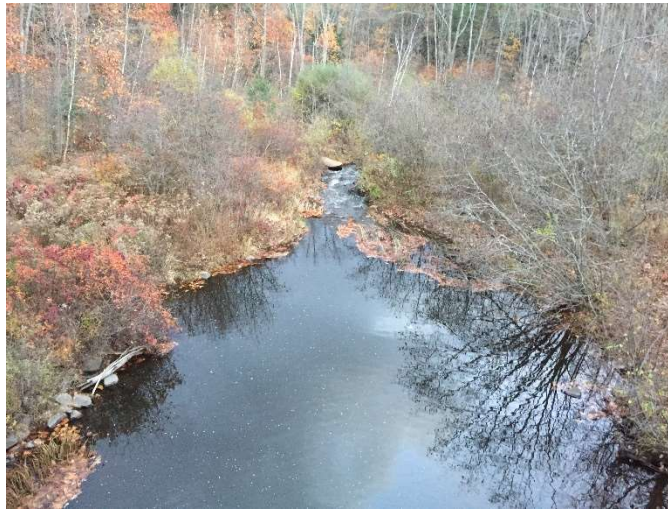
Sites with visible bank erosion or channel-widening immediately downstream or upstream, e.g., 5-CB: **Photo 14**, of the flow structure (i.e., indicates under-sized structure) and those with dams are designated as flow-restricted (Restriction = '5' in Appendix C). Undersized structures appear to have caused channel erosion on Jones Creek at site 2-JC and Dunstan River at sites 7A-DR and 7B-DR. A sheet-pile dam on Cascade Brook (5-CB) upstream from Old Blue Point Road appears to restrict ebb tide drainage and fish passage. A concrete dam inside a box culvert in Mill Brook-west (site 7-MB-west, **Photo 15**) creates an impoundment upstream, traps sediment and limits fish passage. Based on tidal water-level monitoring by others, a dam installed in the mid-1980s on Jones Creek (site 4-JC, see **Photo 16**) appears to limit tidal flushing west (upstream) of the dam.

Photo 14 (5-CB: channel-widening upstream from culvert inlet; view from inlet)

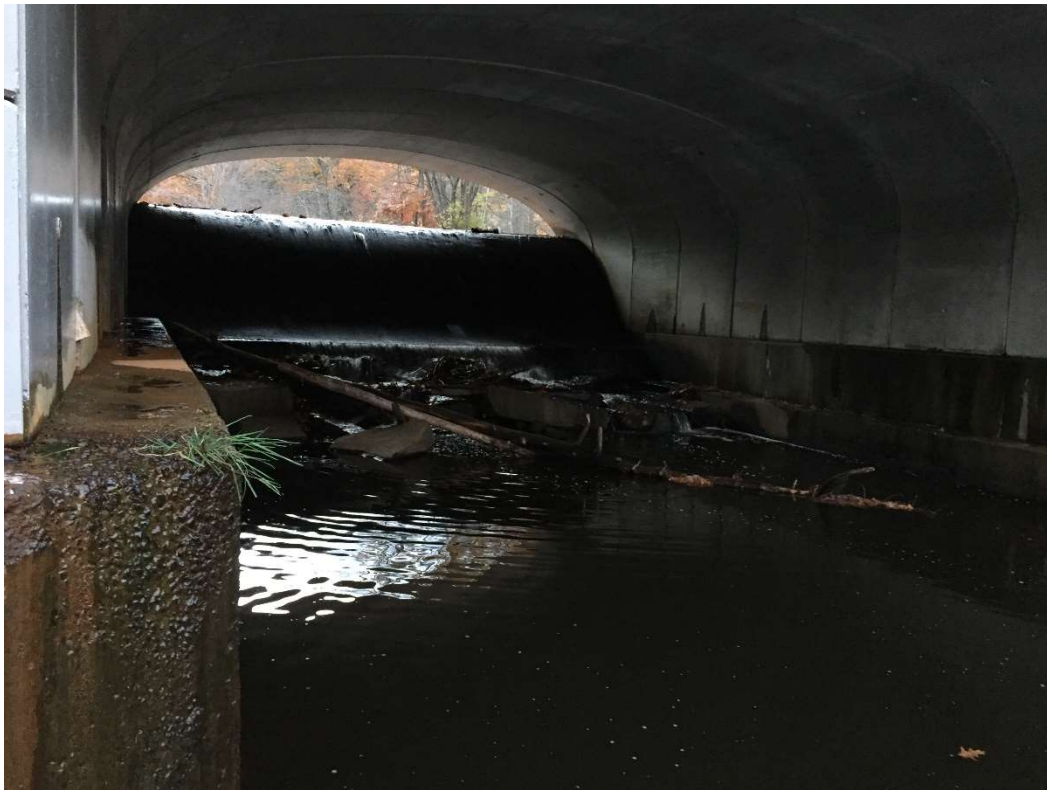
Photo 15 (7-MB west: concrete dam inside box culvert)

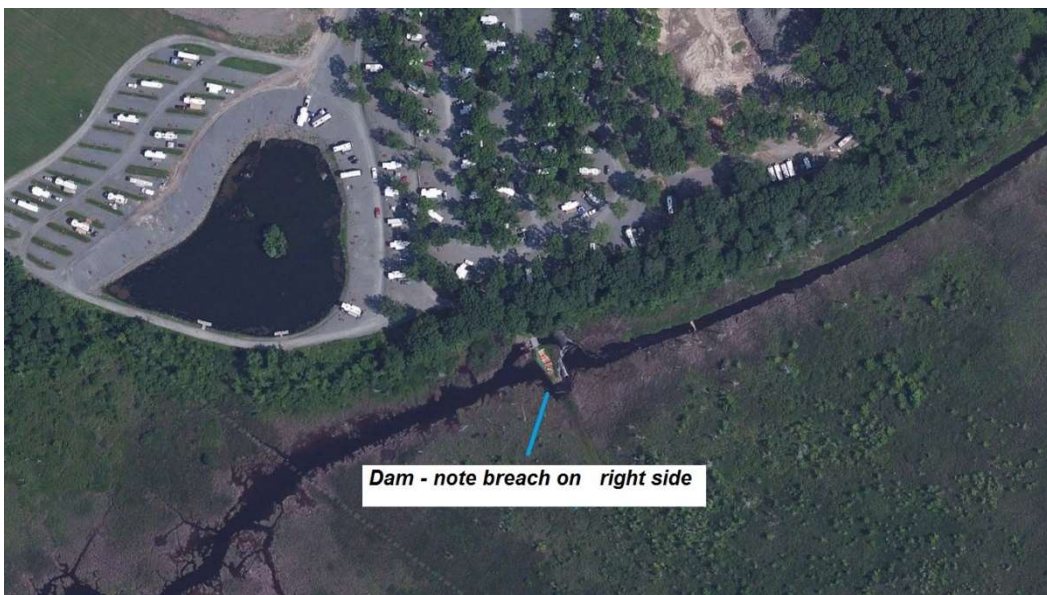
Photo 16 (4-JC: aerial view of dam on Jones Creek)

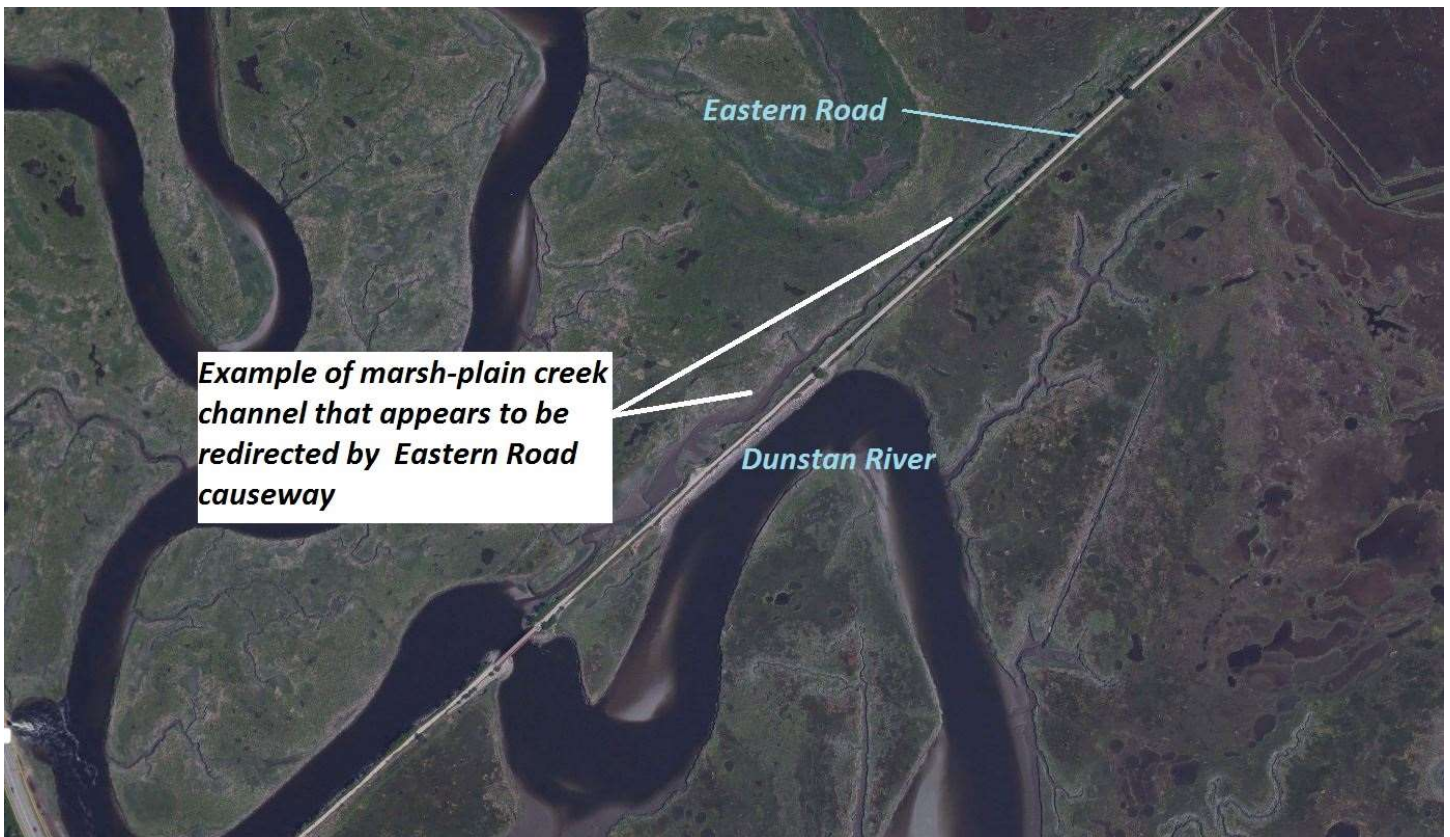
Photo 17 – Location of Site CW-1 on Map B-2

Area CW-1 along the north side of Eastern Road – **Photo 17** presents an aerial view of a local creek (unnamed) which flows southwesterly toward Dunstan River along the Eastern Road causeway, rather than south toward a more proximal creek.

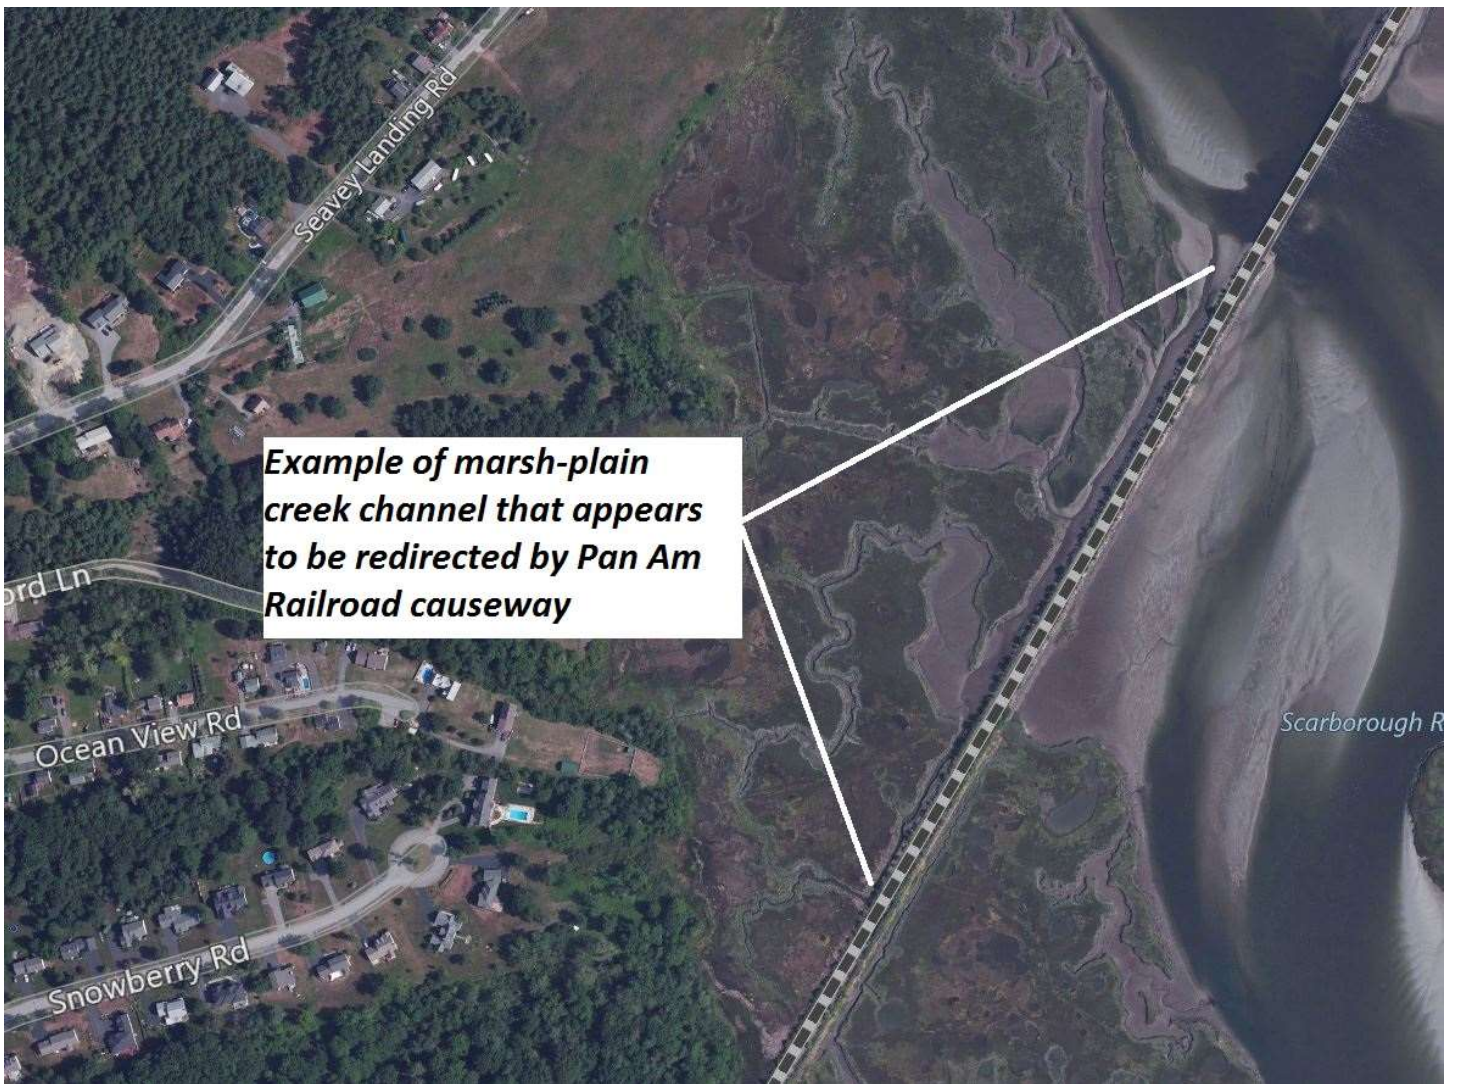
Photo 18 – Location of Site CW-2 on Map B-2

Area CW-2 along the north side of Pan Am Railroad, west of Scarborough River – **Photo 18** presents an aerial view of a local creek which flows northeasterly along the railroad causeway, rather than southerly toward the nearest reach of the Scarborough River.

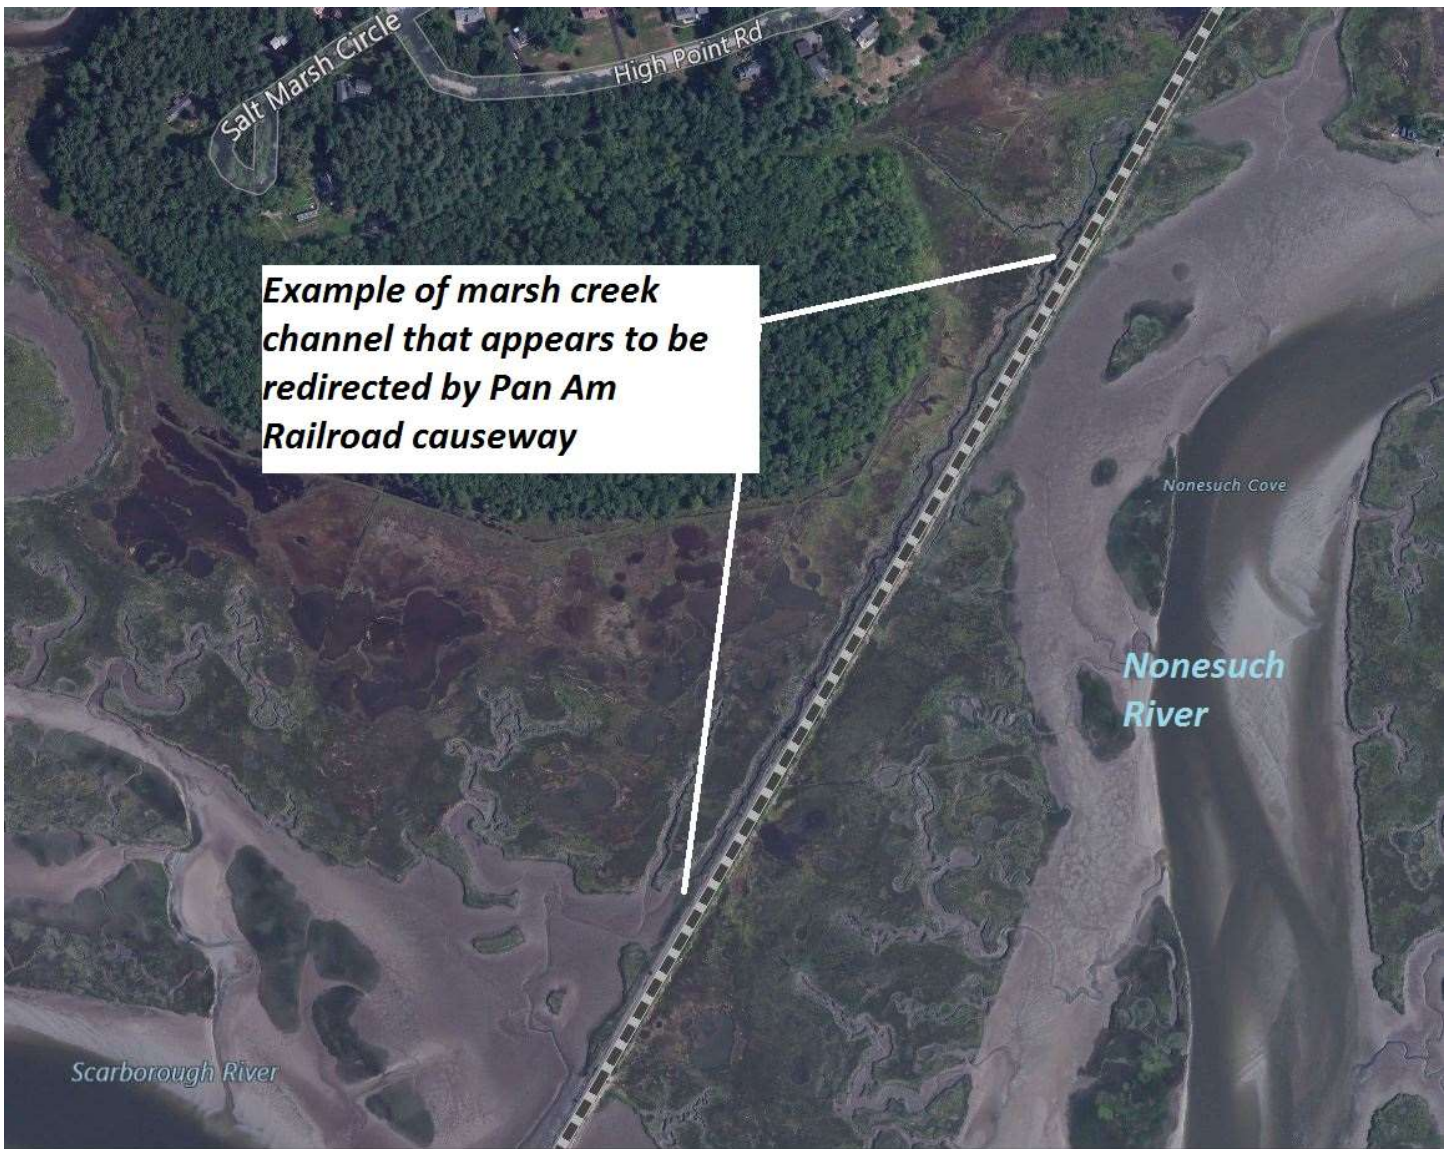
Photo 20a – Location of Site CW-4 on Map B-2

Area CW-4 along the north side of Pan Am Railroad, east of Winnocks Neck Road – **Photo 20a** presents an aerial view of several small creeks that drain southerly to a northeast-flowing collector creek along the base of the railroad causeway, rather than flowing toward the nearest reach of the Nonesuch River immediately south of the railroad. **Photo 20b** shows a ground-level perspective of this feature (view toward the northeast).

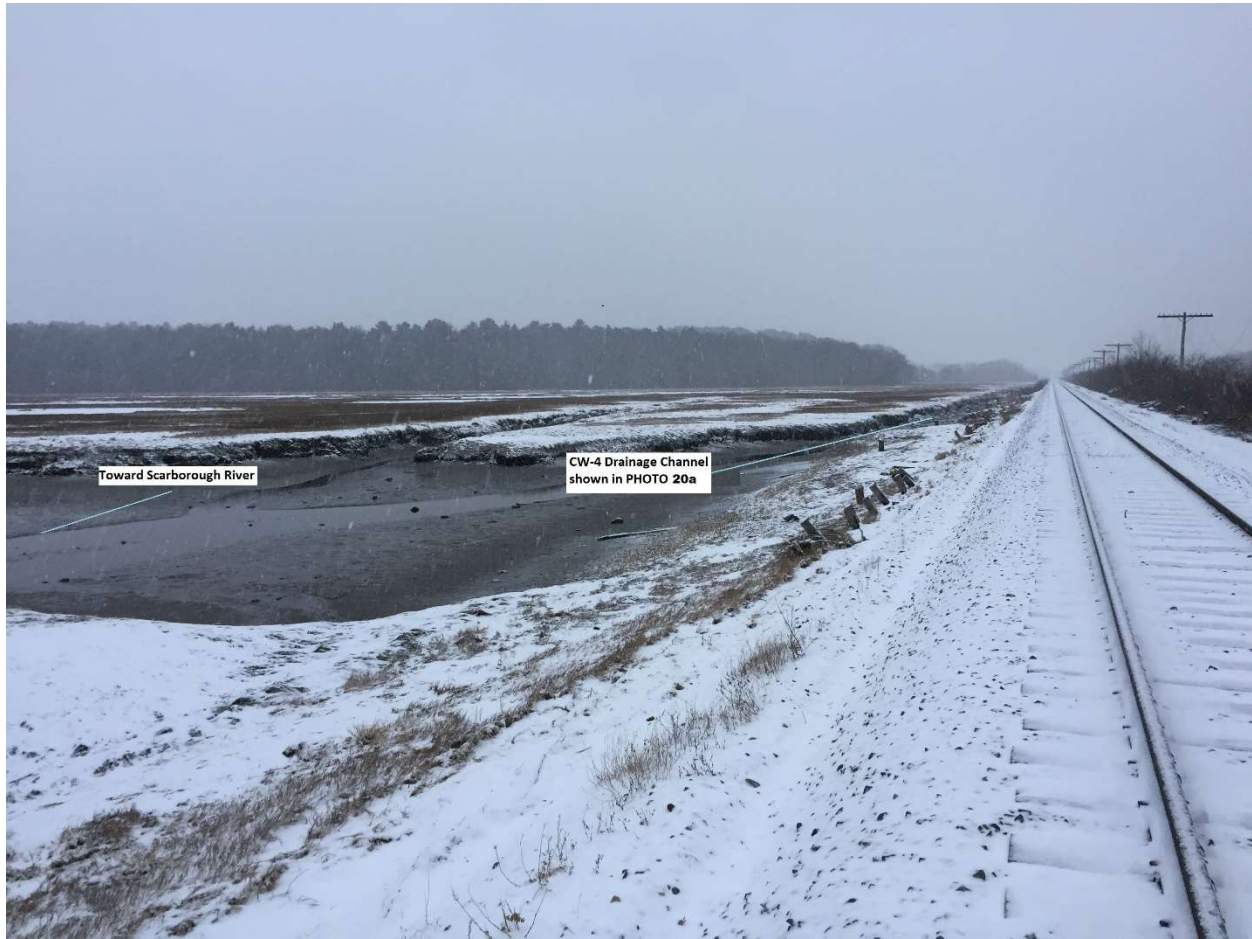
Photo 20b – Ground-level photo of CW-4 site; view is toward the northeast

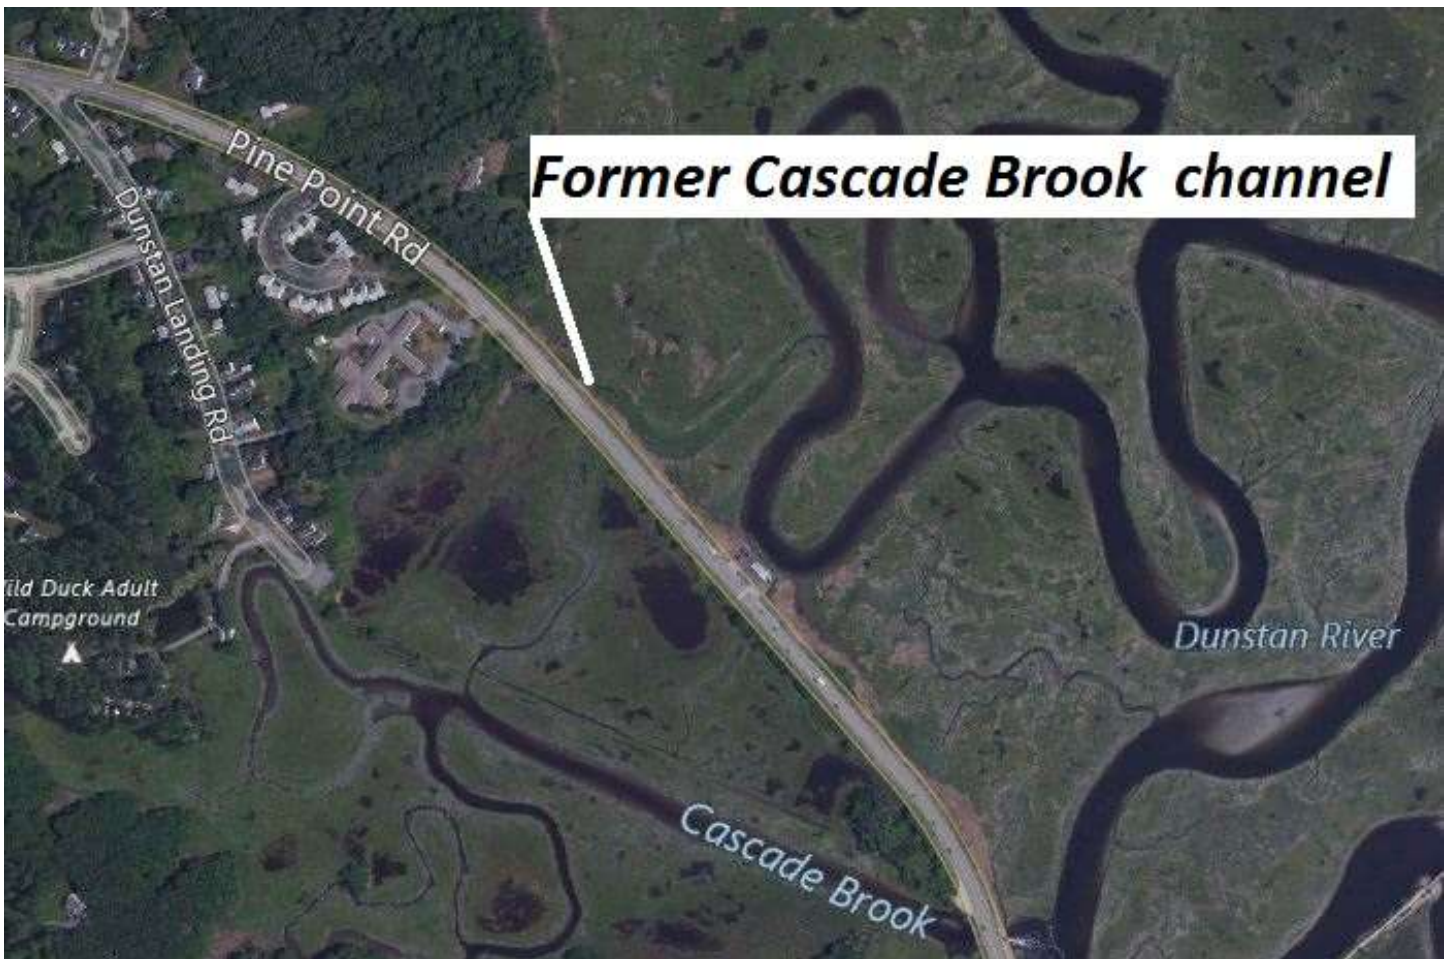
Photo 21 – Location of CW-5 on Map B-1

Area CW-5 on Pine Point Road – **Photo 21** presents an aerial view showing where Pine Point Road crosses an abandoned reach of Cascade Brook (note swath with greener vegetation on right/east side of road). Normandeau and Dewan (2002) recommended establishing a hydrologic connection between both segments of this abandoned channel.
