**SEAVEY LANDING SALT MARSH  
YEAR 5 POST-RESTORATION MONITORING  
PROJECT SUMMARY REPORT**

**SEAVEY LANDING, SCARBOROUGH, MAINE**

**January 2007**

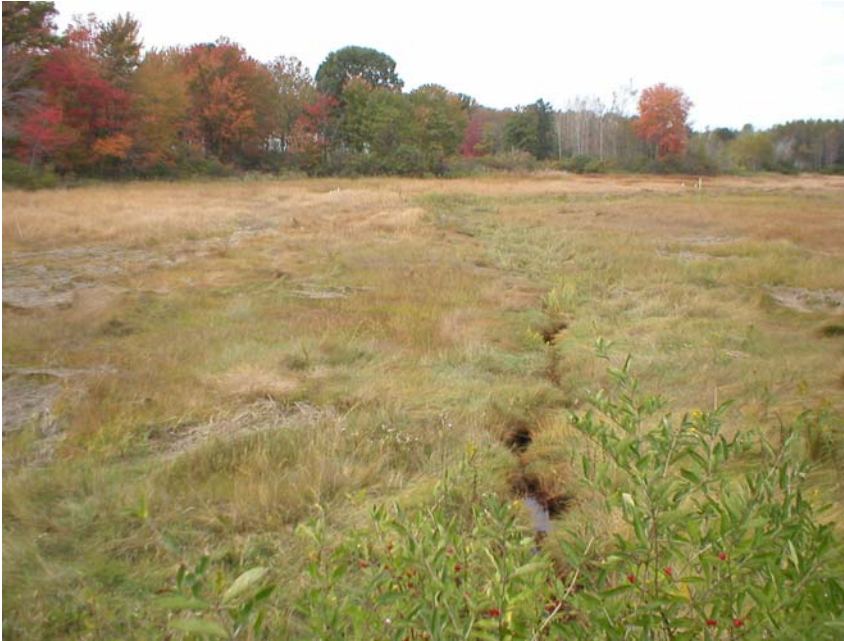
**Photographer:** S. Casto  
**Date:** 10-03-06  
**Photo No.:** 1(3)  
**Direction:** 310

Photo station # 1. Photo shows marsh surface with small drainage ditch in foreground during average low tide condition. Water Sampling Station is visible in far right of photo.

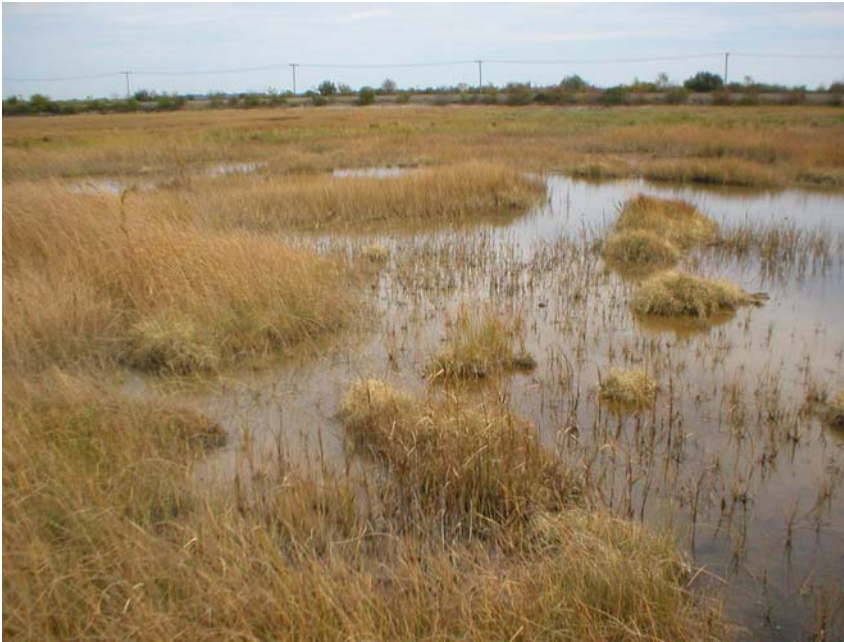
**Photographer:** S. Casto  
**Date:** 10-03-06  
**Photo No.:** 3(3)  
**Direction:** 140

areas, *Spartina patens* and/or *Spartina alterniflora* communities appear to be stressed and the communities appear to be transitioning toward pool or panne habitats (depending on the hydroperiod in each area). See photographs 2(2), 3(3), and 4(2) to 4(4) in Appendix C for examples. In other areas, the inundation appears to be less in the pool and panne habitats and the communities appear to be transitioning toward *Spartina patens* and/or *Spartina alterniflora* communities. See photographs 5(3) to 5(4) in Appendix C for examples. Additionally, an increase in *Typha* communities was observed during Year 4 and 5 (see photographs 4(1), 11, and 22 in Appendix C).

Photo station # 3, looking southeast. Photo shows flooded marsh surface during average low tide condition.

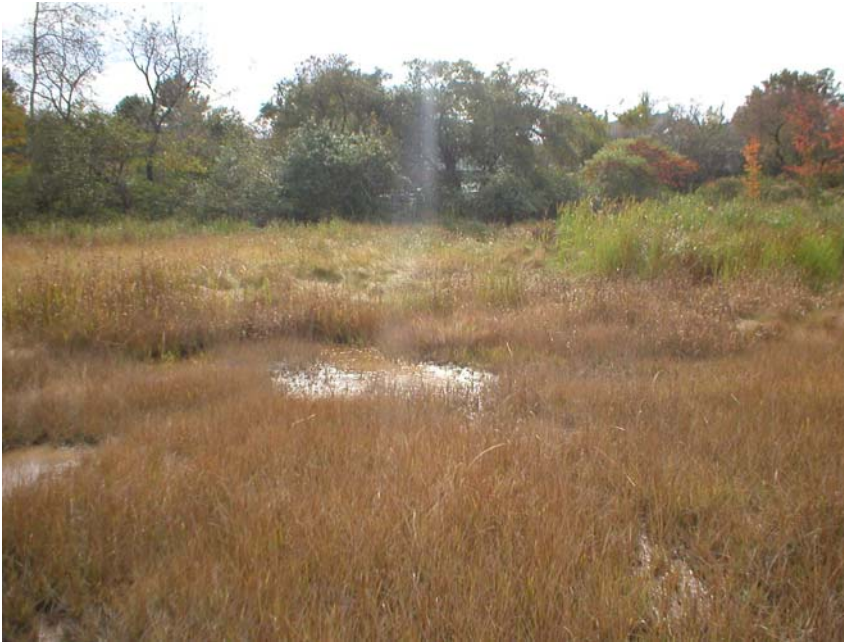
**Photographer:** S. Casto  
**Date:** 10-03-06  
**Photo No.:** 4(1)  
**Direction:** 240

Photo station # 4, looking southwest. Start of panoramic series. Photo shows flooded marsh surface during average low tide condition. Ditch plug # 6 is in the left of this photo. Note the large *Typha* stand in photo (right).

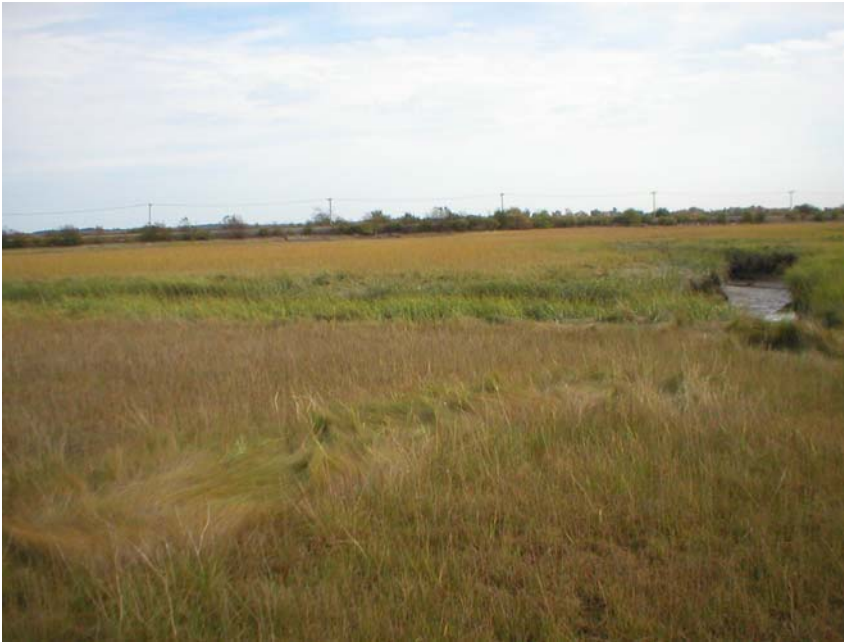
**Photographer:** S. Casto  
**Date:** 10-03-06  
**Photo No.:** 6(1)  
**Direction:** 150

Photo station # 6, looking southeast. Start of the photo series. Photo shows marsh surface during average low tide condition. Channel associated with Ditch Plug # 7 is on the right of the photo.

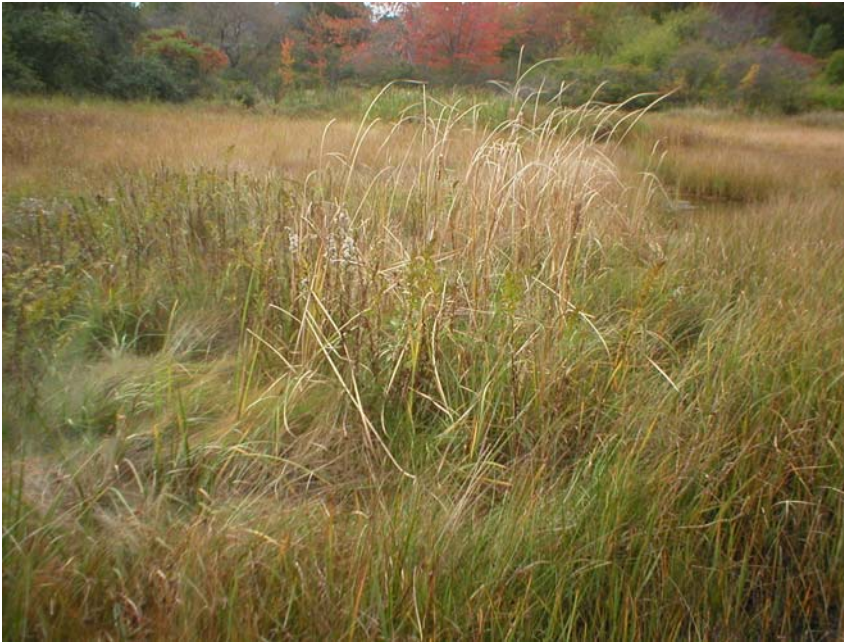
**Photographer:** S. Casto  
**Date:** 10-03-06  
**Photo No.:** 11  
**Direction:** 260

**Comments:**  
Ditch plug # 5 showing no evidence of erosion or leaks. Small stand of undesirable species (*Typha*) present.

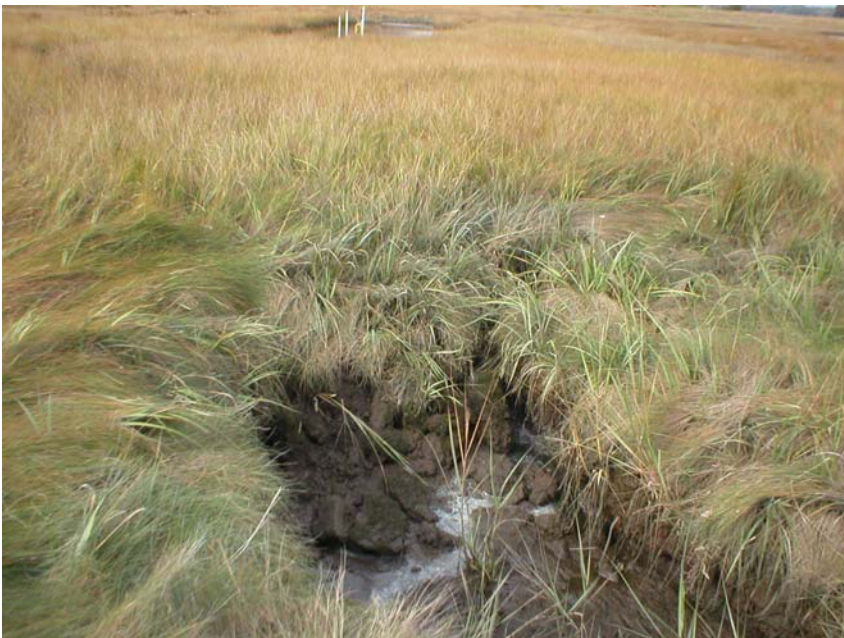
**Photographer:** S. Casto  
**Date:** 10-03-06  
**Photo No.:** 12  
**Direction:** 170

**Comments:**  
Ditch plug # 7 in functional condition showing no evidence of erosion or water leaks.

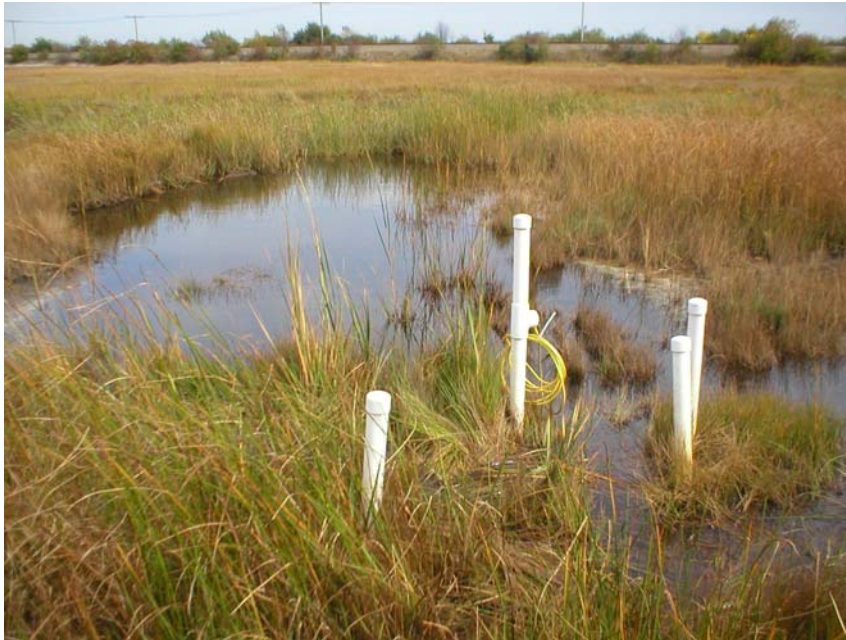
**Photographer:** S. Casto  
**Date:** 10-03-06  
**Photo No.:** 15  
**Direction:** 5

Water Quality Station # 1, looking north/northeast at average low tide conditions. Pool is about 6 to 12 inches deep with various nekton species. Note the water level recorder in place.

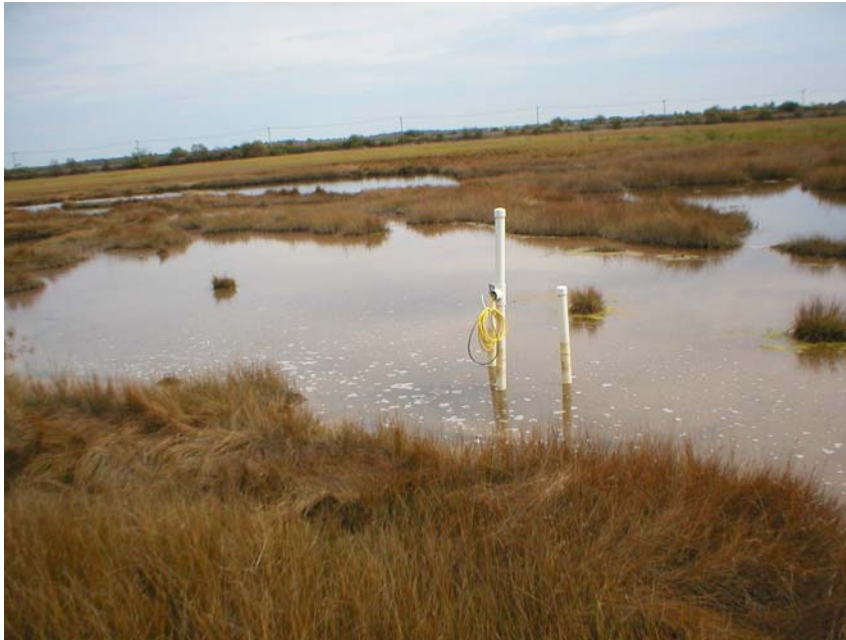
**Photographer:** S. Casto  
**Date:** 10-03-06  
**Photo No.:** 17  
**Direction:** 35

Water Quality Station # 3, looking east/northeast at average low tide conditions. Pool is about 6 inches deep with various nekton species. Note the water level recorder in place.

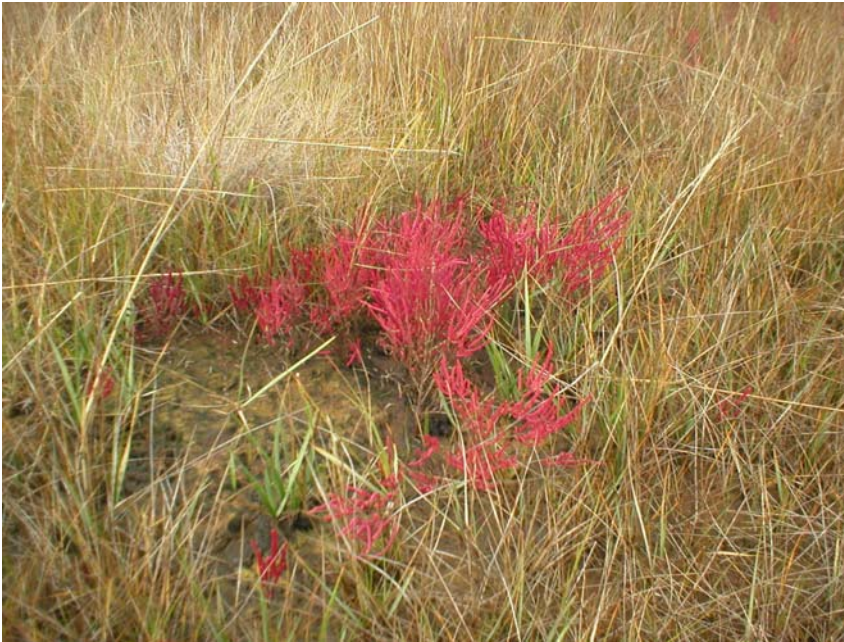
**Photographer:** S. Casto  
**Date:** 10-03-06  
**Photo No.:** 19  
**Direction:** na

Photo shows a native Salicornia spp. An increase in Salicornia coverage on the marsh surface was observed in 2006.
