CASCADE BROOK SALT MARSH RESTORATION MONITORING PROJECT SUMMARY REPORT

CASCADE BROOK, SCARBOROUGH, MAINE

February 2009

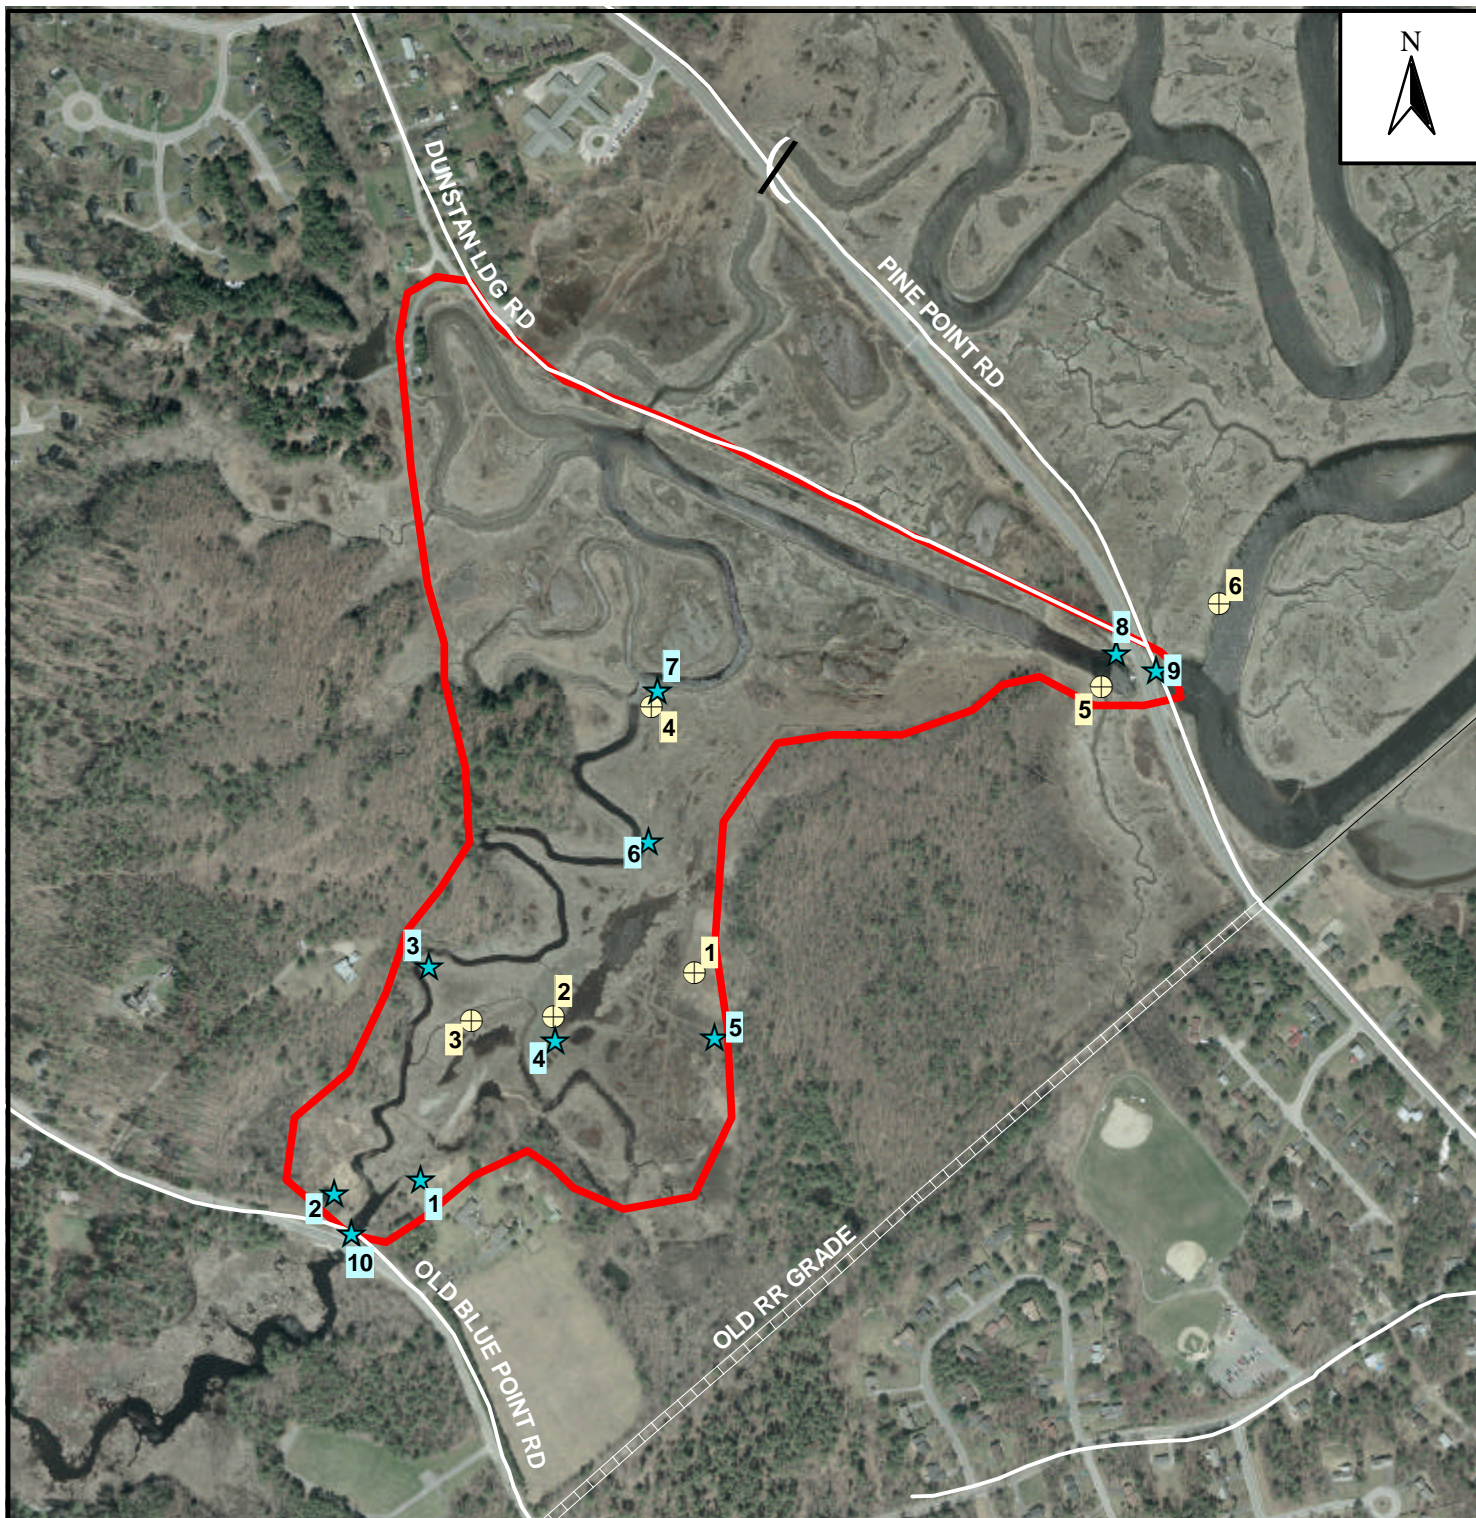
Tidal signal (i.e., surface water depth) and groundwater level were assessed to determine the depth of flooding and duration of inundation of the marsh surface during the tidal cycle. Tidal signal and groundwater level were measured simultaneously using Global Water Model WL15 pressure transducer/data loggers (Global Water Instrumentation, Inc. 2001). To determine water level depth and duration of inundation on the marsh surface data were recorded at five minute intervals at each station for the six week period of August 7, 2008 through September 22, 2008, to record data within a full lunar cycle of two spring and two neap tides. One data gap is present within the collected data for Station 1, when no data was recorded due to battery failure for the 10-day period of August 19, 2008 through August 29, 2008. Figures summarizing the water level data are presented in Appendix E, and water monitoring station locations are shown on Figure 3.

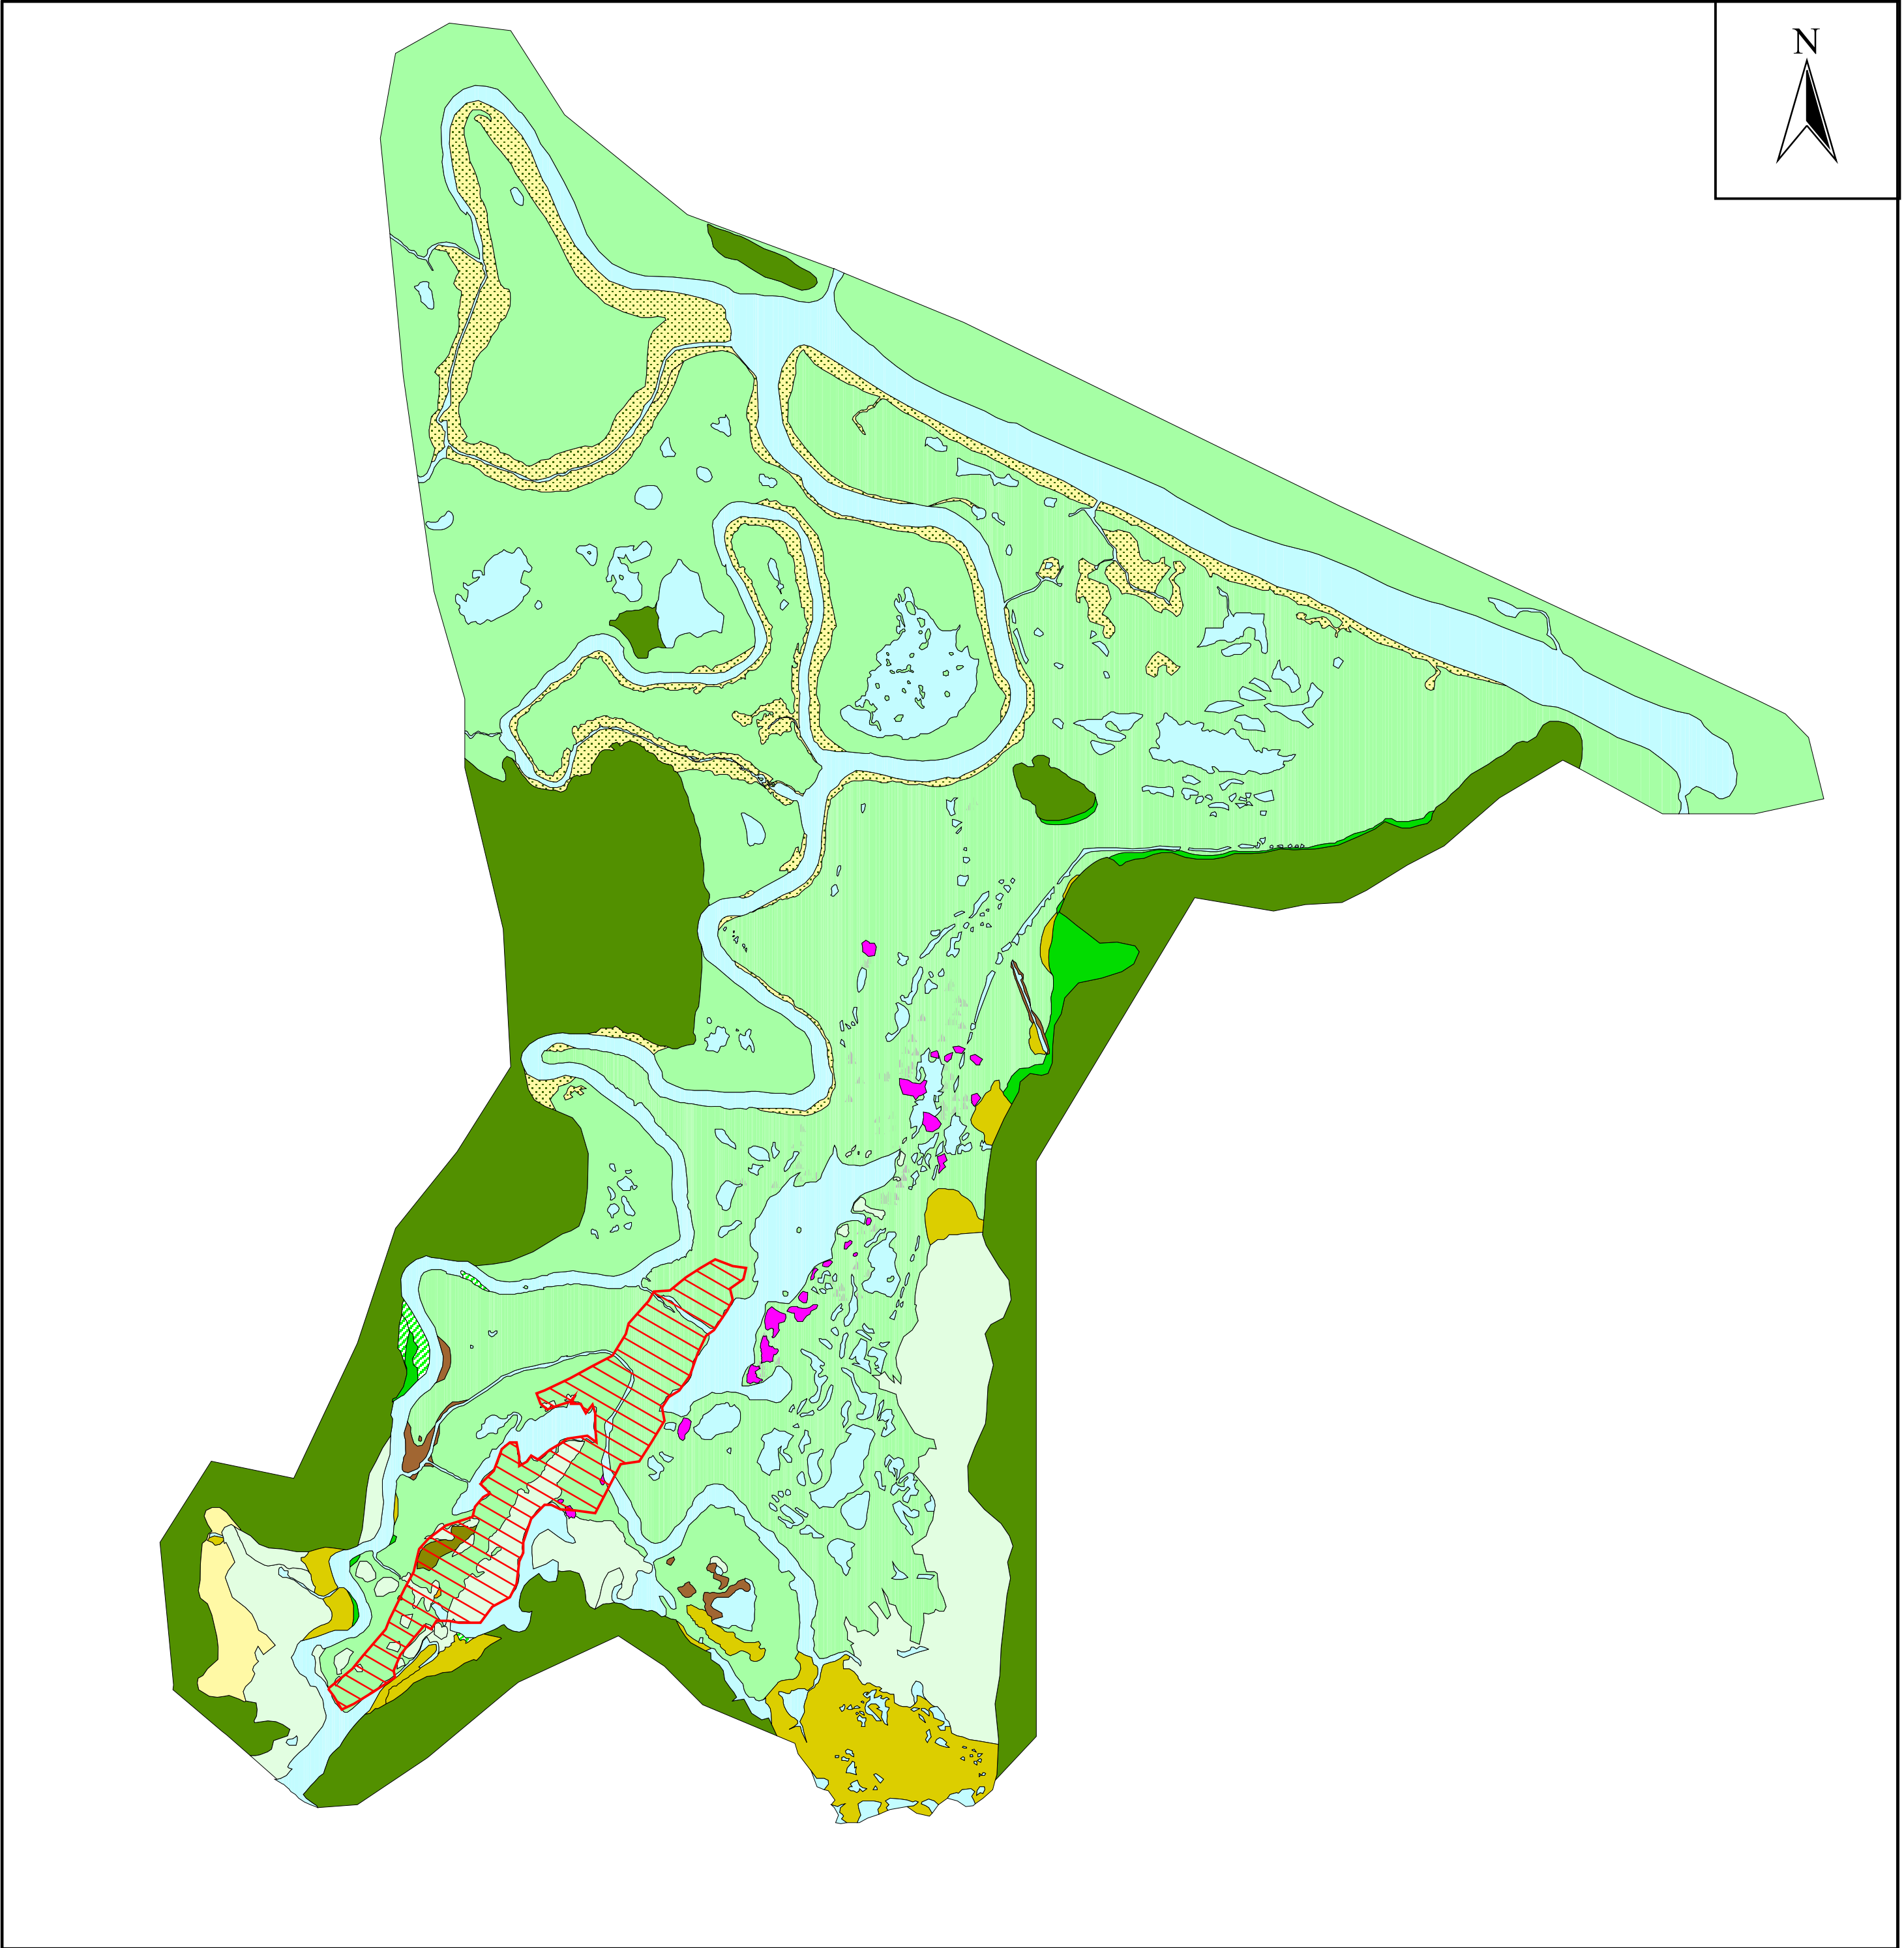
**Pre-Restoration Cover Type Map for
the Cascade Brook Salt Marsh
Restoration Monitoring Project
Scarborough, Maine.**

A cover type map was updated for the 88-acre Project area during the 2008 post-restoration monitoring effort. Updates to the cover type map created during the pre-restoration monitoring conducted in 2002 were based on observations made during an October 31, 2008, site visit. Cover type updates in 2008 included the addition of several new polygons and adjustments to the size and/or shape of a polygon boundary. Minor changes in cover type were noted during successive years of post-restoration monitoring conducted in 2004, 2005, 2006 and 2007, but the cover type map was not updated at those times, pending completion of the Year 5 cover type map update. The 2008 updated cover type map completed as part of Year 5 post-restoration monitoring is provided in Appendix A.

Changes to cover type classification and boundaries were approximated based on a visual assessment of the site conditions during low tide, as observed in the field. A minimum mapping unit of 10 m² (approximately 1,075 ft²) was used. The updated field map was used to update polygon boundaries using a GIS, to create the updated final cover type map. The original 2002 Pre-Restoration, and updated 2008 Post-Restoration cover type maps are included in Appendix A.

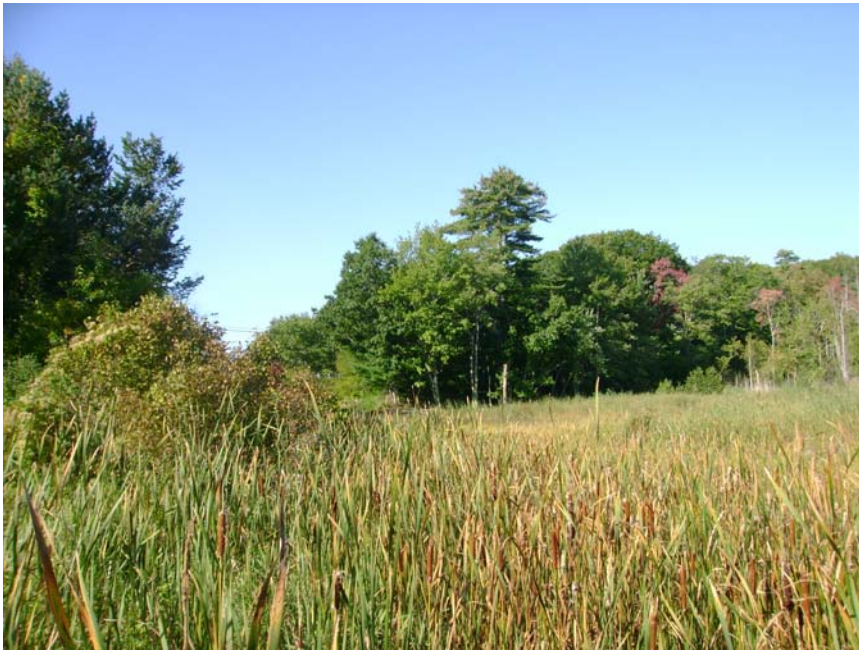
Photo Station #1, low tide.

Phragmites Control Site 1 can be seen in the distance.

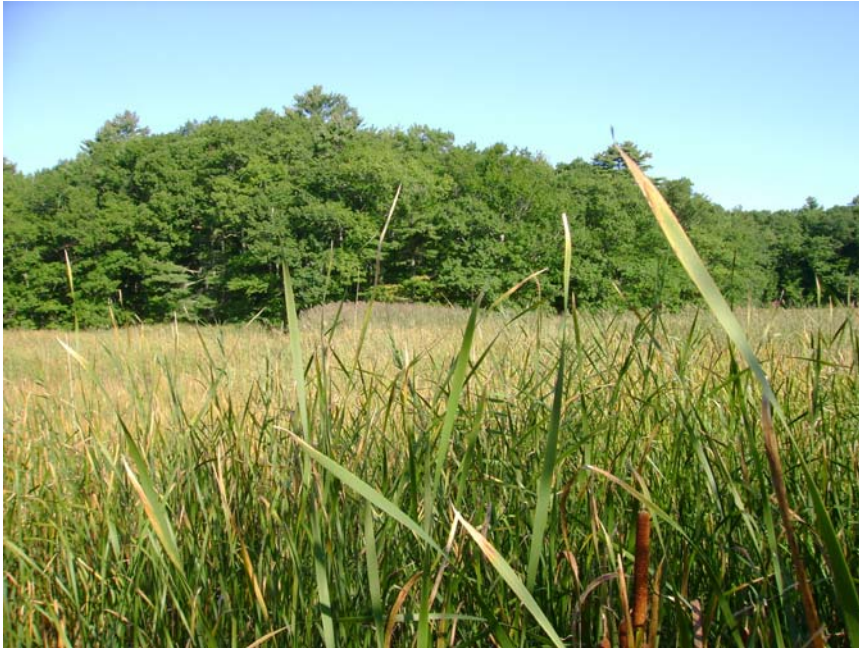
Photographer: L. Rivard
Date: 9/19/08
Photo No.: 1C
Direction: 355

Comments:
Photo Station #1, low tide.

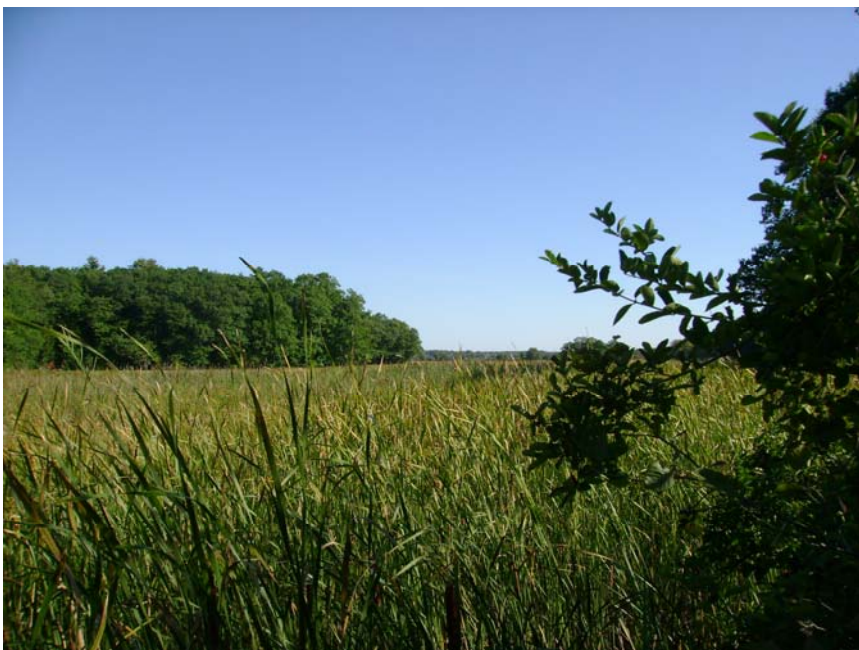
Photographer: L. Rivard
Date: 9/19/08
Photo No.: 1D
Direction: 35

Comments:
Photo Station #1, low tide.

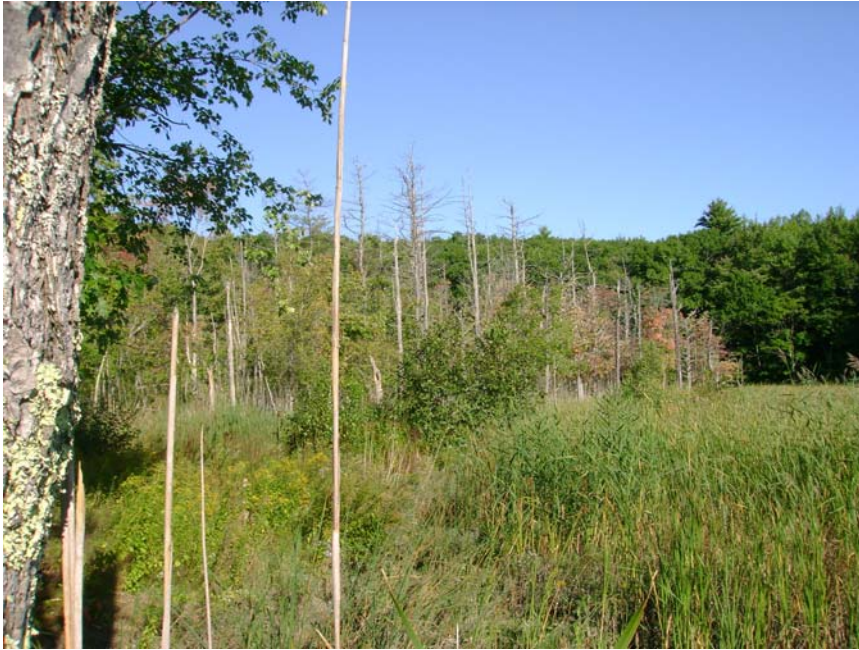
Photo Station #2, low tide.
Phragmites Control Site 1;
forested wetland can be seen in
the distance.

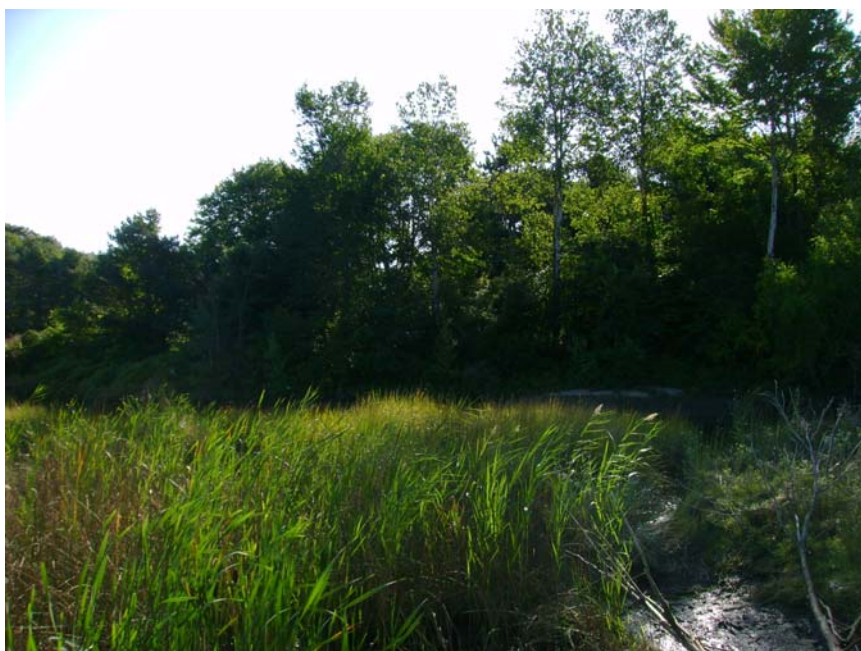
Photo Station #2, low tide.

Phragmites Control Site 1.

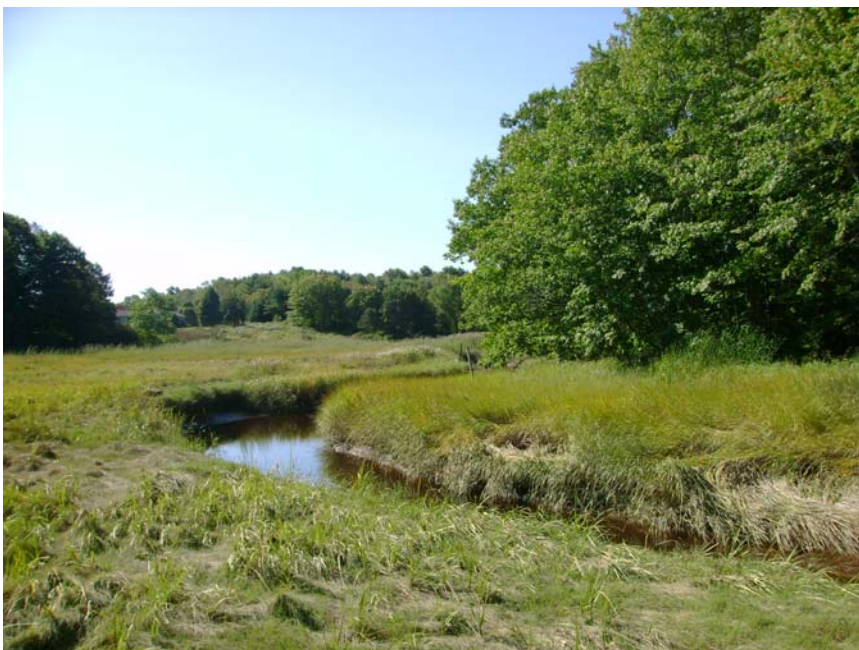
Photo Station #2, low tide.

Phragmites Control Site 1, and
Old Blue Point Road bridge.

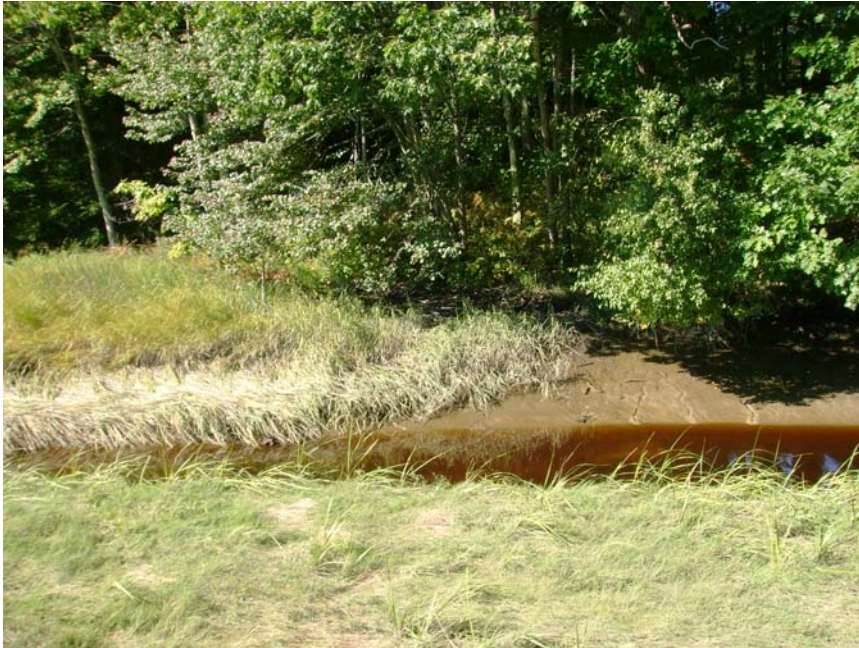
Photographer: L. Rivard
Date: 9/19/08
Photo No.: 3B
Direction: 224

Comments:
Photo Station #3, low tide.
Main tidal creek.

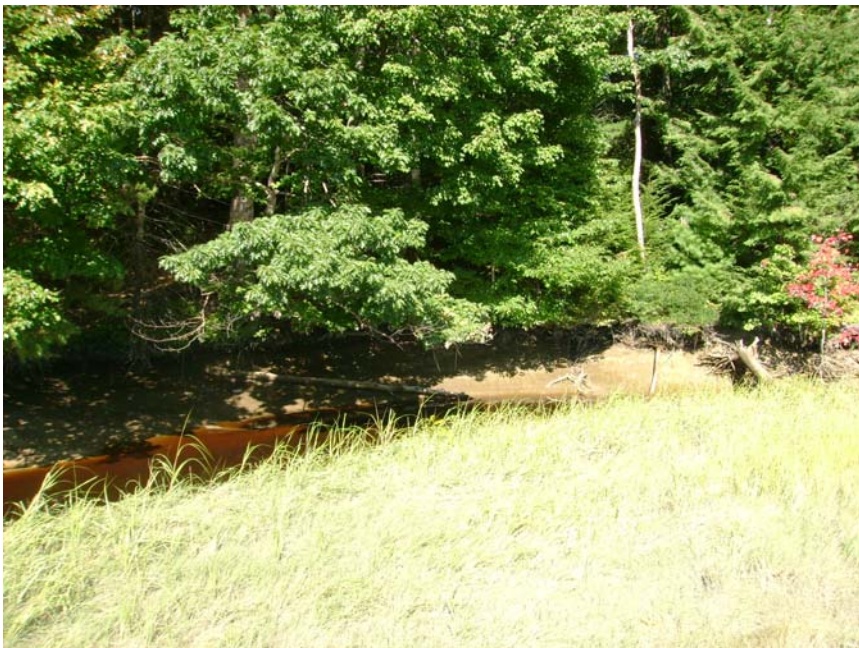
Photographer: L. Rivard
Date: 9/19/08
Photo No.: 3C
Direction: 313

Comments:
Photo Station #3, low tide.
Main tidal creek.

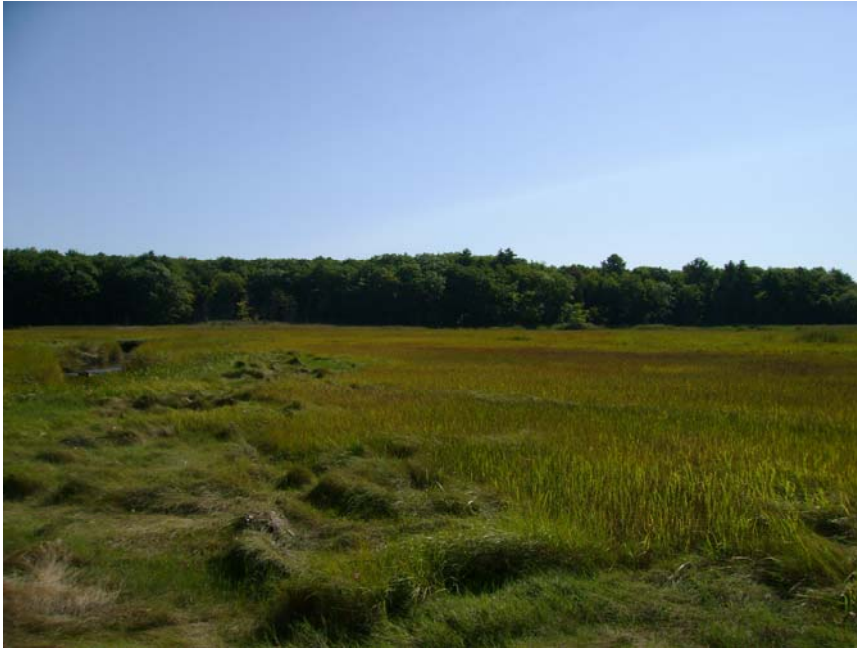
Photographer: L. Rivard
Date: 9/19/08
Photo No.: 3F
Direction: 105

Comments:
Photo Station #3, low tide.

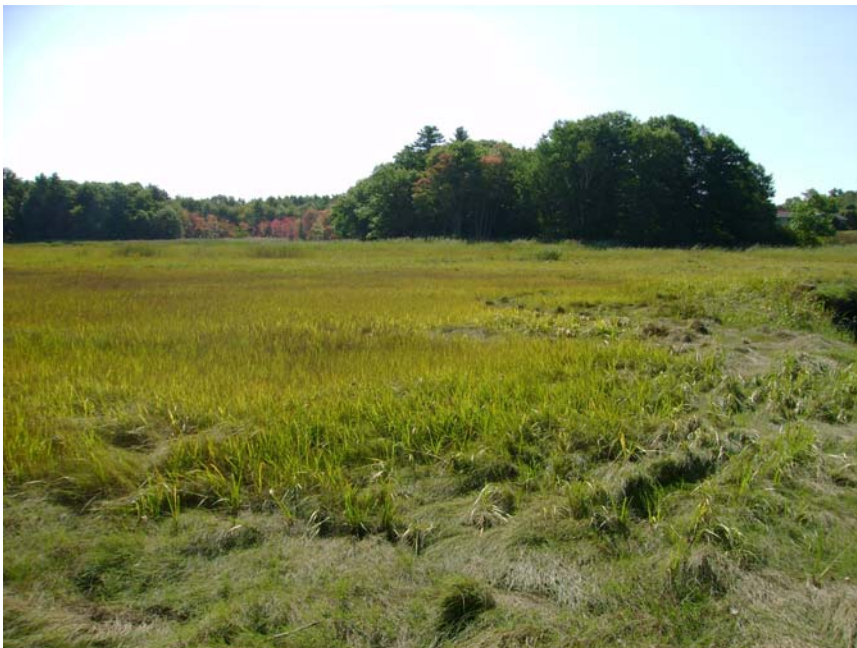
Photographer: L. Rivard
Date: 9/19/08
Photo No.: 3G
Direction: 150

Comments:
Photo Station #3, low tide.

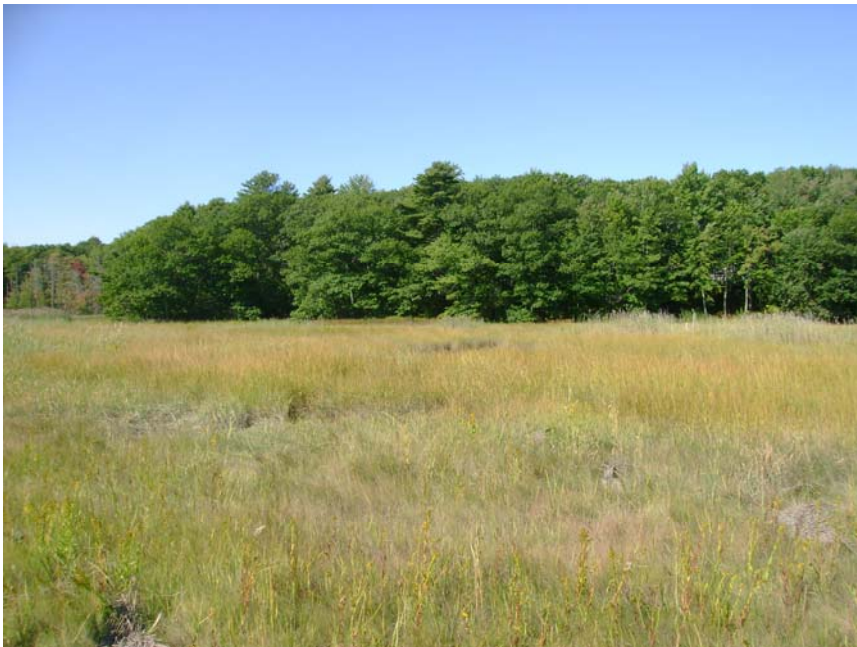
Photo Station #4, low tide.

Phragmites Control Site 2 and Old Blue Point Road bridge can be seen in the distance.

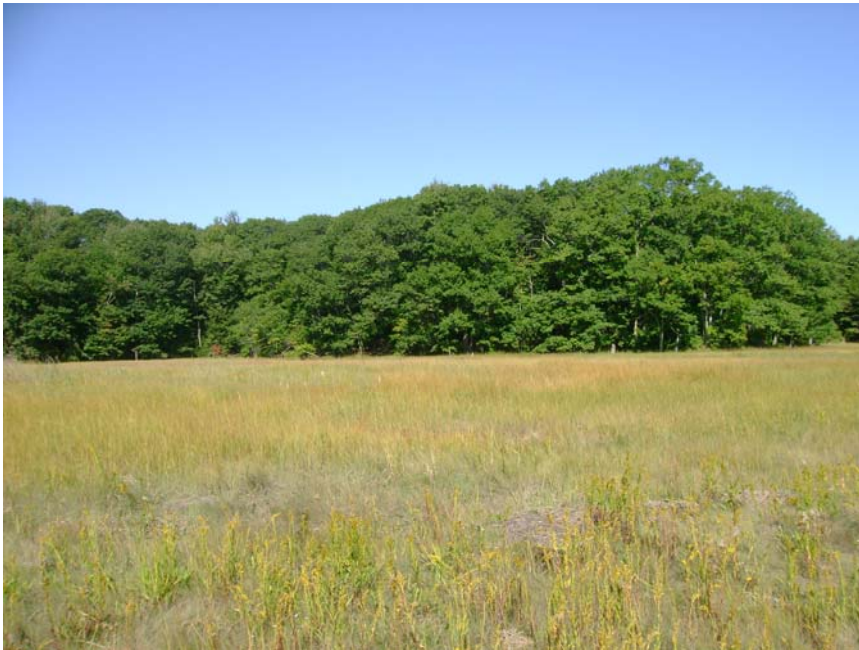
Photographer: L. Rivard
Date: 9/19/08
Photo No.: 4C
Direction: 335

Comments:
Photo Station #4, low tide.

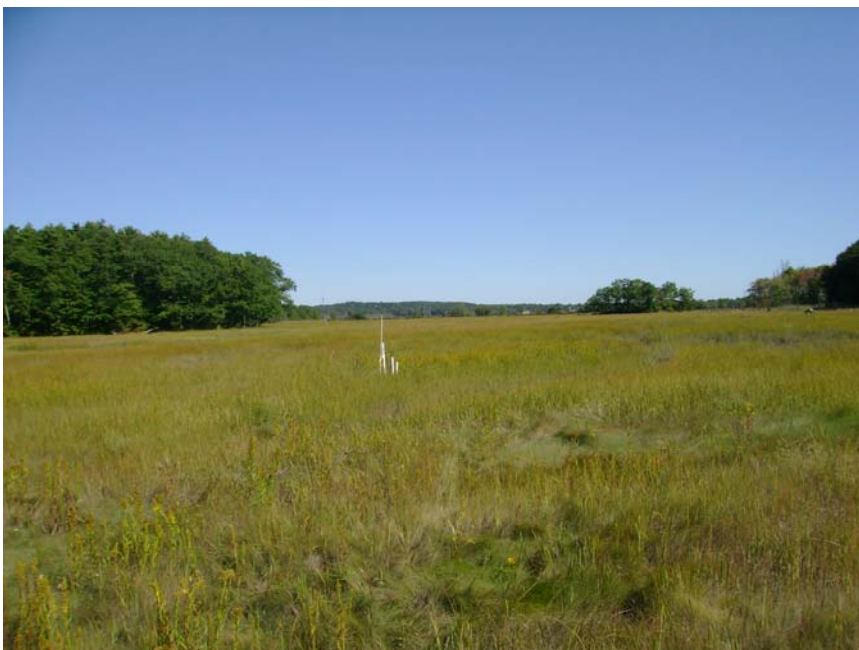
Photographer: L. Rivard
Date: 9/19/08
Photo No.: 4D
Direction: 25

Comments:
Photo Station #4, low tide.
Station #2 can be seen in center.
The largest tidal pond in the
Project area can be seen at right,
with *Spartina* growth the light
green color.

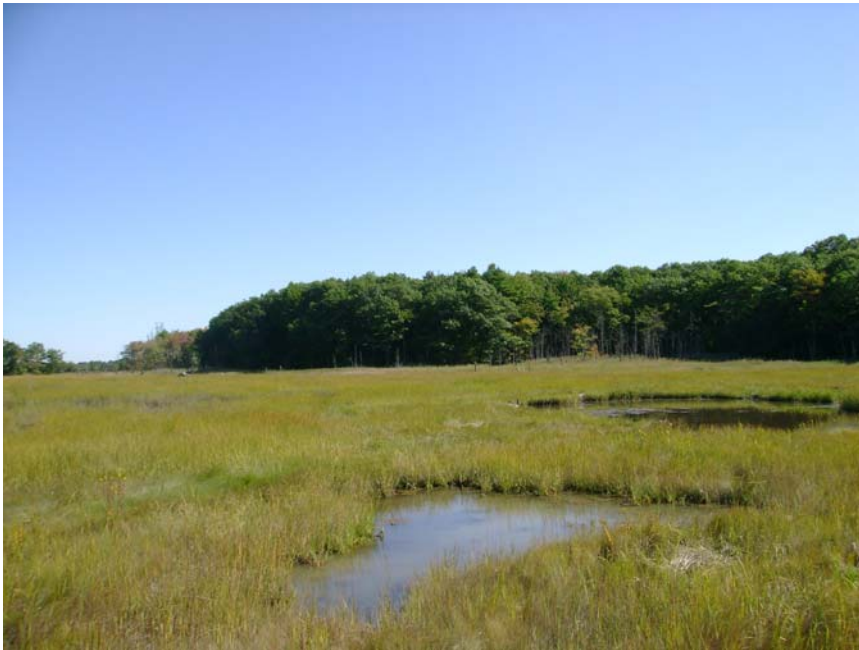
The largest tidal pond in the Project area can be seen at left, with *Spartina* growth the light green color. Phragmites Control Site 4 can be seen in the distance.

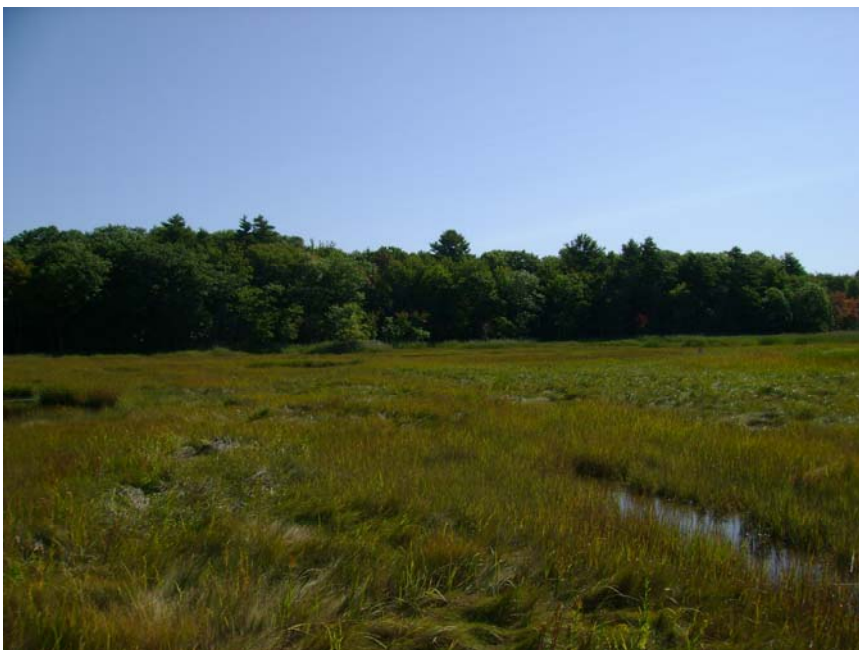
Photo Station #4, low tide.

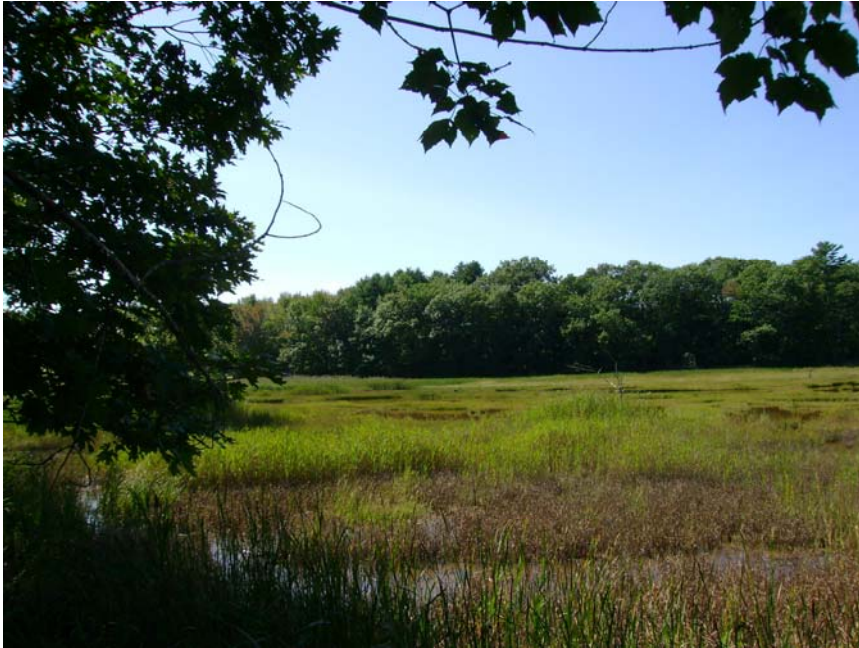
Photographer: L. Rivard
Date: 9/19/08
Photo No.: 5A
Direction: 200

Comments:
Photo Station #5, low tide.
Phragmites Control Site 4.

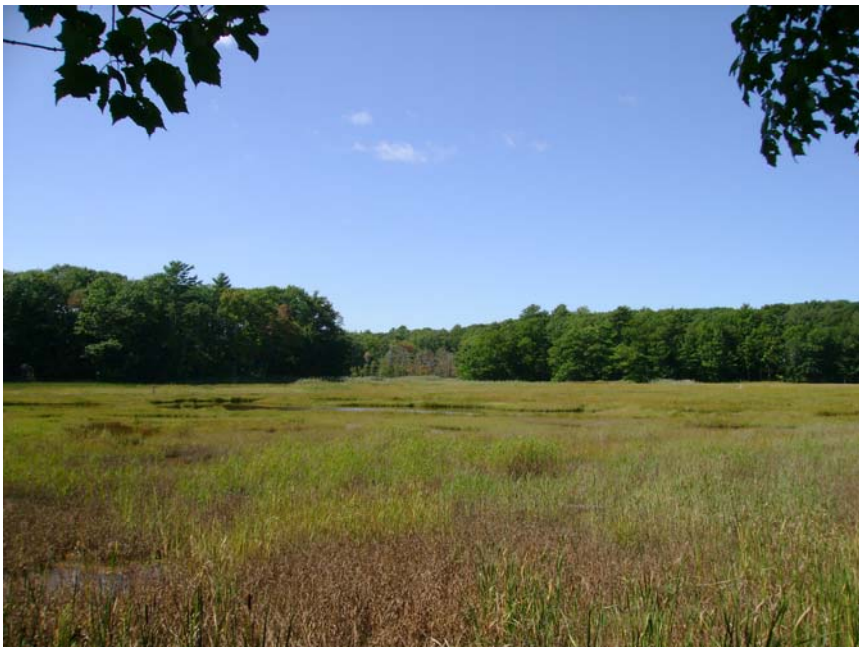
Photographer: L. Rivard
Date: 9/19/08
Photo No.: 5B
Direction: 245

Comments:
Photo Station #5, low tide.
Phragmites Control Site 4.

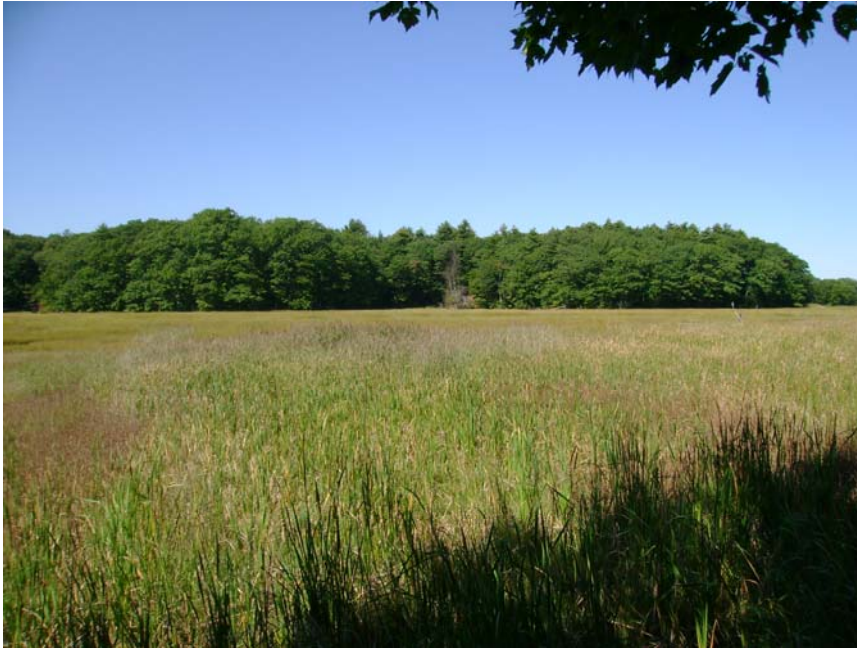
Photographer: L. Rivard
Date: 9/19/08
Photo No.: 5C
Direction: 290

Comments:
Photo Station #5, low tide.
Phragmites Control Site 4.

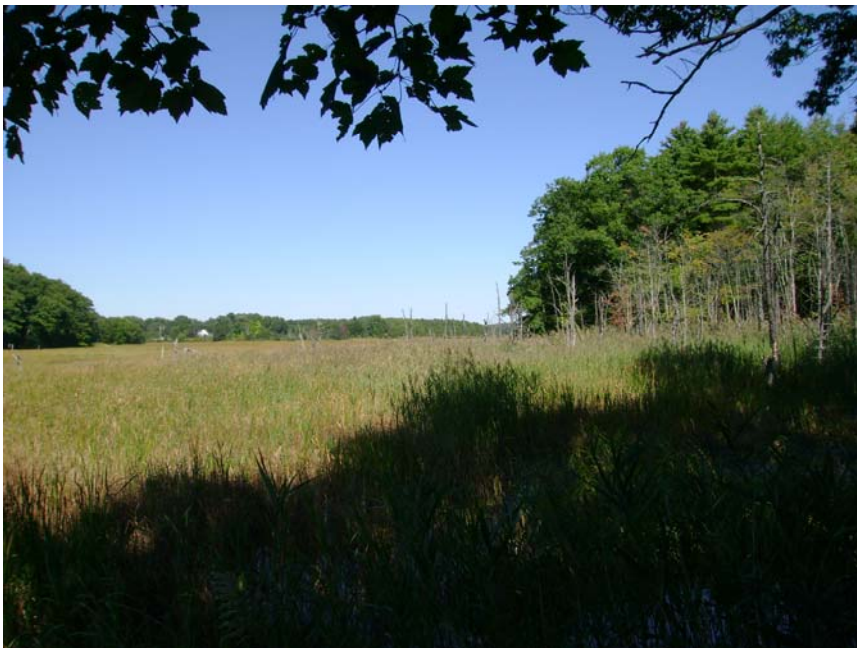
Photographer: L. Rivard
Date: 9/19/08
Photo No.: 5D
Direction: 340

Comments:
Photo Station #5, low tide.
Phragmites Control Site 4.

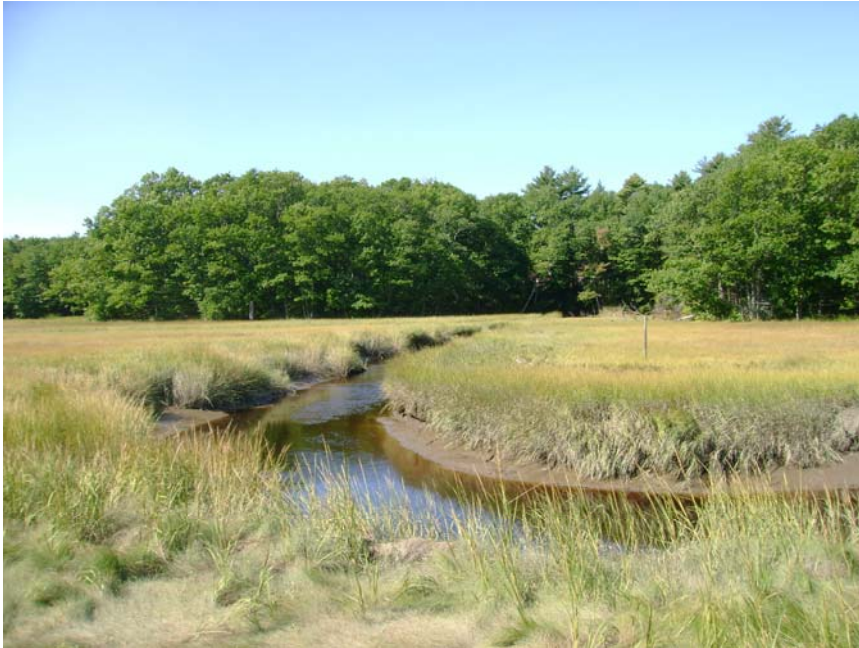
Photographer: L. Rivard
Date: 9/19/08
Photo No.: 6A
Direction: 250

Comments:
Photo Station #6, low tide.
Main tidal creek.

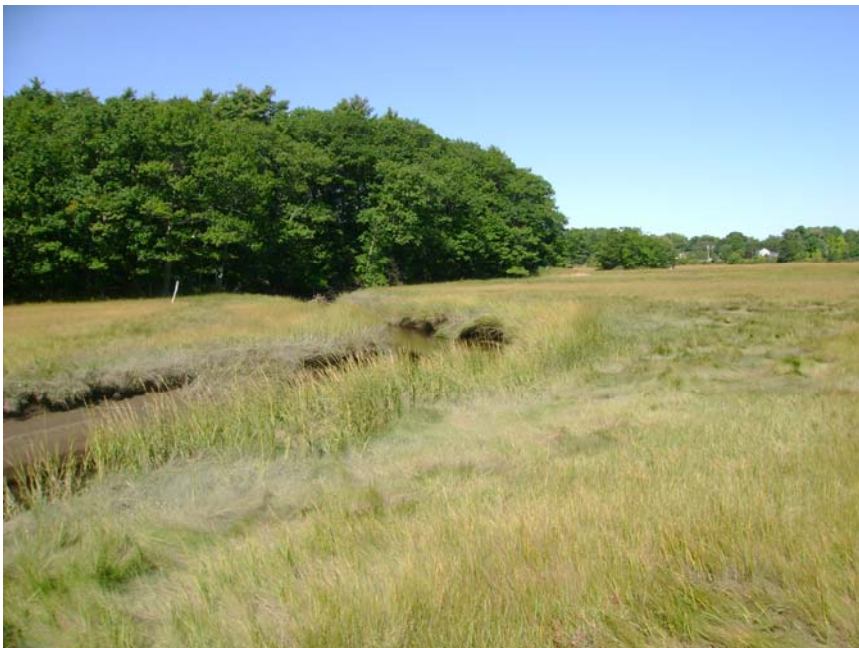
Photographer: L. Rivard
Date: 9/19/08
Photo No.: 6B
Direction: 295

Comments:
Photo Station #6, low tide.
Main tidal creek.

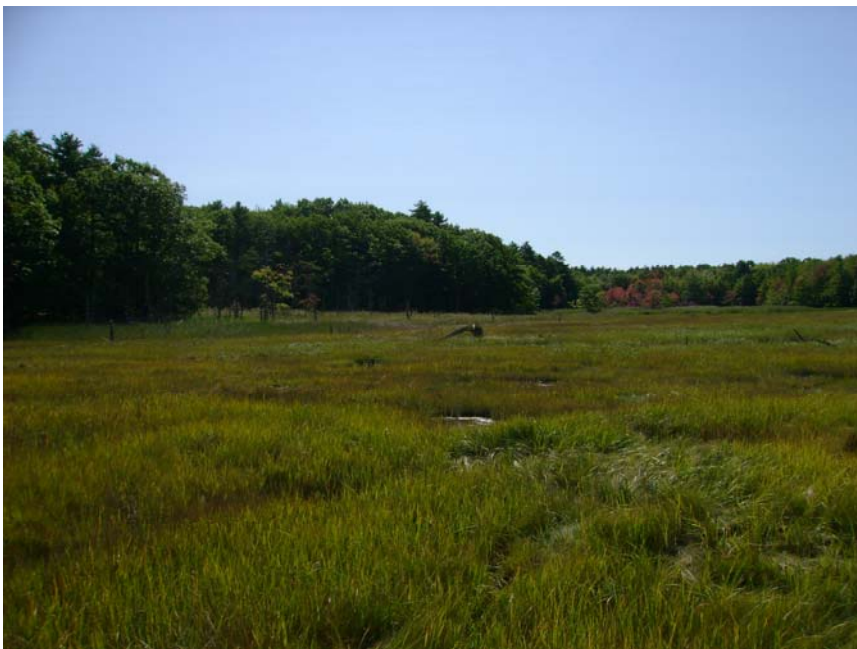
Photographer: L. Rivard
Date: 9/19/08
Photo No.: 6F
Direction: 160

Comments:
Photo Station #6, low tide.
Phragmites Control Site 4 can be seen in the distance.

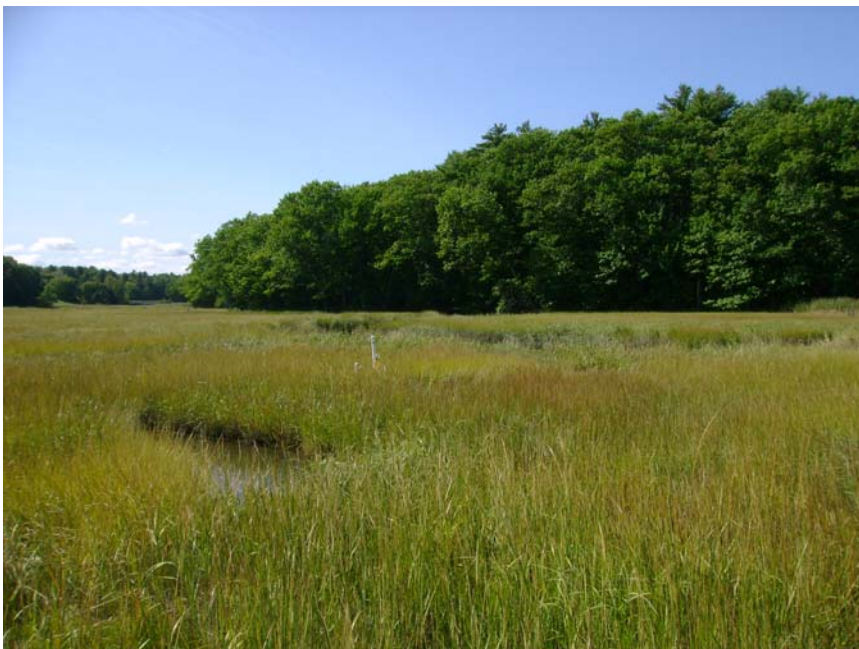
Photographer: L. Rivard
Date: 9/19/08
Photo No.: 7A
Direction: 230

Comments:
Photo Station #7, low tide.
Station #4 can be seen in the center. Main tidal creek.

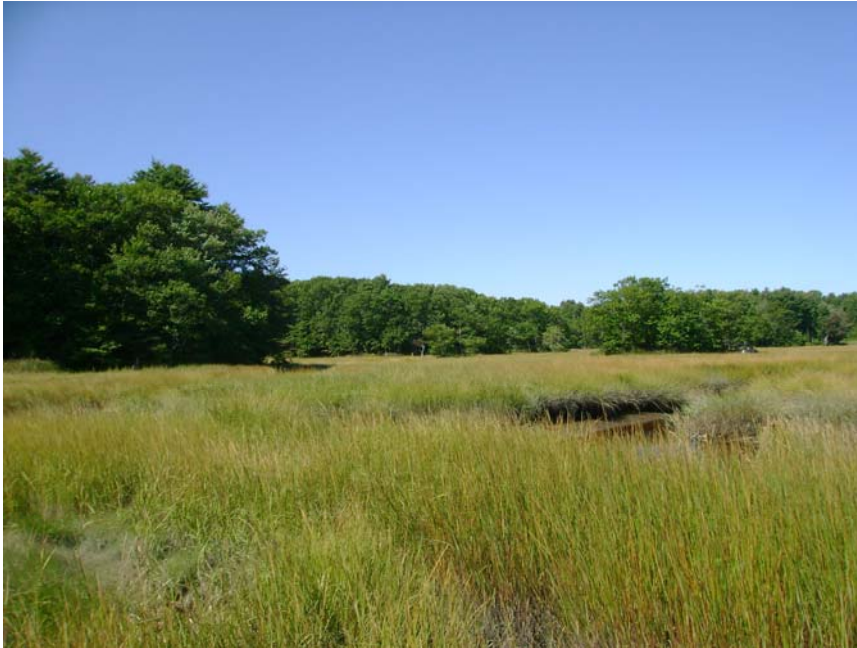
Photographer: L. Rivard
Date: 9/19/08
Photo No.: 7B
Direction: 280

Comments:
Photo Station #7, low tide.
Main tidal creek.

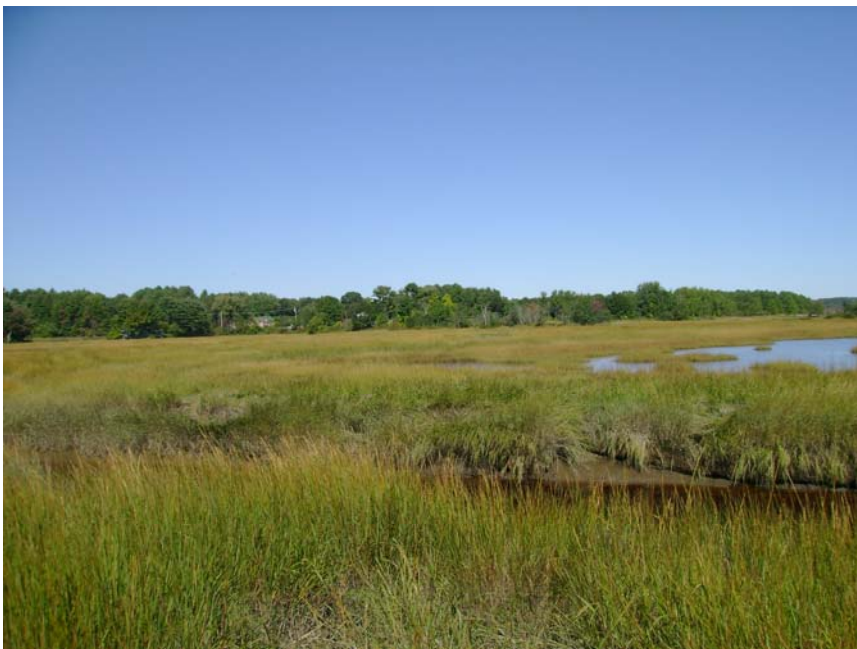
Photographer: L. Rivard
Date: 9/19/08
Photo No.: 7C
Direction: 335

Comments:
Photo Station #7, low tide.
Main tidal creek.

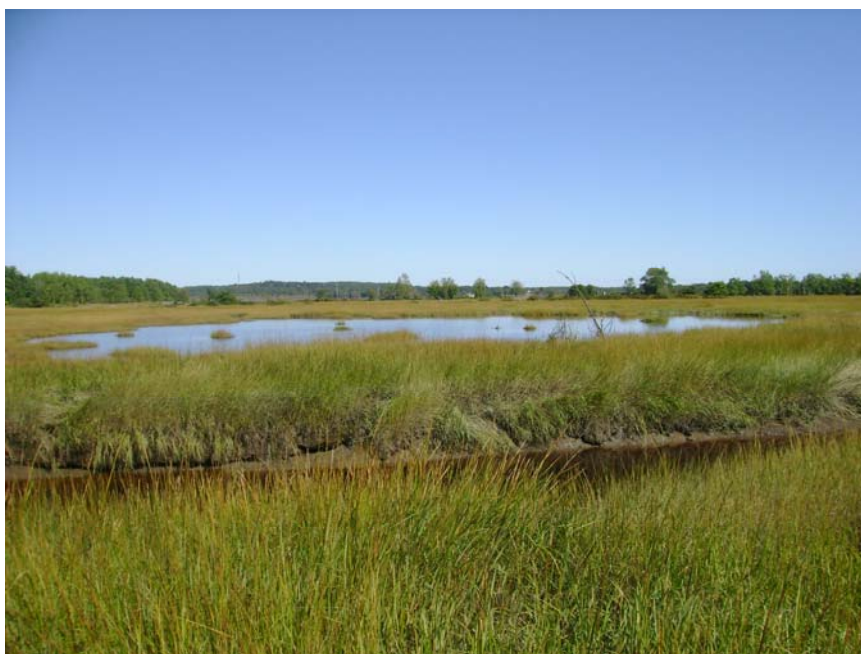
Photographer: L. Rivard
Date: 9/19/08
Photo No.: 7D
Direction: 15

Comments:
Photo Station #7, low tide.
Main tidal creek.

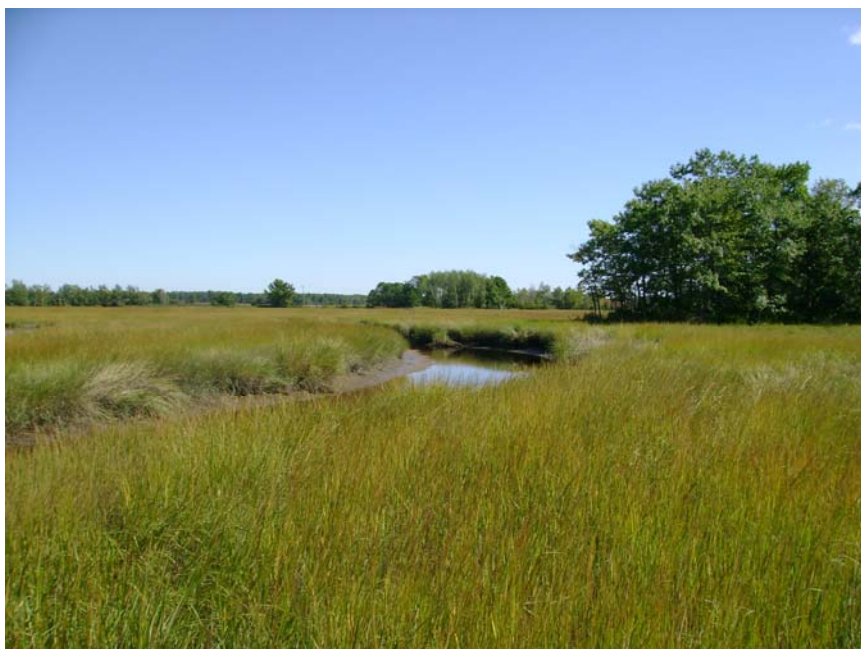
Photographer: L. Rivard
Date: 9/19/08
Photo No.: 7E
Direction: 85

Comments:
Photo Station #7, low tide.
Main tidal creek and pools.

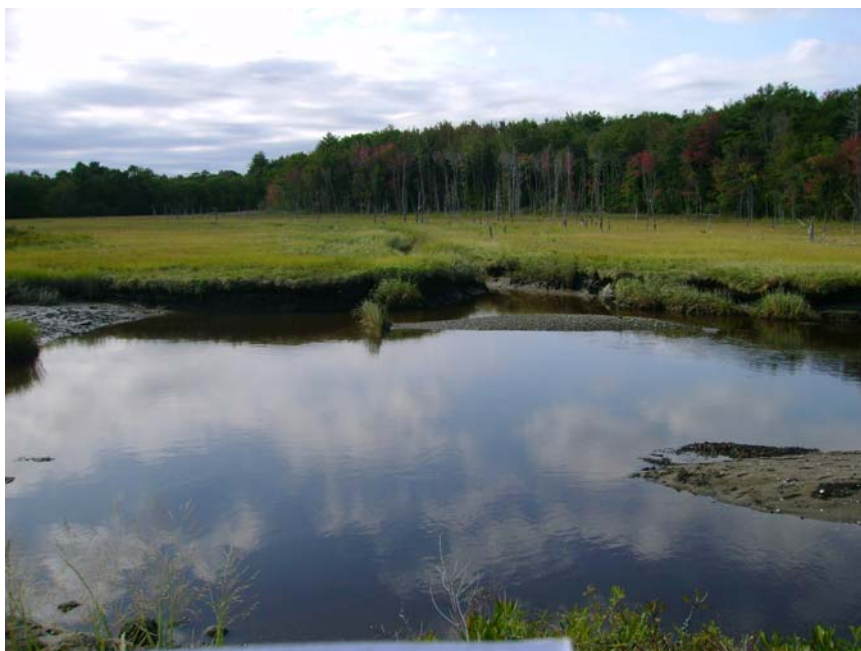
Pine Point Road culvert, upstream,
and water control structures.

Dunstan Canal/ main tidal creek.
