CASCADE BROOK SALT MARSH RESTORATION MONITORING PROJECT SUMMARY REPORT

CASCADE BROOK, SCARBOROUGH, MAINE

February 2009

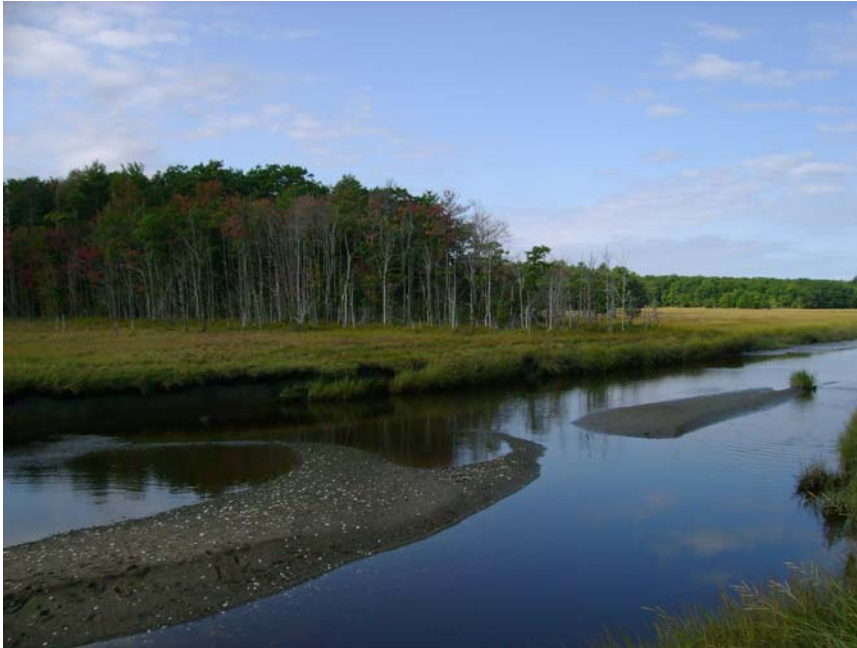
Photographer: L. Rivard
Date: 9/22/08
Photo No.: 8C
Direction: 245

Comments:
Photo Station #8, low tide.
Dunstan Canal.

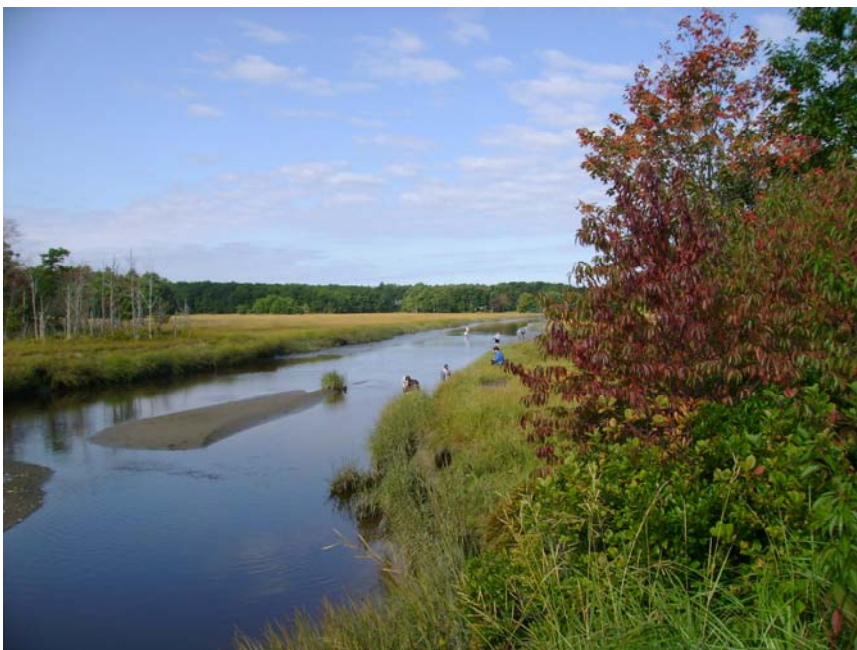
Photographer: L. Rivard
Date: 9/22/08
Photo No.: 8D
Direction: 275

Comments:
Photo Station #8, low tide.
Dunstan Canal.

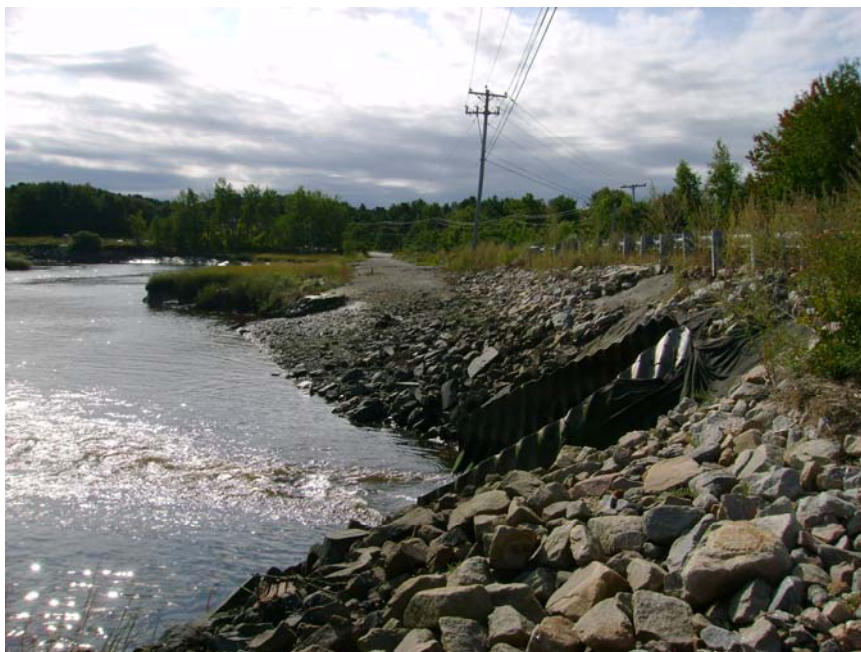
Photographer: L. Rivard
Date: 9/22/08
Photo No.: 9A
Direction: 180

Comments:
Photo Station #9, low tide.
Pine Point Road culvert,
downstream. Dunstan River.

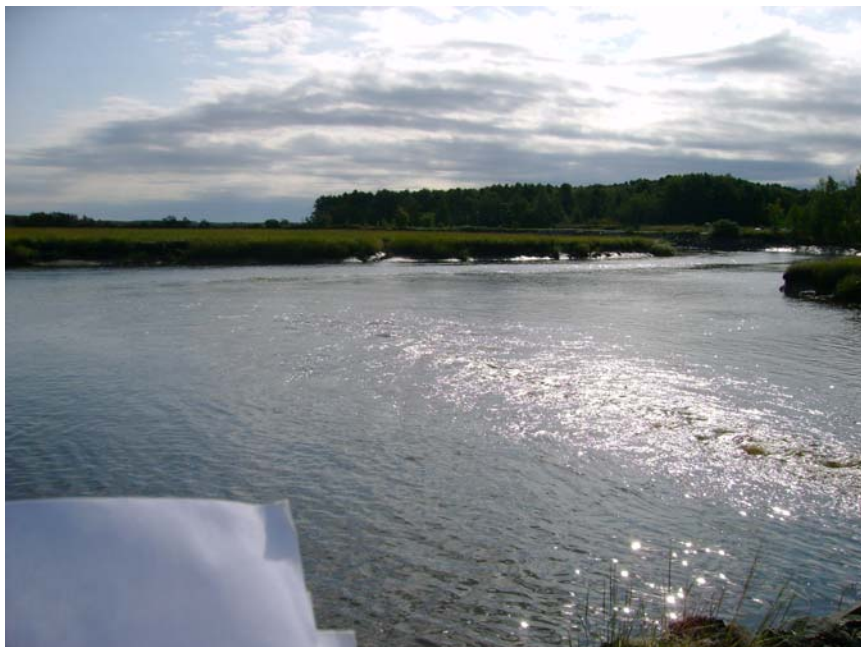
Photographer: L. Rivard
Date: 9/22/08
Photo No.: 9B
Direction: 135

Comments:
Photo Station #9, low tide.
Dunstan River.

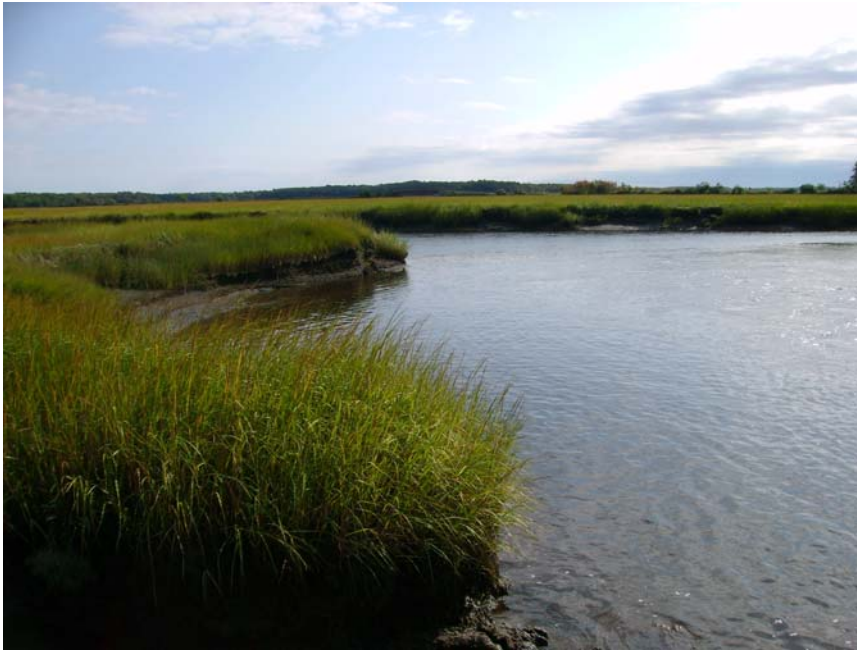
Photographer: L. Rivard
Date: 9/22/08
Photo No.: 9C
Direction: 90

Comments:
Photo Station #9, low tide.
Dunstan River.

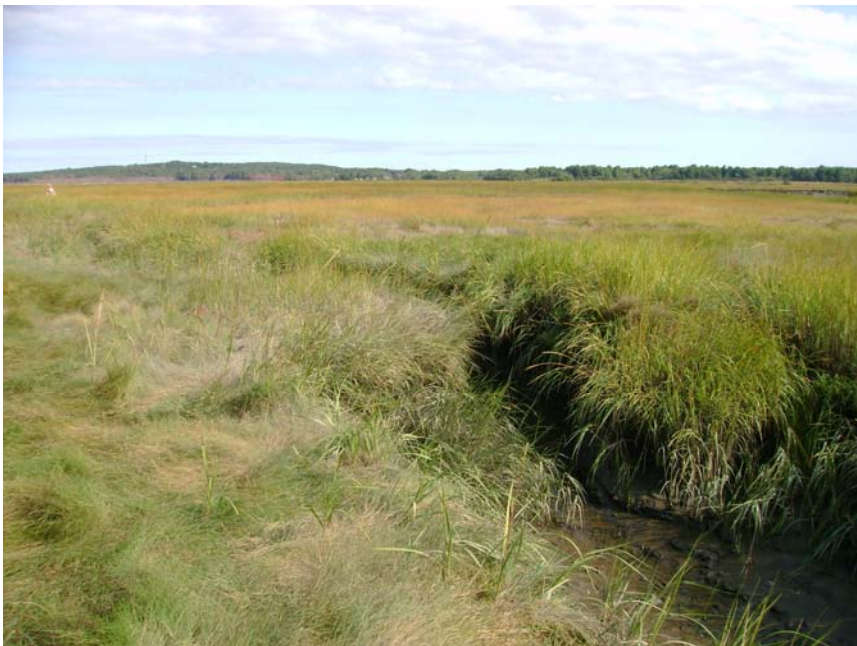
Photographer: L. Rivard
Date: 9/22/08
Photo No.: 9D
Direction: 45

Comments:
Photo Station #9, low tide.

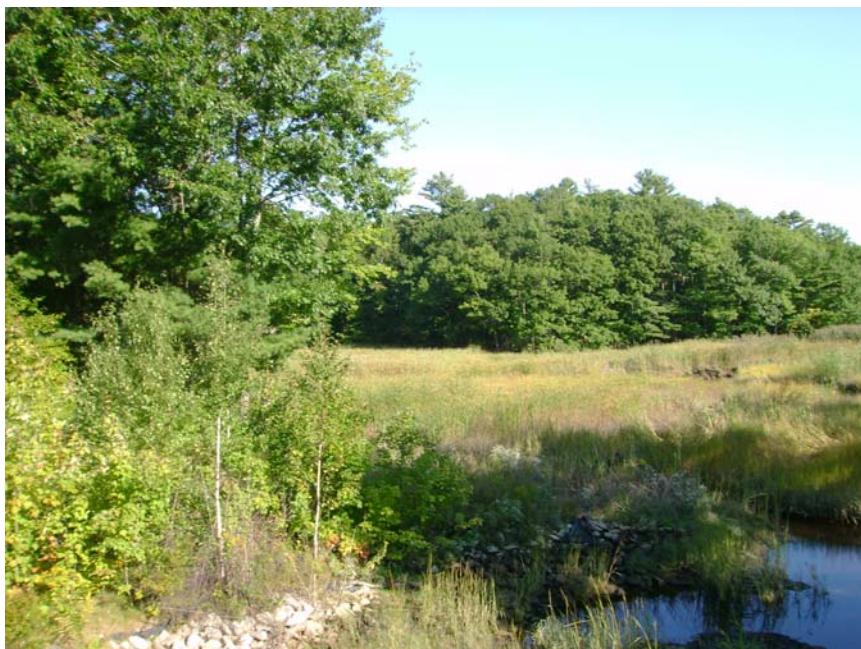
Photographer: L. Rivard
Date: 9/19/08
Photo No.: 10A
Direction: 340

Comments:
Photo Station #10, low tide.
Phragmites Control Site 1. Riprap
rock and silt fence stabilize the
banks.

When compared to pre-restoration photographs, the photos of the *Phragmites* control areas (i.e., Photo Stations #1A-C, 2A-E, 4A, 4E-F, 5A-D, and 10A-B) show that the homogenous *Phragmites* stands have been reduced significantly, however regrowth of *Phragmites* can be observed in some areas. Additionally, areas where *Phragmites* was excavated are repopulating with a combination of undesirable (i.e., *Phragmites*) and desirable salt marsh species. Photos of the SRA (i.e., Photo Stations #4B-D, 6E-G, and 10A-B) continue to show that the marsh is revegetating following the removal of the spoil material deposited following the road and culvert failure.

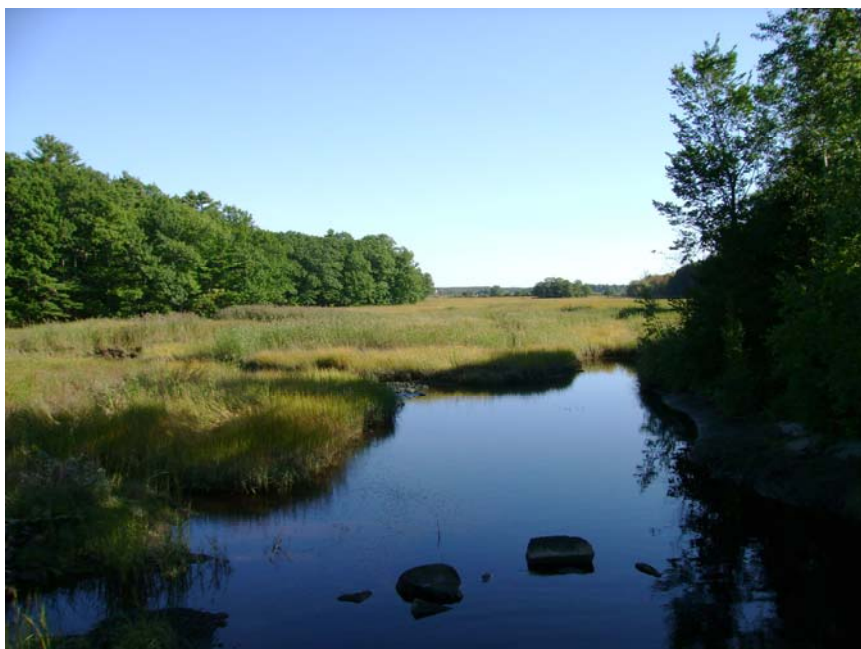
Photographer: L. Rivard
Date: 9/19/08
Photo No.: 10B
Direction: 35

Comments:
Photo Station #10, low tide.
Phragmites Control Site 1. Main
tidal creek.

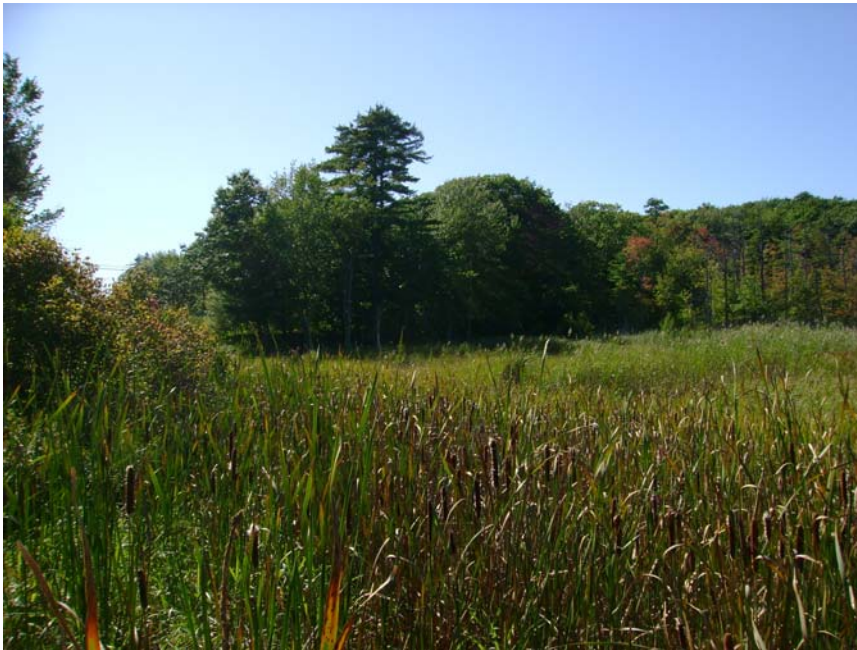
Photo Station #1, high tide.

Phragmites Control Site 1 can be seen in the distance.

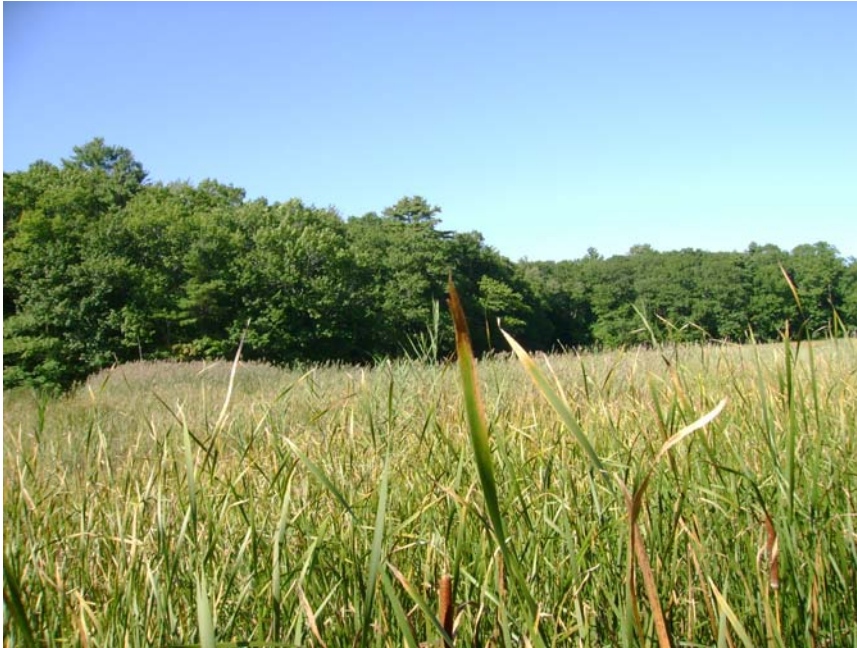
Photographer: L. Rivard
Date: 9/19/08
Photo No.: 1C
Direction: 355

Comments:
Photo Station #1, high tide.

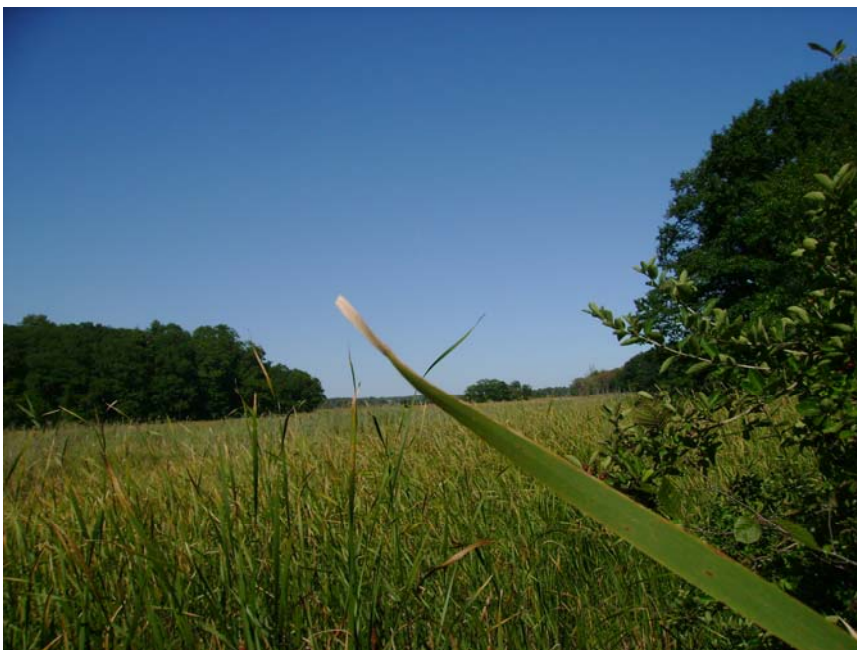
Photographer: L. Rivard
Date: 9/19/08
Photo No.: 1D
Direction: 35

Comments:
Photo Station #1, high tide.

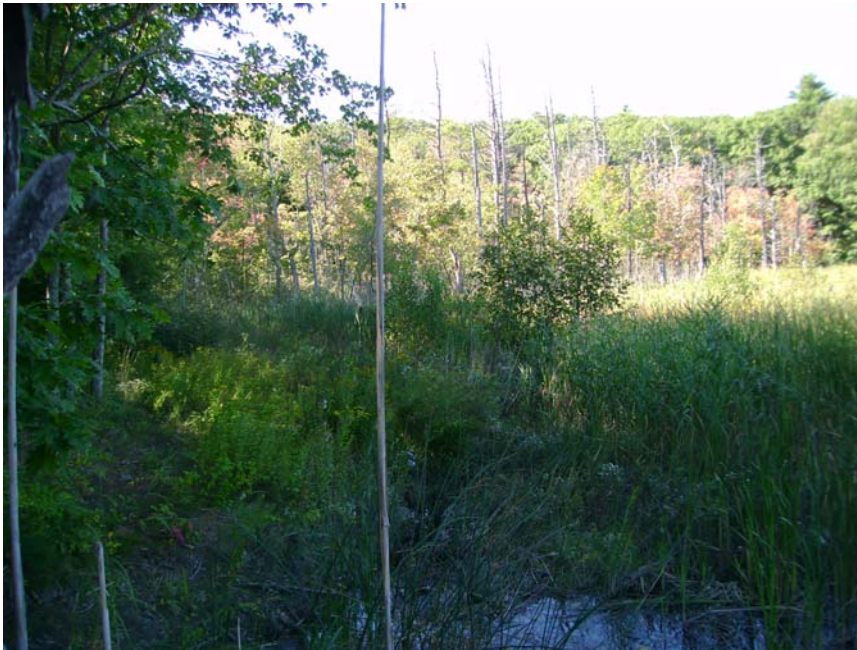
Photographer: L. Rivard
Date: 9/19/08
Photo No.: 2A
Direction: 330

Comments:
Photo Station #2, high tide.
Phragmites Control Site 1;
forested wetland can be seen in
the distance.

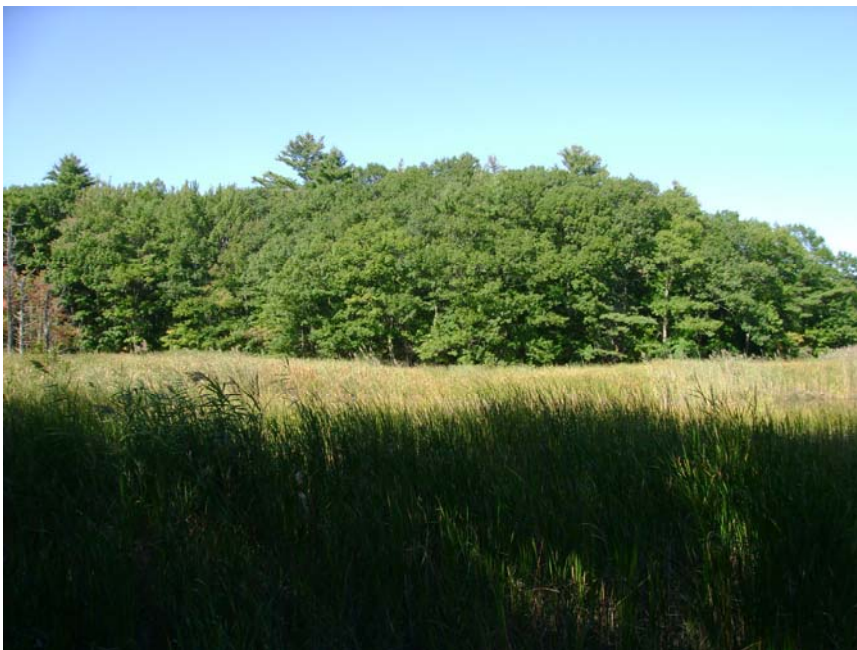
Photographer: L. Rivard
Date: 9/19/08
Photo No.: 2B
Direction: 15

Comments:
Photo Station #2, high tide.
Phragmites Control Site 1.

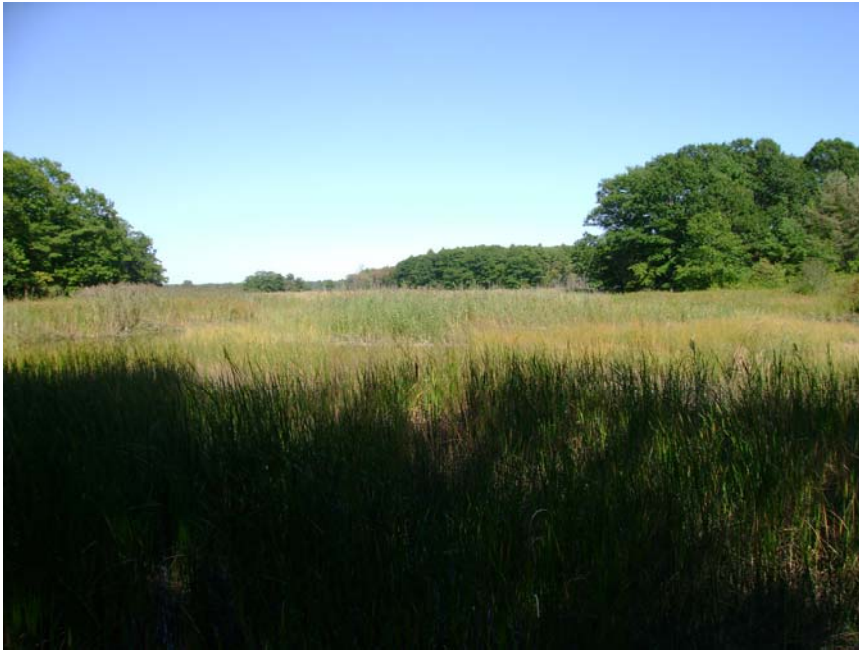
Photo Station #2, high tide.
Phragmites Control Site 1.

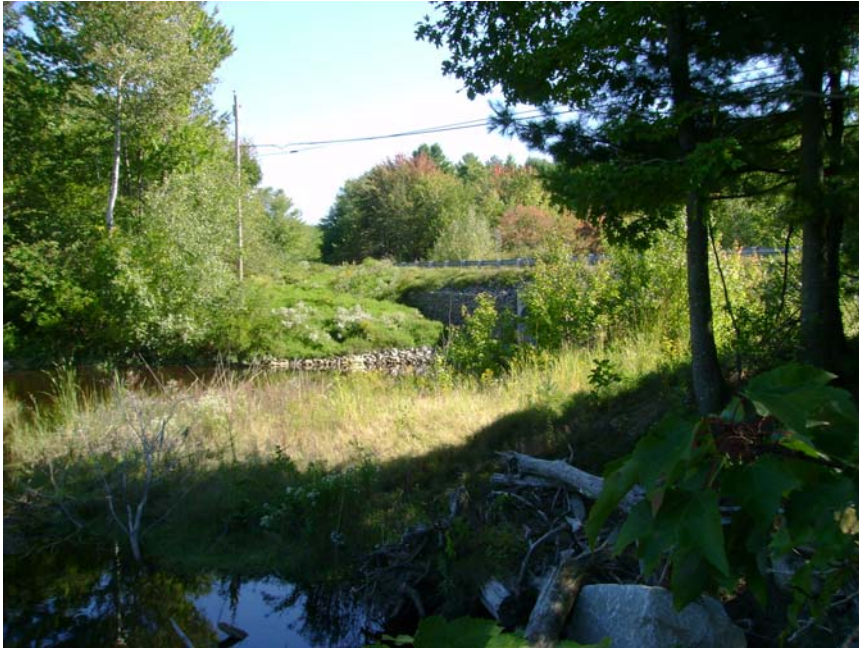
Photo Station #2, high tide.
Phragmites Control Site 1, and
Old Blue Point Road bridge.

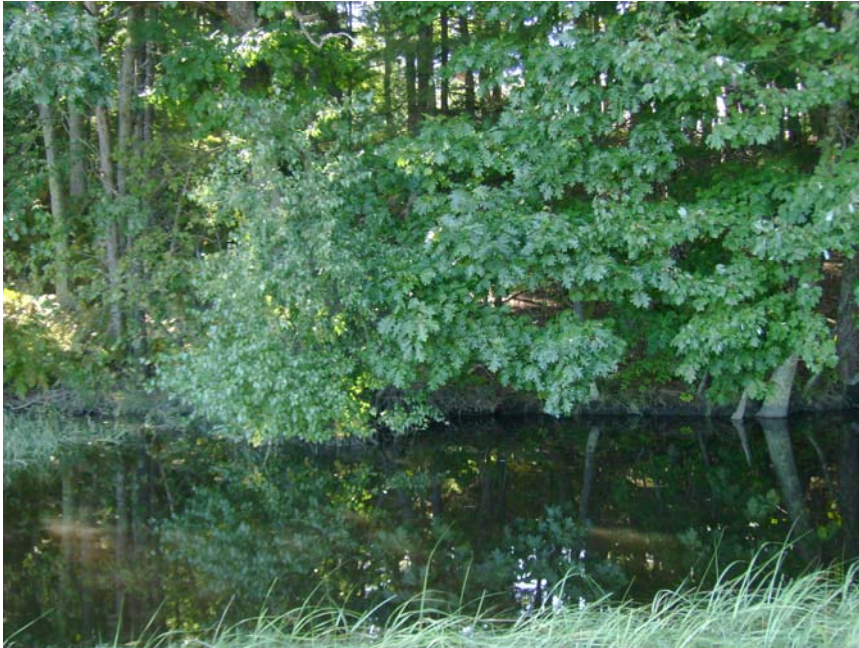
Photographer: L. Rivard
Date: 9/19/08
Photo No.: 3B
Direction: 299

Comments:
Photo Station #3, high tide. Main tidal creek.

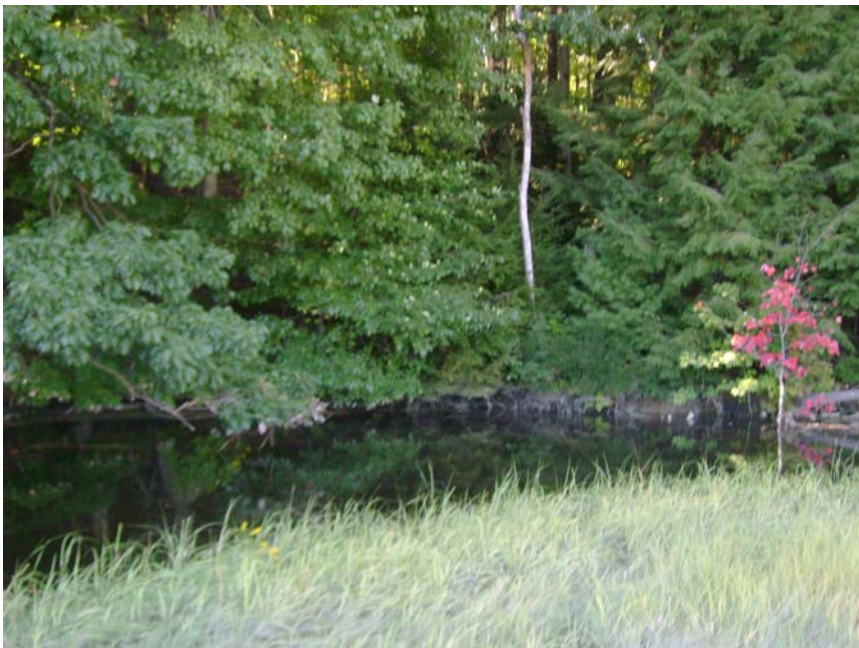
Photographer: L. Rivard
Date: 9/19/08
Photo No.: 3C
Direction: 313

Comments:
Photo Station #3, high tide.
Main tidal creek.

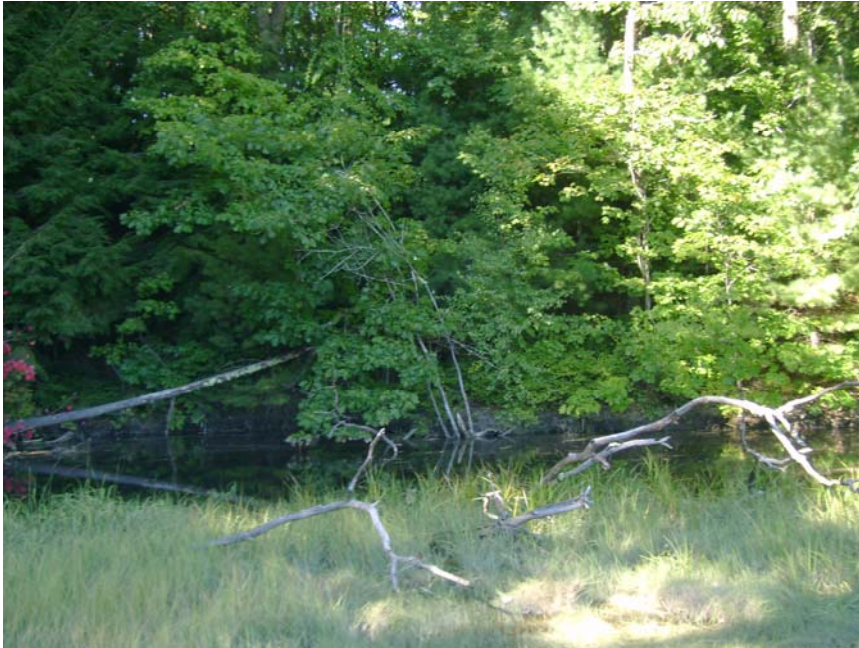
Photographer: L. Rivard
Date: 9/19/08
Photo No.: 3D
Direction: 340

Comments:
Photo Station #3, high tide. Main tidal creek.

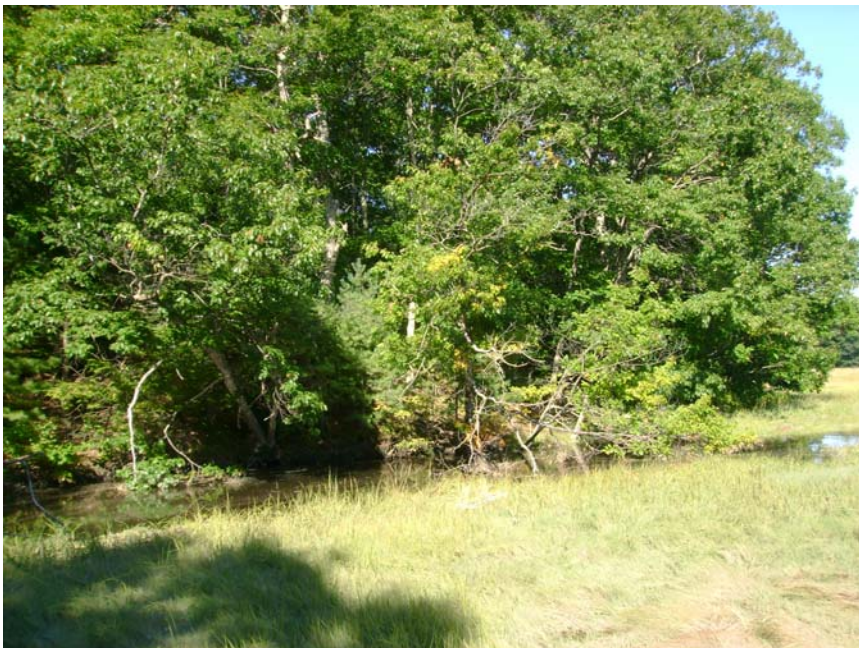
Photographer: L. Rivard
Date: 9/19/08
Photo No.: 3E
Direction: 58

Comments:
Photo Station #3, high tide.
Main tidal creek.

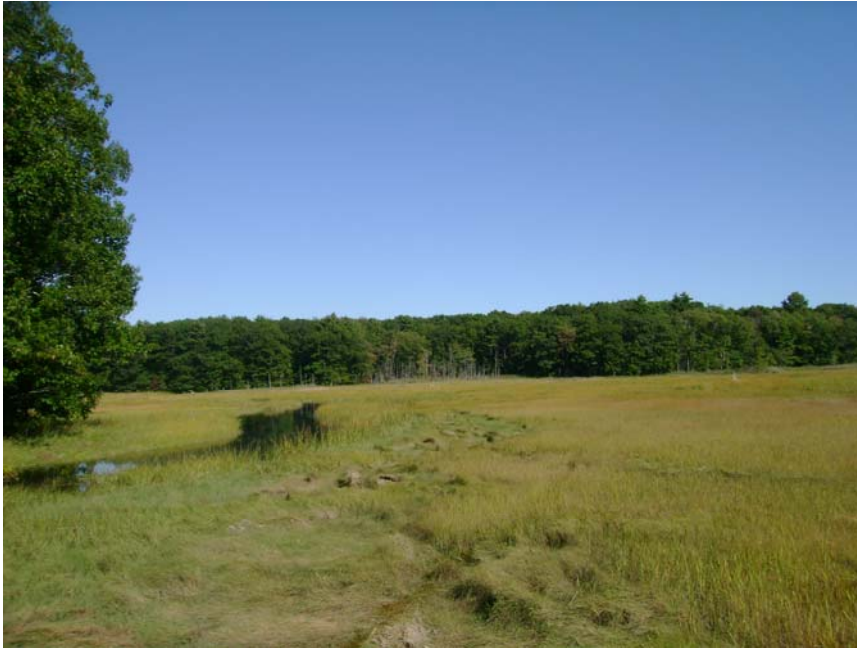
Photographer: L. Rivard
Date: 9/19/08
Photo No.: 3F
Direction: 95

Comments:
Photo Station #3, high tide.

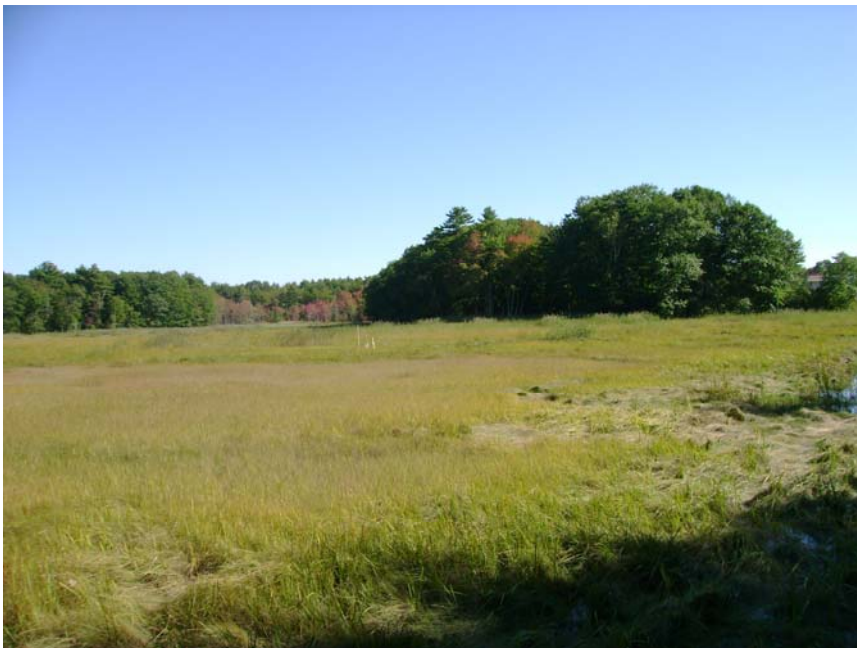
Photographer: L. Rivard
Date: 9/19/08
Photo No.: 3G
Direction: 150

Comments:
Photo Station #3, high tide.

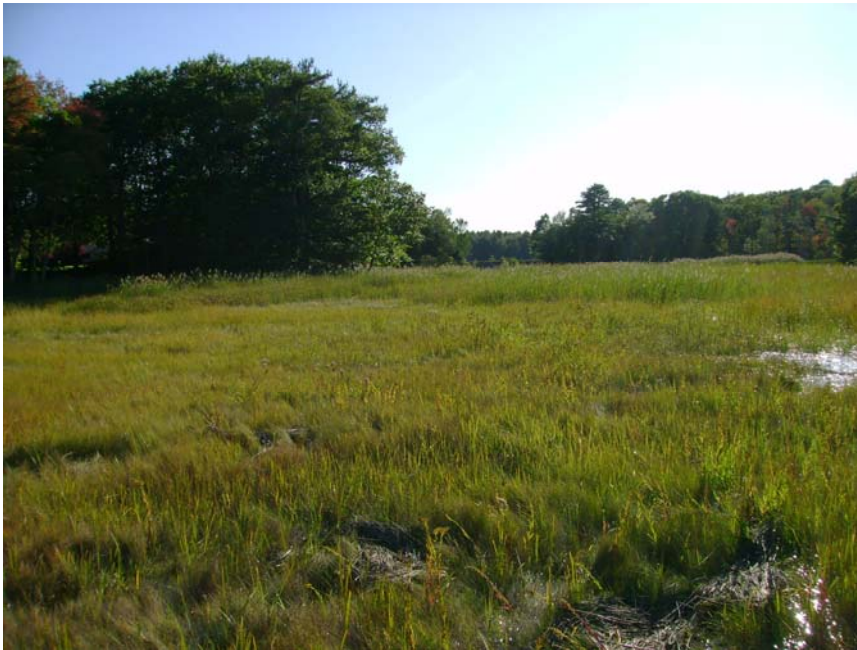
Photo Station #4, high tide.
Phragmites Control Site 2 and Old
Blue Point Road bridge can be
seen in the distance.

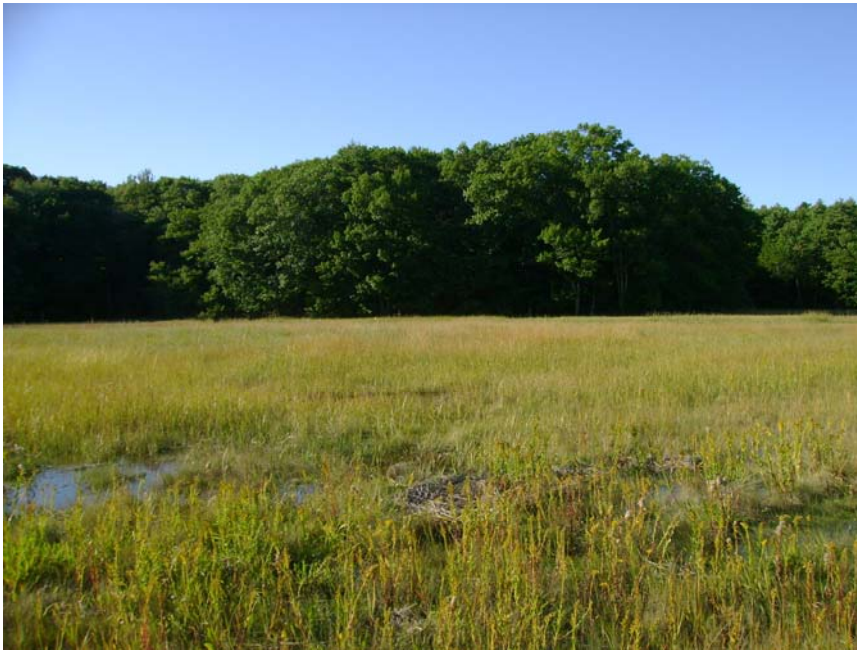
Photographer: L. Rivard
Date: 9/19/08
Photo No.: 4C
Direction: 335

- occur during low tide have allowed native salt marsh species to become established in the former pool, and mudflat to be exposed during low tide. See high and low tide photographs for Photo Station #4, 4A through 4F.
- Photo Station #1, 2, 4, 5, 6, and 10: The marsh in the vicinity of Photo Stations 1, 2, 4, 5, 6, and 10 have changed dramatically from pre-restoration conditions as a direct result of herbicide treatment and removal of the large stands of *Phragmites*. Native salt marsh species have revegetated the *Phragmites* control areas, although small areas of *Phragmites* regrowth can be seen in the photographs. See low tide photograph for Photo Station #1, 1A; #2, 2C; #4, 4A and 4B; #5, 5A–5D; #6, 6D–6F; and #10, 10A and 10B.
 - Photo Station #3, 7, 8, and 9: The differences in marsh surface conditions pre-restoration compared to post-restoration are not dramatic at these sites.

Comments:
Photo Station #4, high tide.

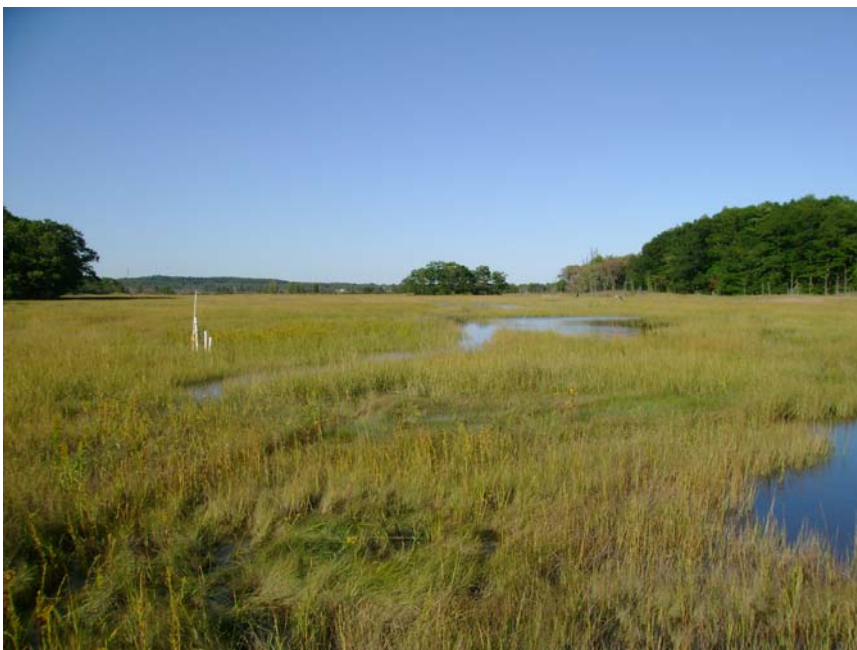
Photographer: L. Rivard
Date: 9/19/08
Photo No.: 4D
Direction: 30

Comments:
Photo Station #4, high tide.
Station #2 can be seen in center.
The largest tidal pond in the
Project area can be seen at right,
with *Spartina* growth the light
green color.

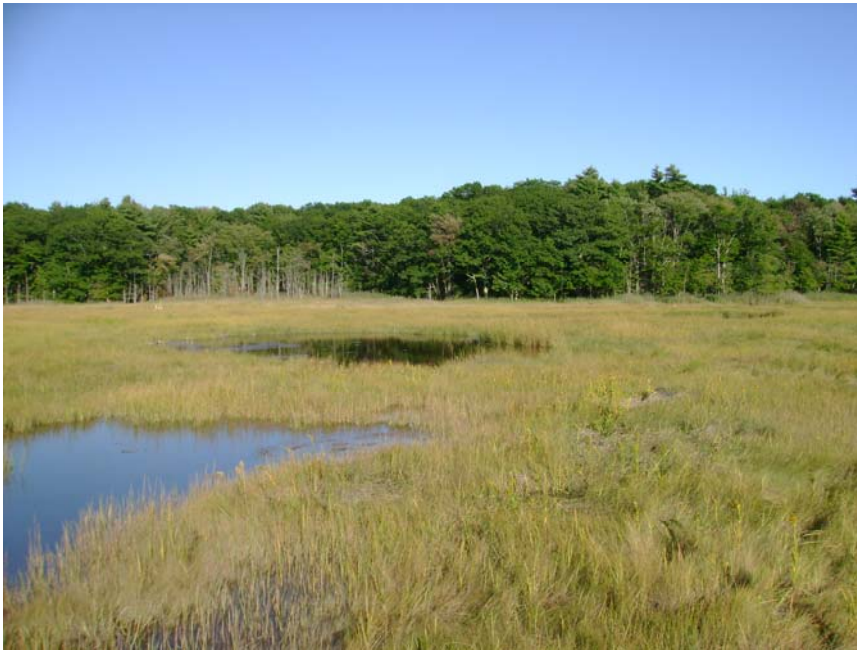
Photo Station #4, high tide.

The largest tidal pond in the Project area can be seen at left, with *Spartina* growth the light green color. Phragmites Control Site 4 can be seen in the distance.

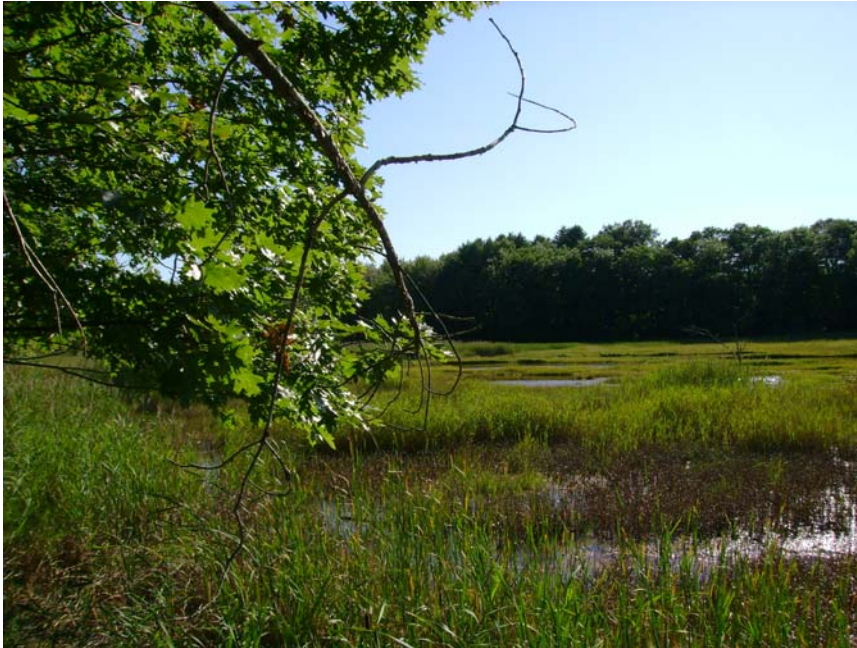
Photographer: L. Rivard
Date: 9/19/08
Photo No.: 5A
Direction: 200

Comments:
Photo Station #5, high tide.
Phragmites Control Site 4.

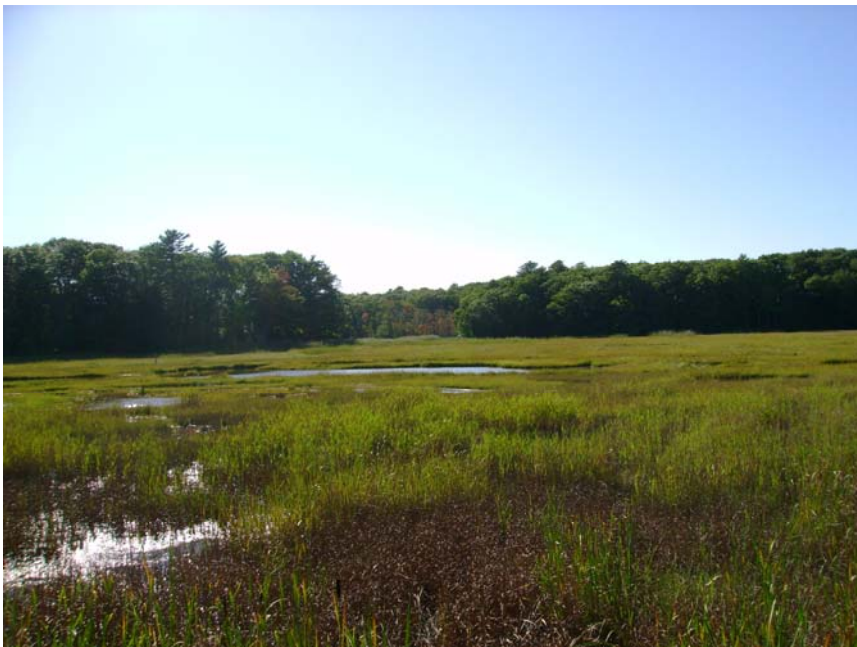
Photographer: L. Rivard
Date: 9/19/08
Photo No.: 5B
Direction: 245

Comments:
Photo Station #5, high tide.
Phragmites Control Site 4.

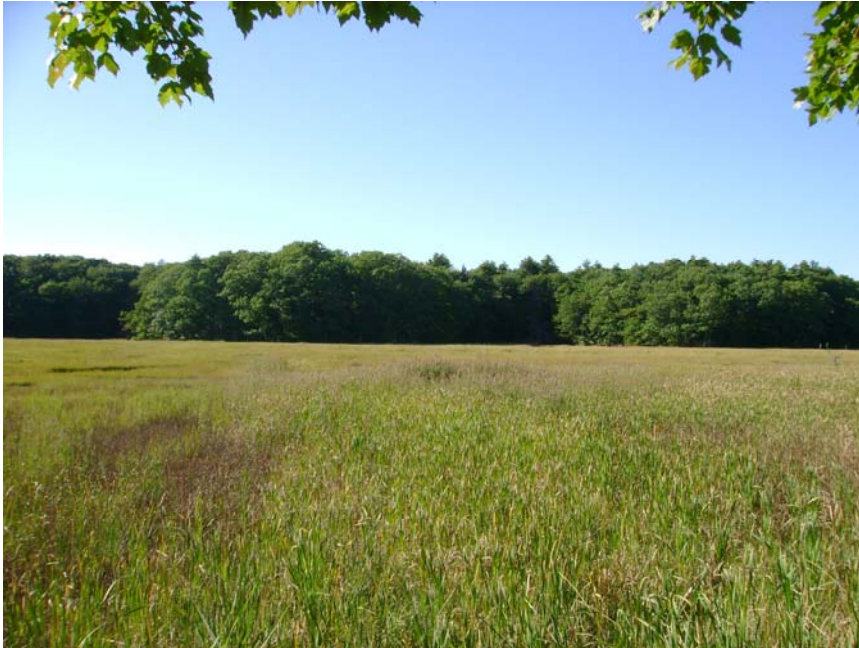
Photographer: L. Rivard
Date: 9/19/08
Photo No.: 5C
Direction: 290

Comments:
Photo Station #5, high tide.
Phragmites Control Site 4.

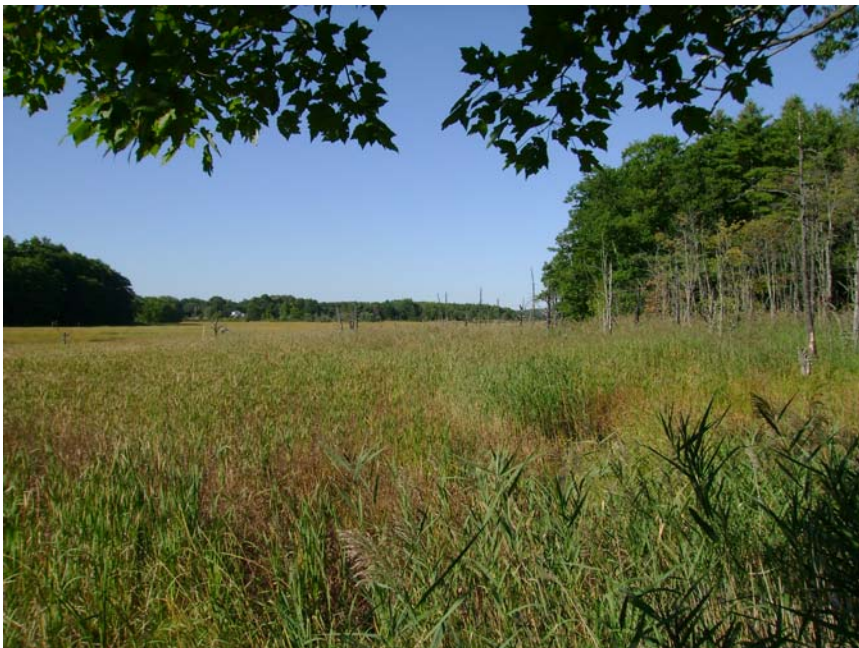
Photographer: L. Rivard
Date: 9/19/08
Photo No.: 5D
Direction: 340

Comments:
Photo Station #5, high tide.
Phragmites Control Site 4.

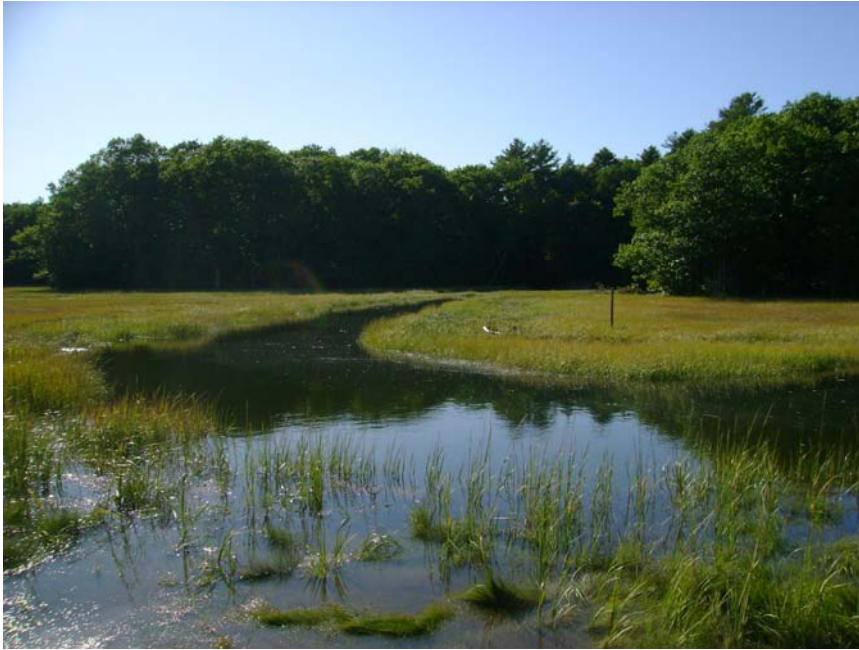
Photographer: L. Rivard
Date: 9/19/08
Photo No.: 6A
Direction: 240

Comments:
Photo Station #6, high tide.
Main tidal creek.

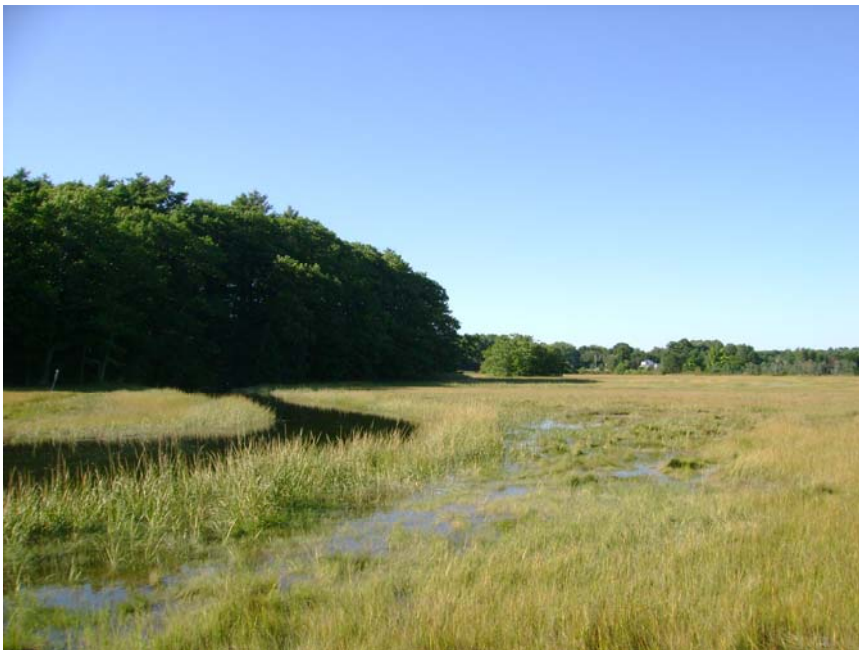
Photographer: L. Rivard
Date: 9/19/08
Photo No.: 6B
Direction: 280

Comments:
Photo Station #6, high tide.
Main tidal creek.

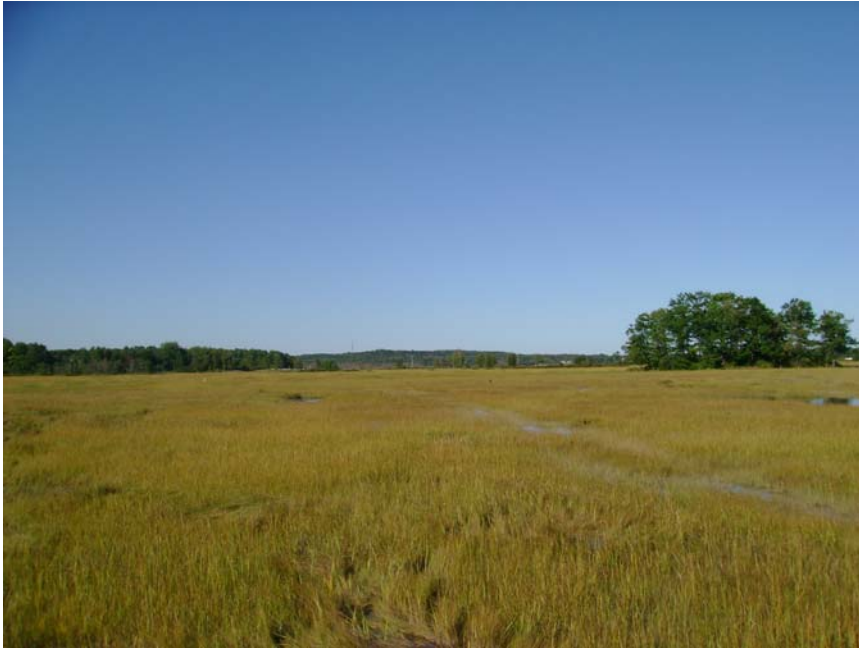
Photographer: L. Rivard
Date: 9/19/08
Photo No.: 6C
Direction: 20

Comments:
Photo Station #6, high tide.

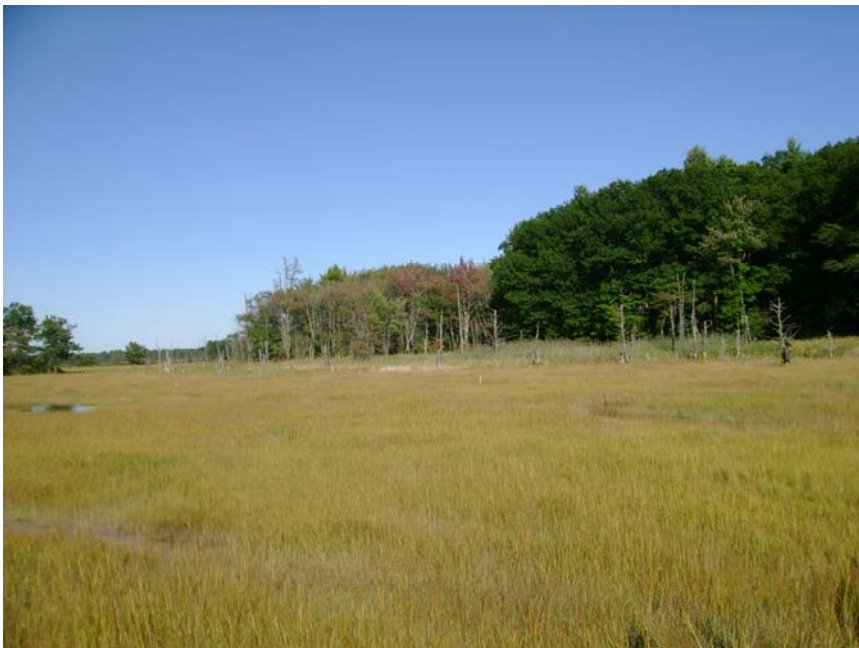
Photographer: L. Rivard
Date: 9/19/08
Photo No.: 6D
Direction: 68

Comments:
Photo Station #6, high tide.

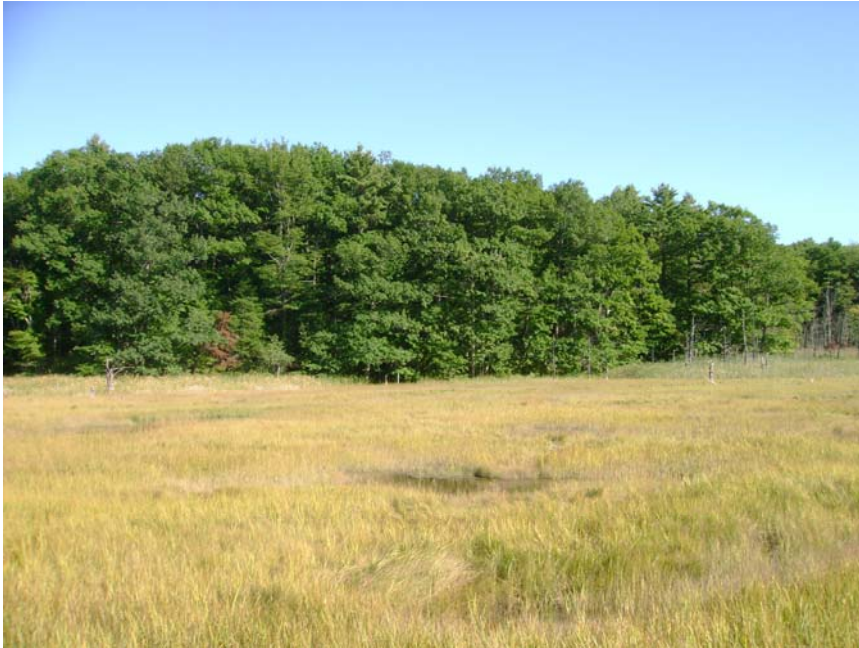
Photographer: L. Rivard
Date: 9/19/08
Photo No.: 6E
Direction: 135

Comments:
Photo Station #6, high tide.

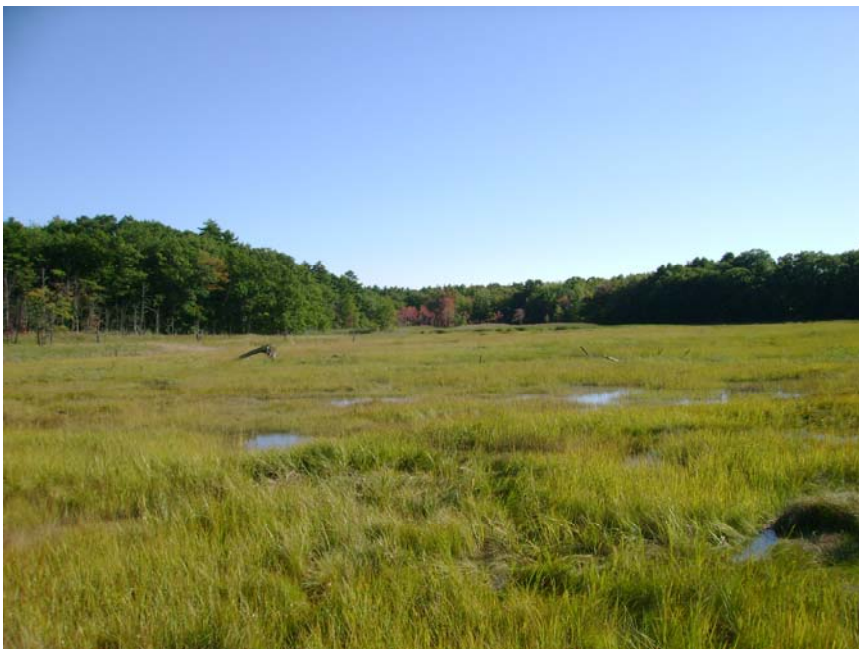
Photographer: L. Rivard
Date: 9/19/08
Photo No.: 6F
Direction: 175

Comments:
Photo Station #6, high tide.
Phragmites Control Site 4 can be seen in the distance.

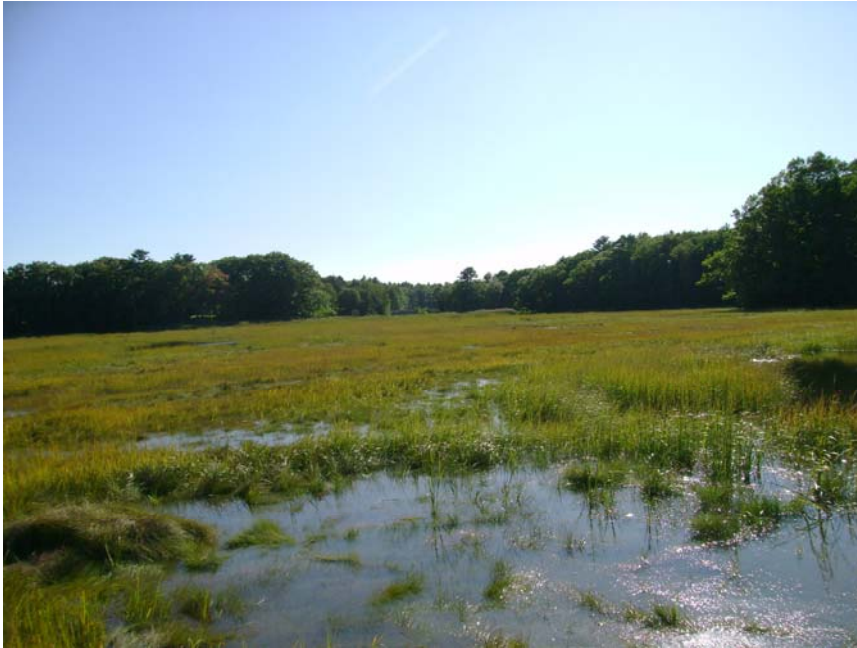
Photographer: L. Rivard
Date: 9/19/08
Photo No.: 6G
Direction: 224

Comments:
Photo Station #6, high tide.

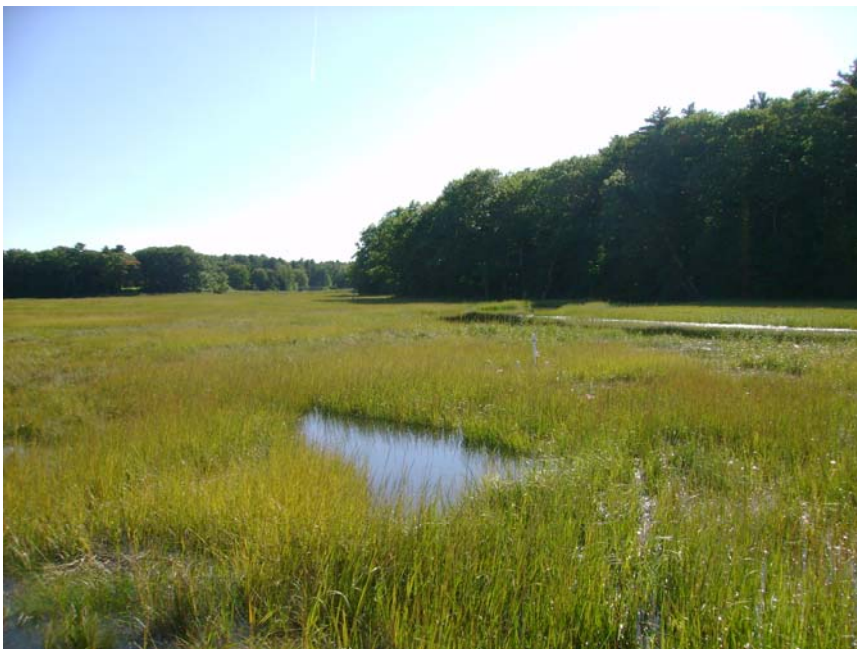
Photographer: L. Rivard
Date: 9/19/08
Photo No.: 7A
Direction: 230

Comments:
Photo Station #7, high tide.
Station #4 can be seen in the center. Main tidal creek.

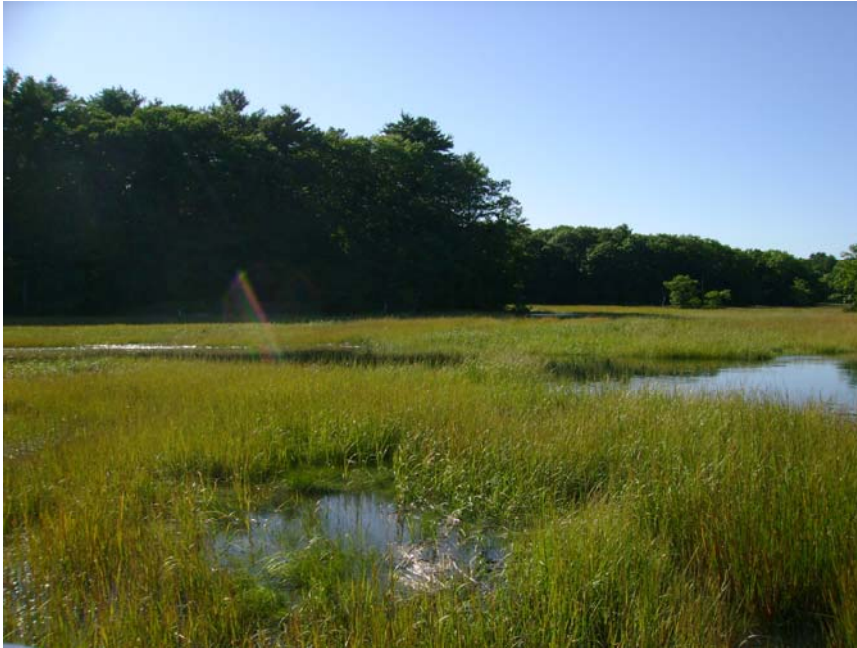
Photographer: L. Rivard
Date: 9/19/08
Photo No.: 7B
Direction: 270

Comments:
Photo Station #7, high tide.
Main tidal creek.
