CASCADE BROOK SALT MARSH RESTORATION MONITORING PROJECT SUMMARY REPORT

CASCADE BROOK, SCARBOROUGH, MAINE

February 2009

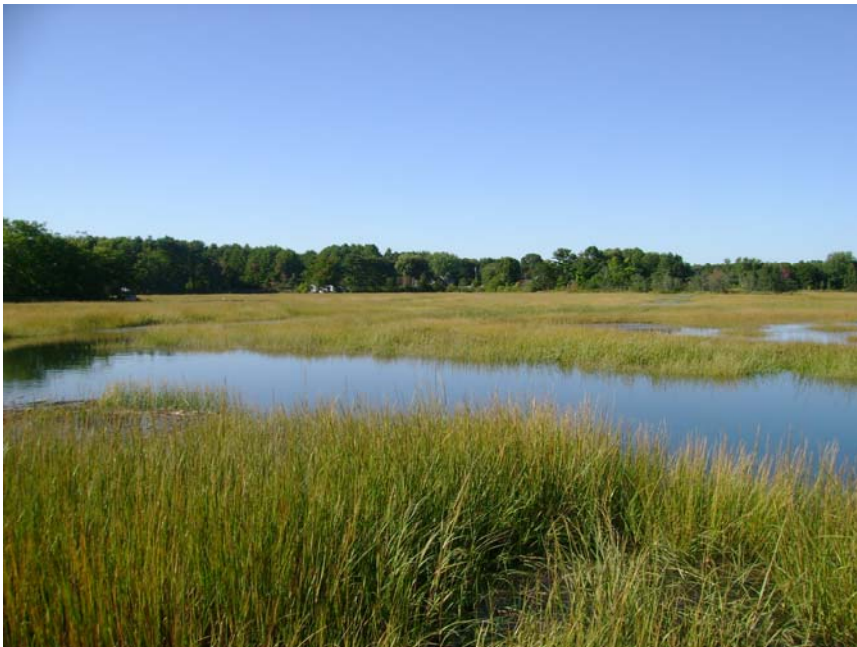
Photographer: L. Rivard
Date: 9/19/08
Photo No.: 7C
Direction: 315

Comments:
Photo Station #7, high tide.
Main tidal creek.

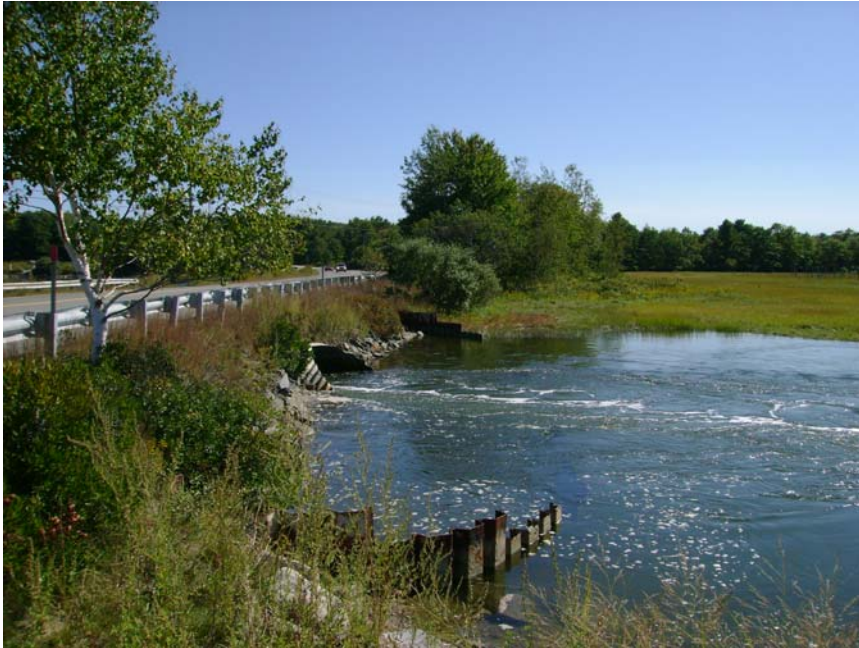
Photo Station #8, high tide.
Pine Point Road culvert, upstream,
and water control structures.
Dunstan Canal/ main tidal creek.

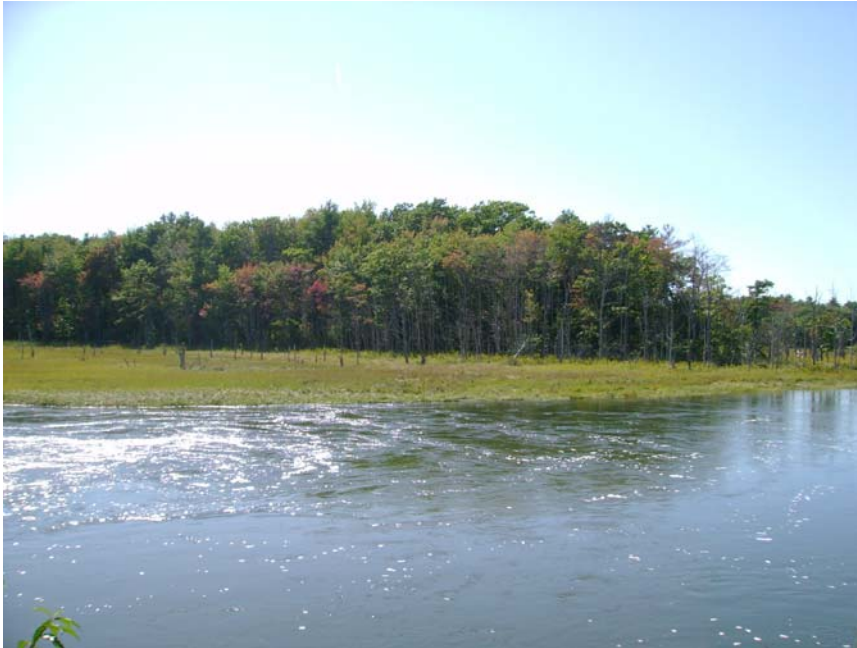
Photographer: L. Rivard
Date: 9/19/08
Photo No.: 8C
Direction: 245

Comments:
Photo Station #8, high tide.
Dunstan Canal.

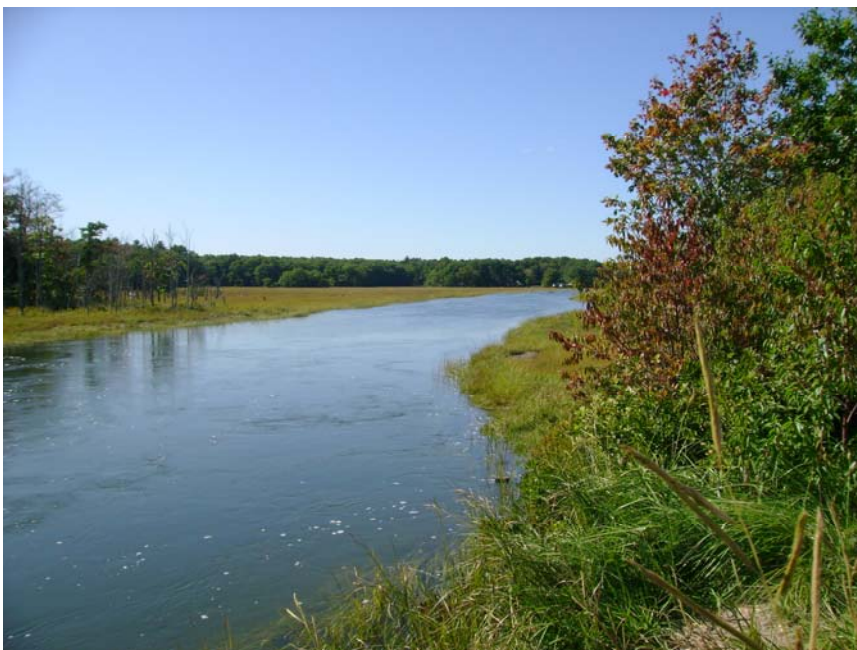
Photographer: L. Rivard
Date: 9/19/08
Photo No.: 8D
Direction: 275

Comments:
Photo Station #8, high tide.
Dunstan Canal.

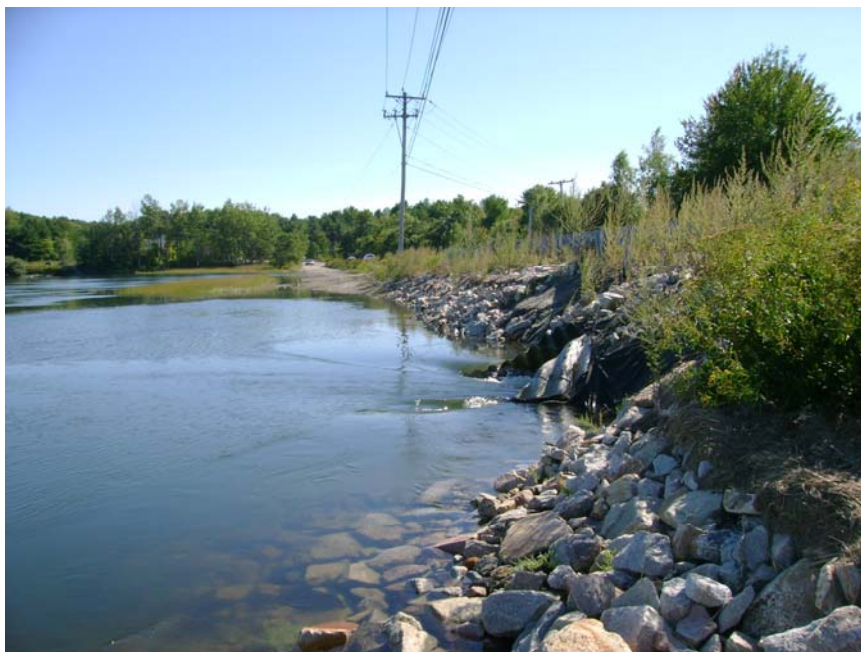
Photo Station #9, high tide.
Pine Point Road culvert,
downstream. Dunstan River.

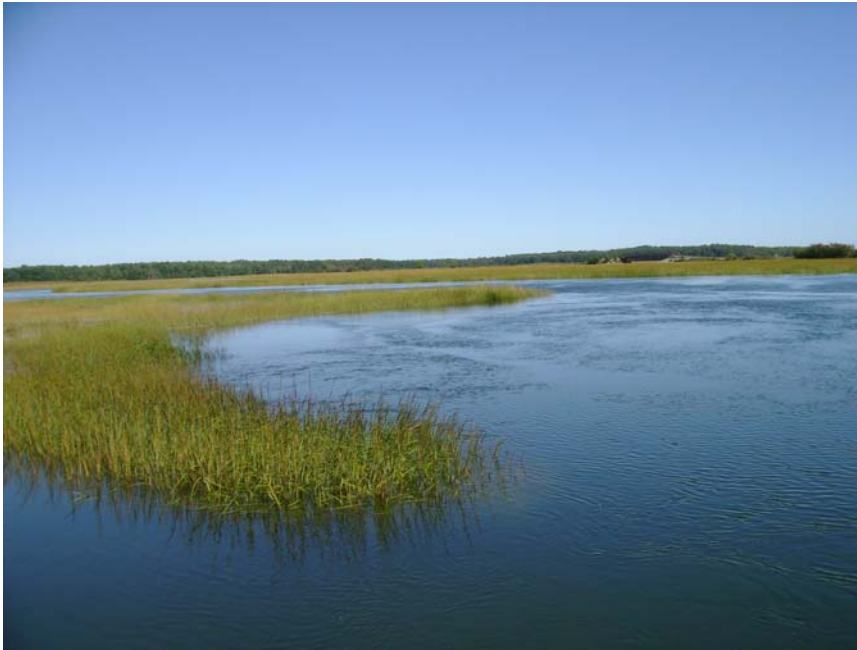
Photographer: L. Rivard
Date: 9/19/08
Photo No.: 9C
Direction: 90

Comments:
Photo Station #9, high tide.
Dunstan River.

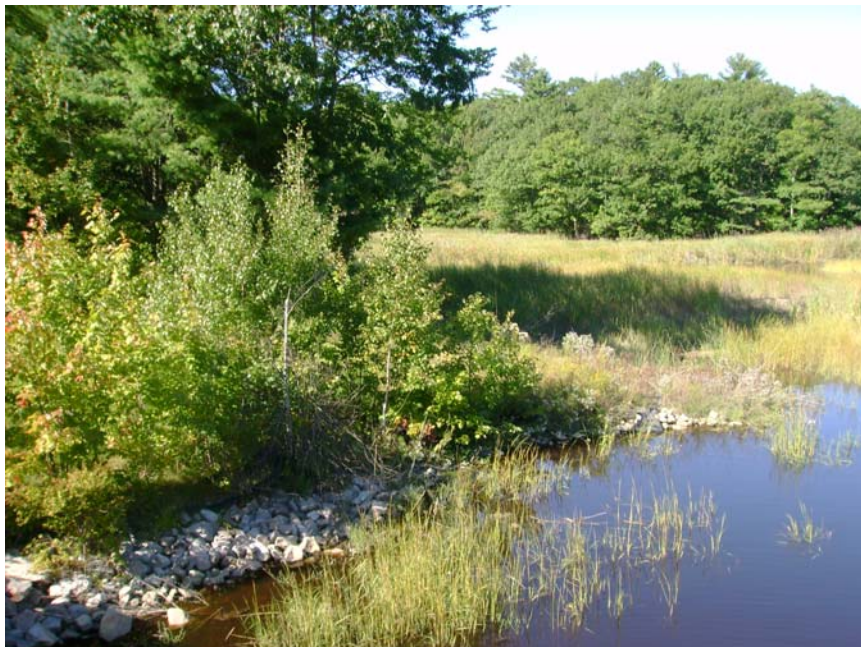
Photographer: L. Rivard
Date: 9/19/08
Photo No.: 10A
Direction: 340

Photo Station #10, high tide.
Phragmites Control Site 1. Riprap
rock and silt fence stabilize the
banks.
