NONESUCH RIVER SALT MARSH YEAR 5 POST-RESTORATION MONITORING AND PROJECT SUMMARY REPORT

NONESUCH RIVER, SCARBOROUGH, MAINE

Prepared for:
Friends of Scarborough Marsh

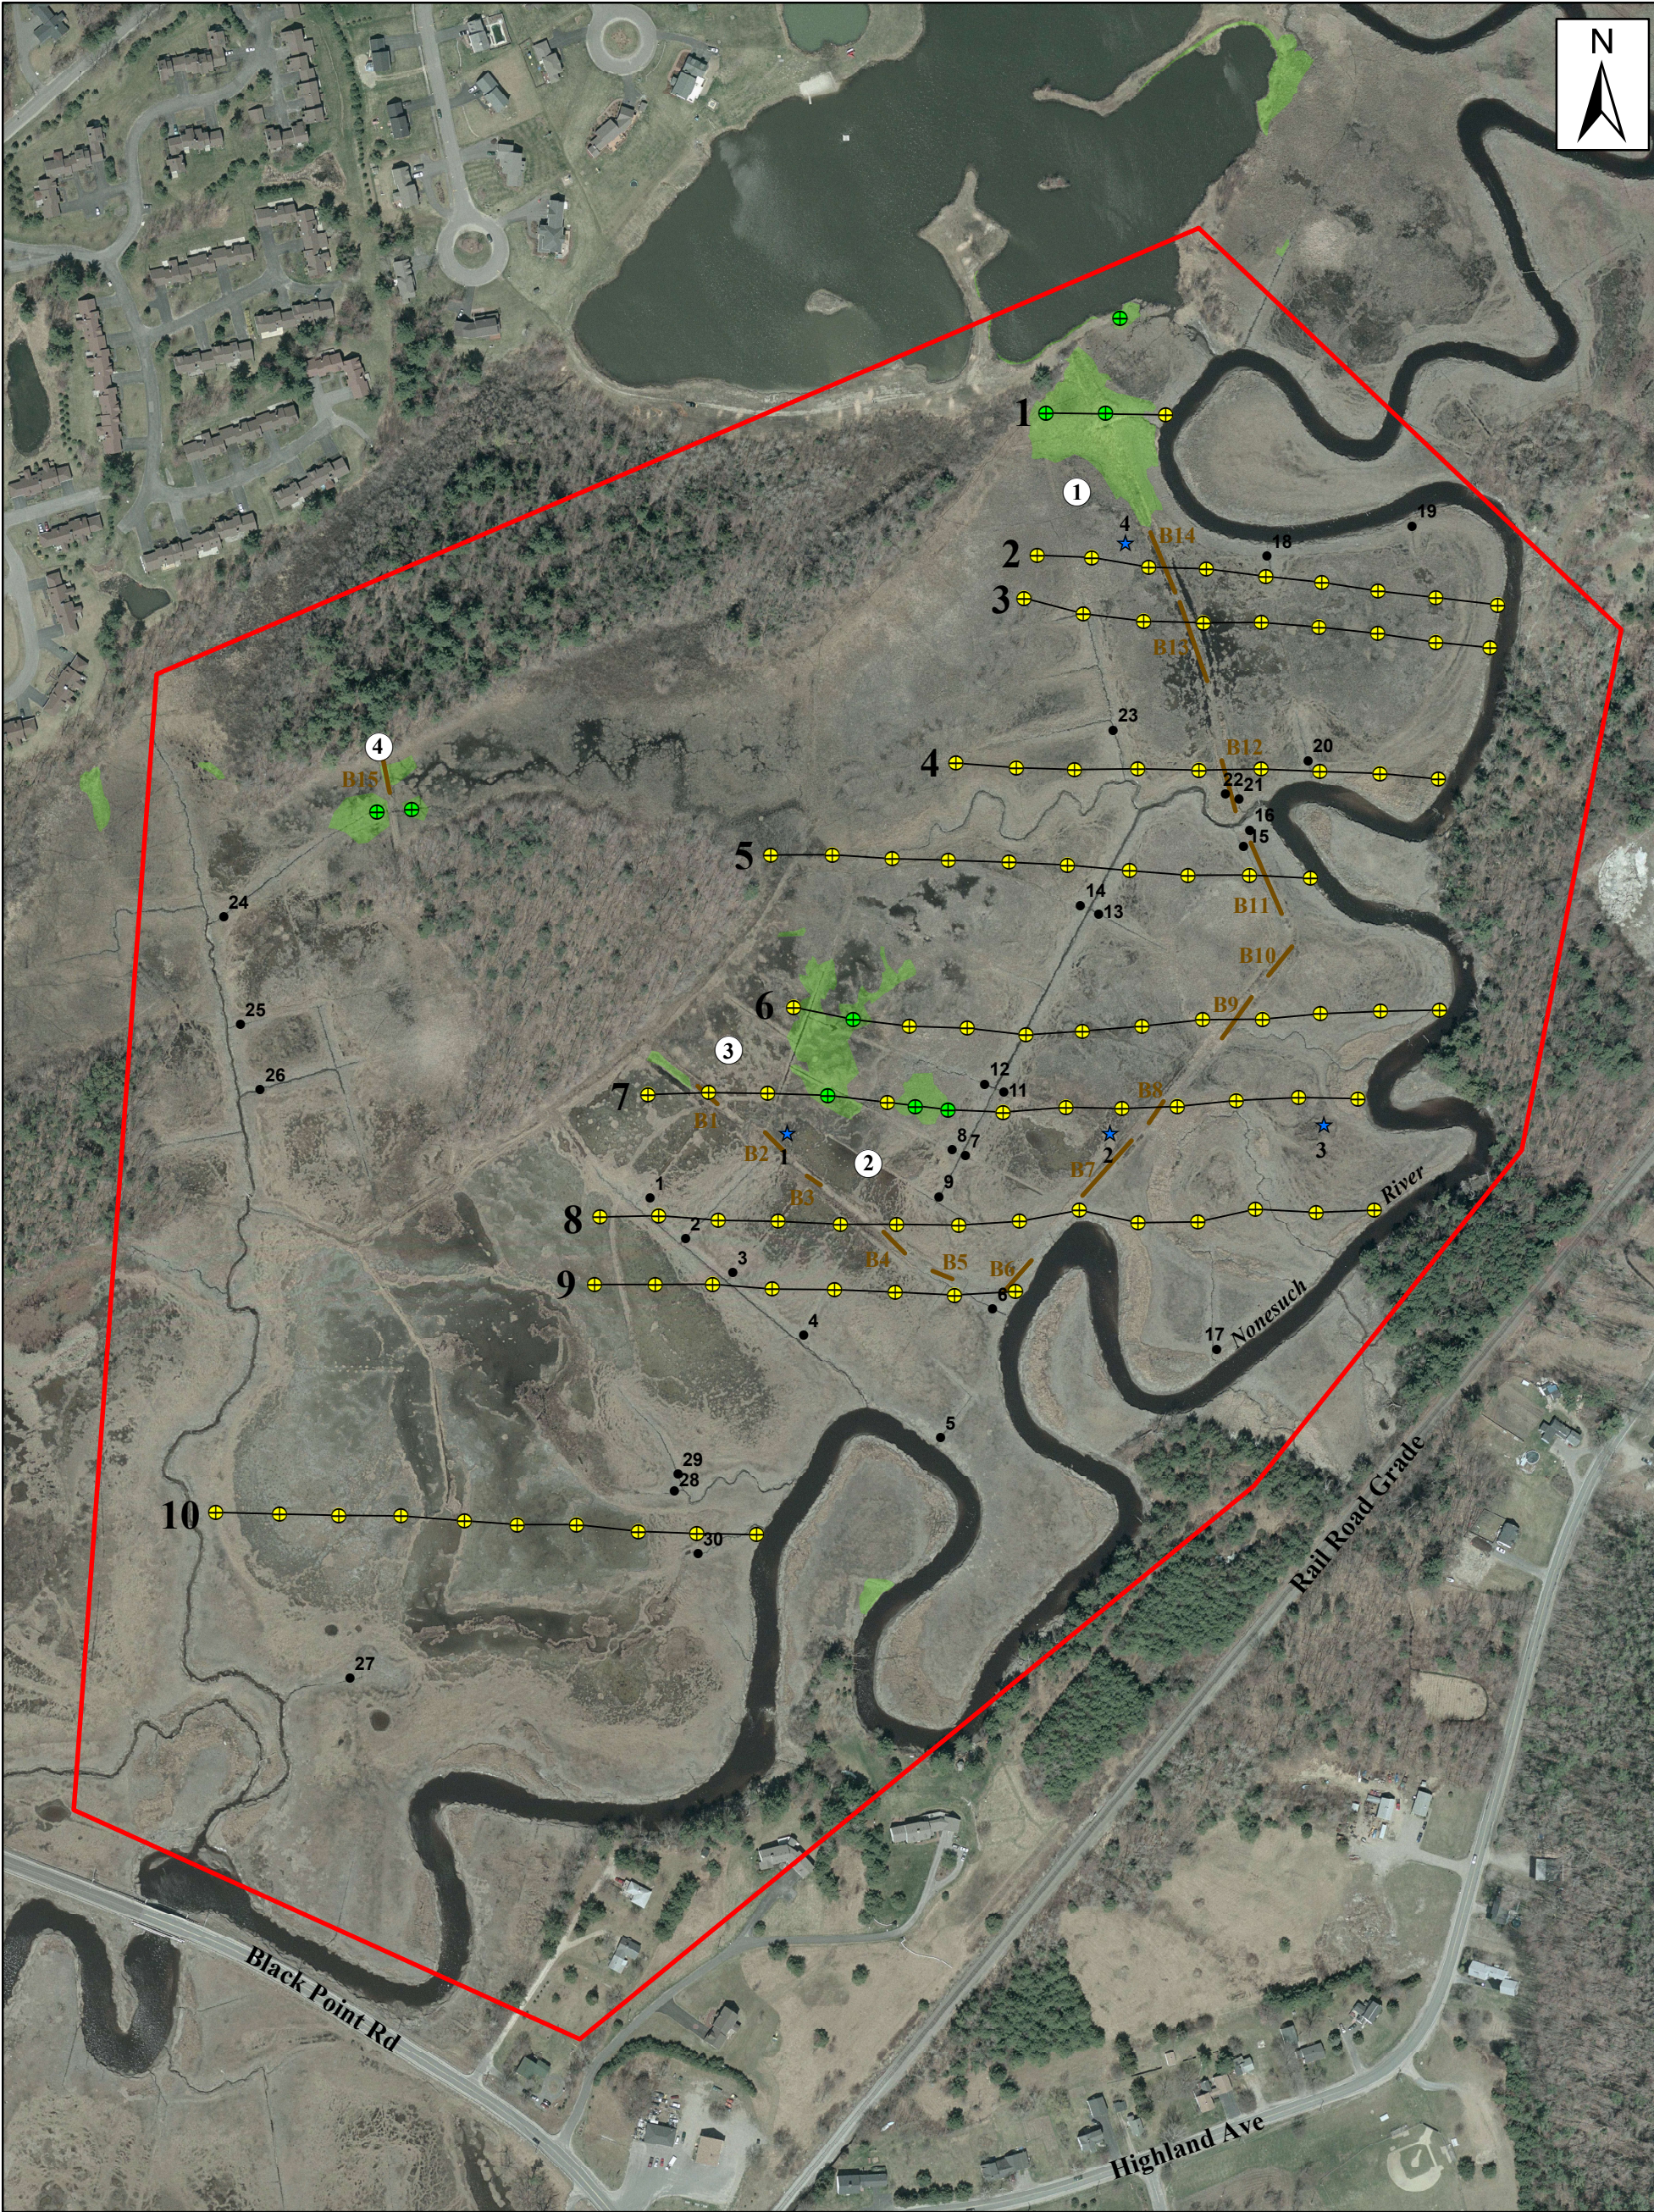
| <p>Project Location</p> | <p>500 250 0 500</p> <p>SCALE</p> <p>Feet</p> <p>LEGEND</p> <ul style="list-style-type: none">● Ditch Plug*① Photo Station— Transect⊕ Vegetation Quadrat— Berm Ditch Line*★ Water Monitoring Station⊕ <i>Phragmites australis</i> Quadrat■ Former <i>Phragmites australis</i> Polygon*□ Project Boundary | <p>Figure 3. Photographic and Sampling Station Locations for Nonesuch River Salt Marsh Restoration Monitoring Project, Scarborough, Maine.</p> |

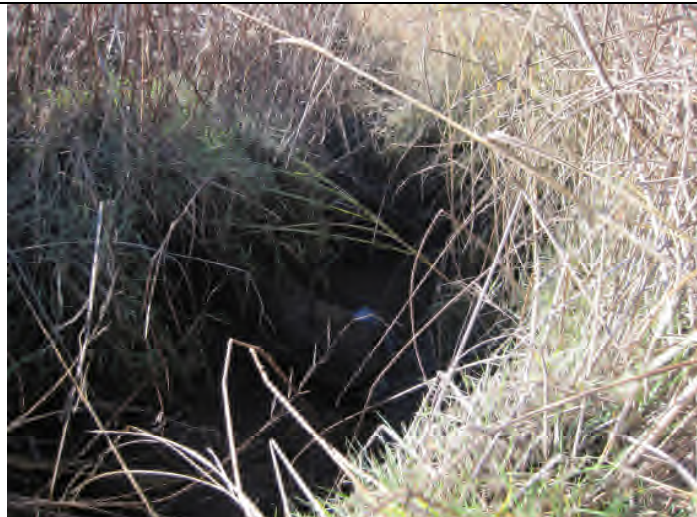
| TETRA TECH, Inc. | | | | | |
|---|--|---|--|--|--|
| Ditch Plug 24 (2) | | | | Ditch Plug 24 (3) | |

- In general, the majority of ditch plugs are in excellent condition, have revegetated with desirable species, are stable, and are holding water in permanent pools. A couple of the ditch plugs have been partially compromised, and show some evidence of erosion. In several cases, the actual location of the ditch plug is no longer discernable from the natural marsh. Several of the ditch plugs have *Phragmites* present, including some sites in the vicinity of *Phragmites* Area 2, and in areas distant from the former *Phragmites* areas.

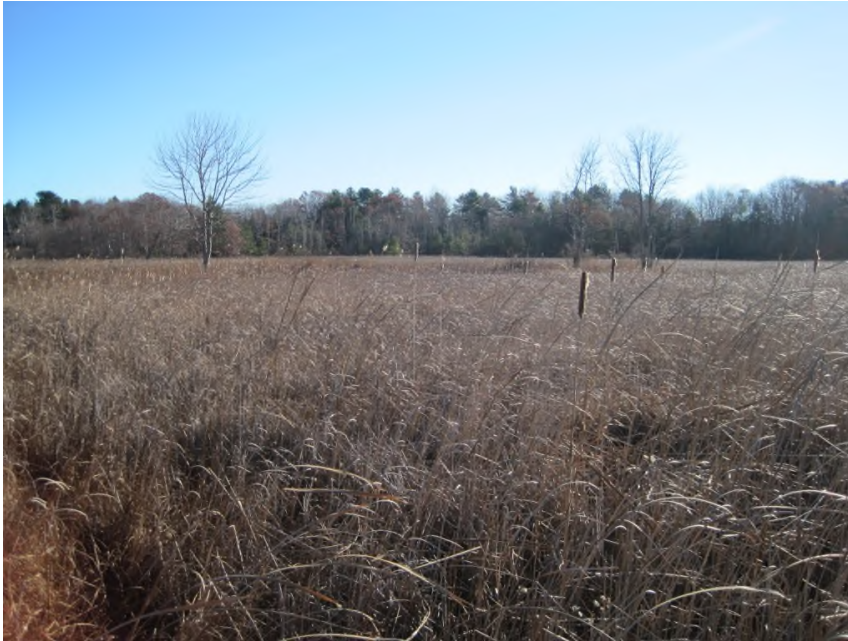
Photographer: S. Watts
Date: 11-12-10
Photo No.: 1-1
Direction: 120

Comments:
Start of panoramic photo series at Photo Station #1. Station is setup just outside of removed *Phragmites* patch, adjacent to water monitoring station #4.

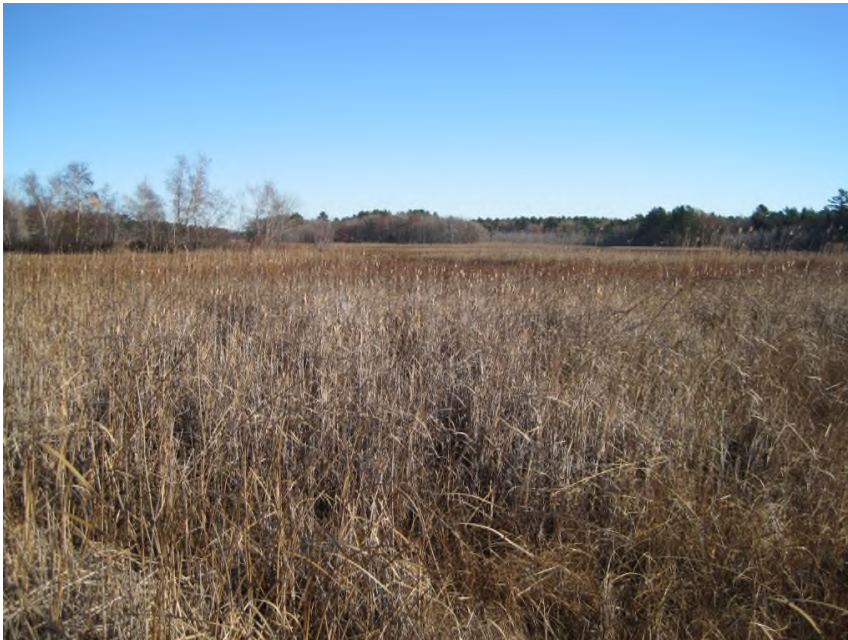
Photographer: S. Watts
Date: 11-12-10
Photo No.: 1-2
Direction: 70

Comments:
Panoramic series from Photo Station #1. Picture of *Phragmites* removal area in the background.

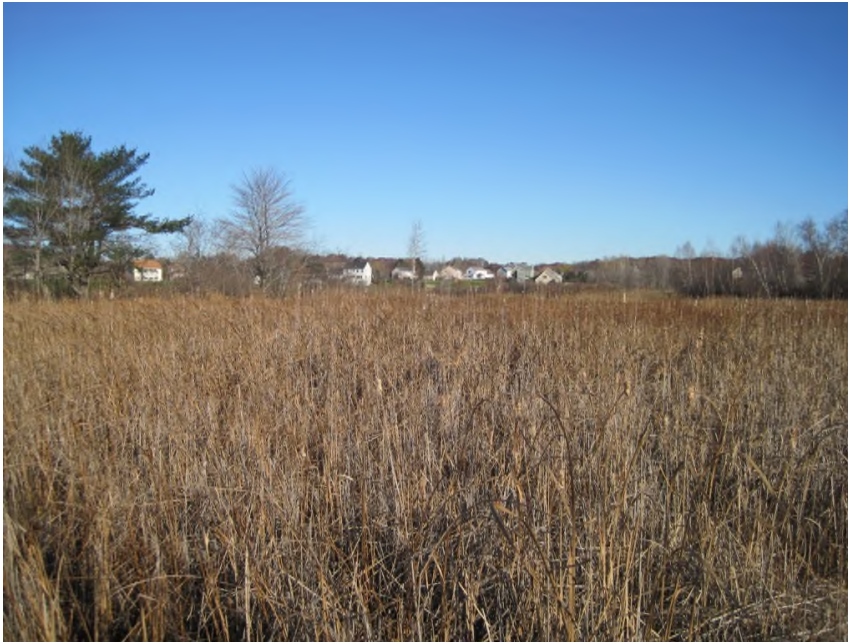
Photographer: S. Watts
Date: 11-12-10
Photo No.: 1-3
Direction: 20

Comments:
Panoramic series from Photo Station #1. Picture of *Phragmites* removal area in the background.

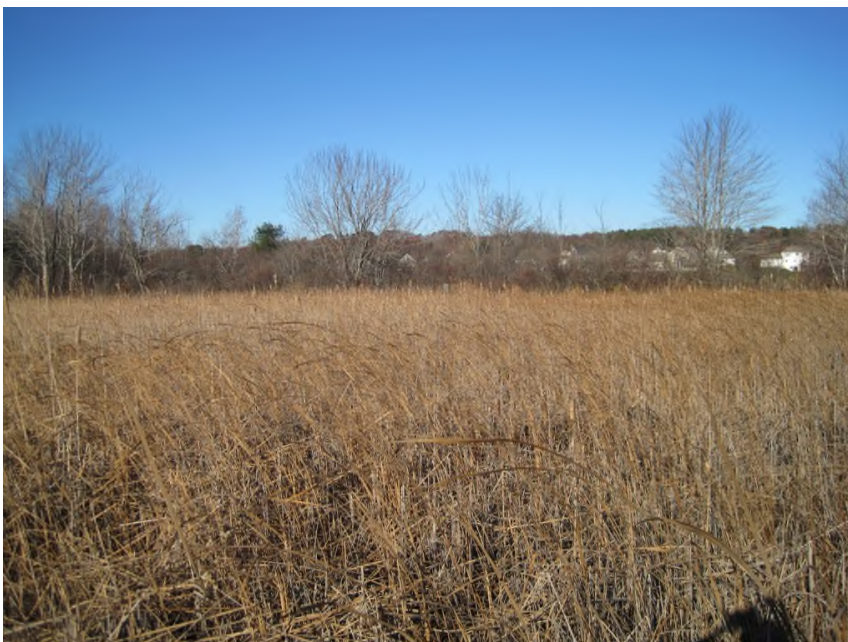
Photographer: S. Watts
Date: 11-12-10
Photo No.: 1-4
Direction: 330

Comments:
End of panoramic series from Photo Station #1. End of the *Phragmites* removal area to the right of center near water monitoring station #4.

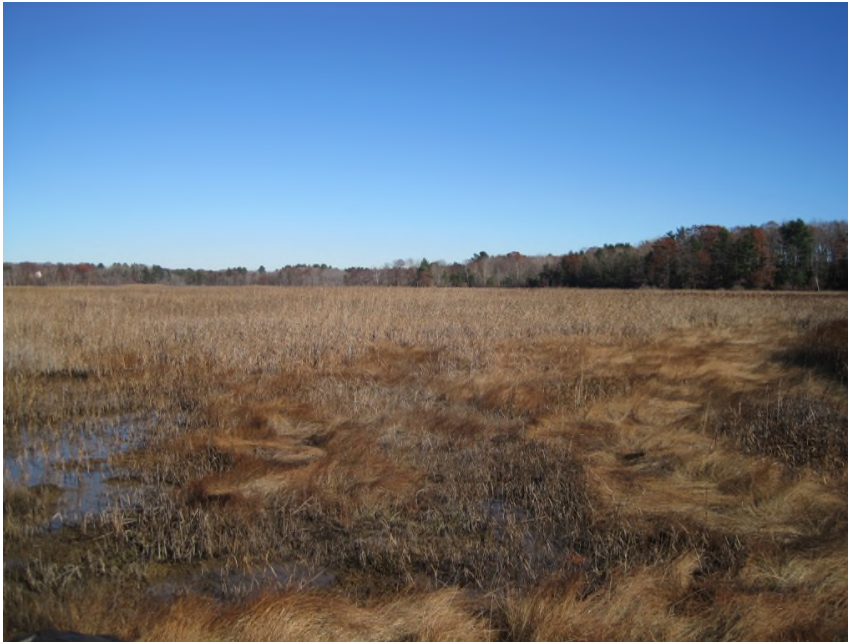
Photographer: S. Watts
Date: 11-12-10
Photo No.: 2-1
Direction: 50

Comments:
Start of panoramic photo series from Photo Station #2 at low tide during neap 1st quarter. *Phragmites* removal area in the distance.

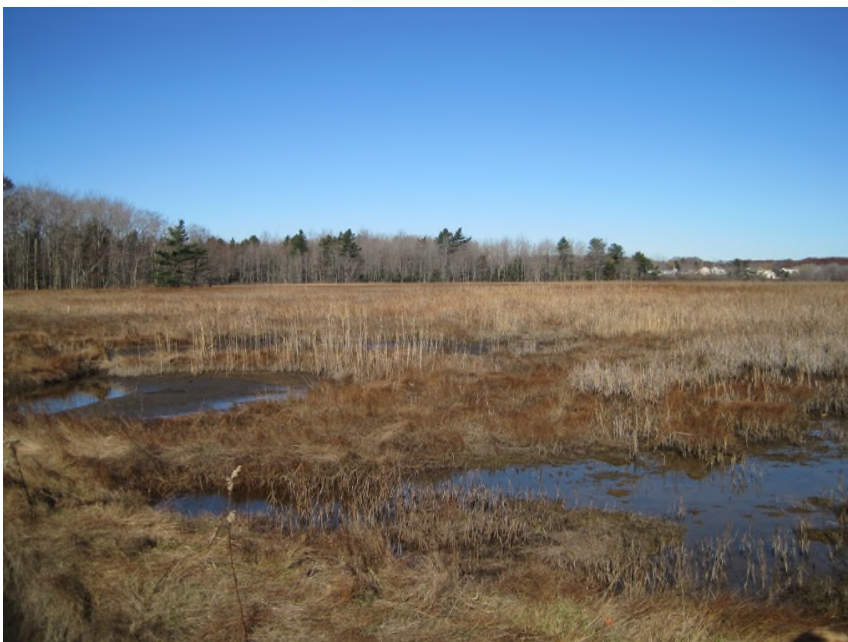
Photographer: S. Watts
Date: 11-12-10
Photo No.: 2-2
Direction: 10

Comments:
Panoramic series from Photo Station #2 at low tide during neap 1st quarter. *Phragmites* removal area to the left of center.

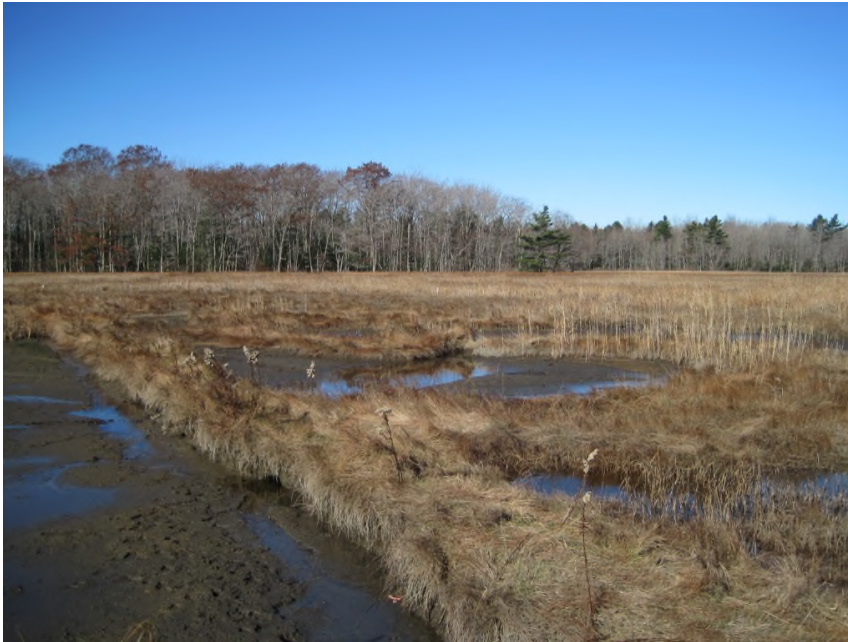
Panoramic series from Photo Station #2 at low tide during neap 1st quarter. *Phragmites* removal area to right of center and in distance at left.

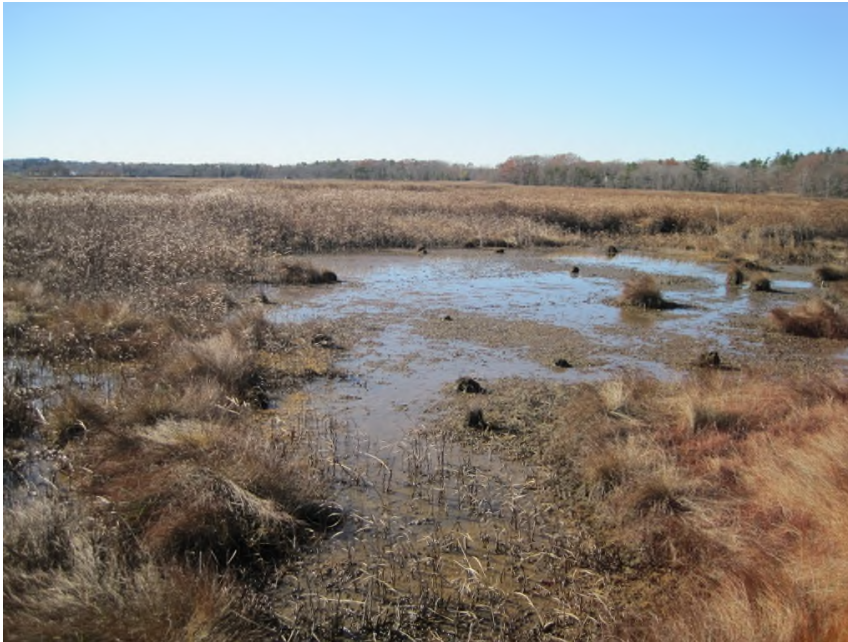
Photographer: S. Watts
Date: 11-12-10
Photo No.: 2-5
Direction: 250

Comments:
Panoramic series from Photo Station #2 at low tide during neap 1st quarter.

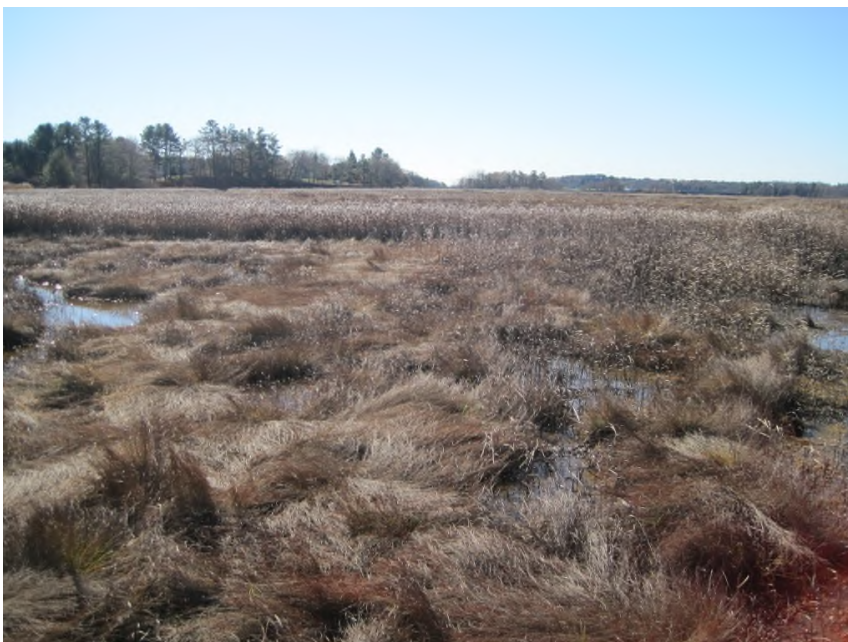
Photographer: S. Watts
Date: 11-12-10
Photo No.: 2-6
Direction: 210

Comments:
Panoramic series from Photo Station #2 at low tide during neap 1st quarter.

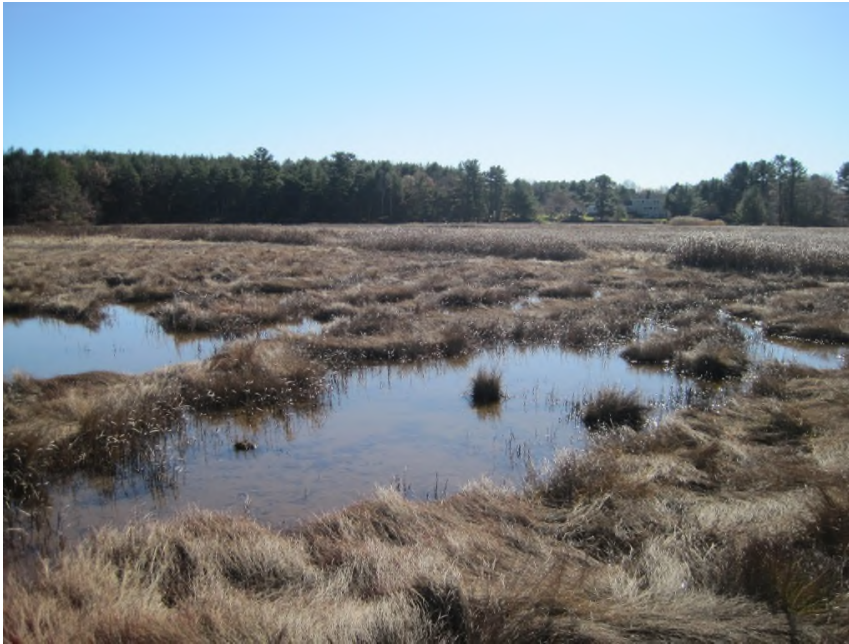
Photographer: S. Watts
Date: 11-12-10
Photo No.: 2-7
Direction: 170

Comments:
Panoramic series from Photo Station #2 at low tide during neap 1st quarter.

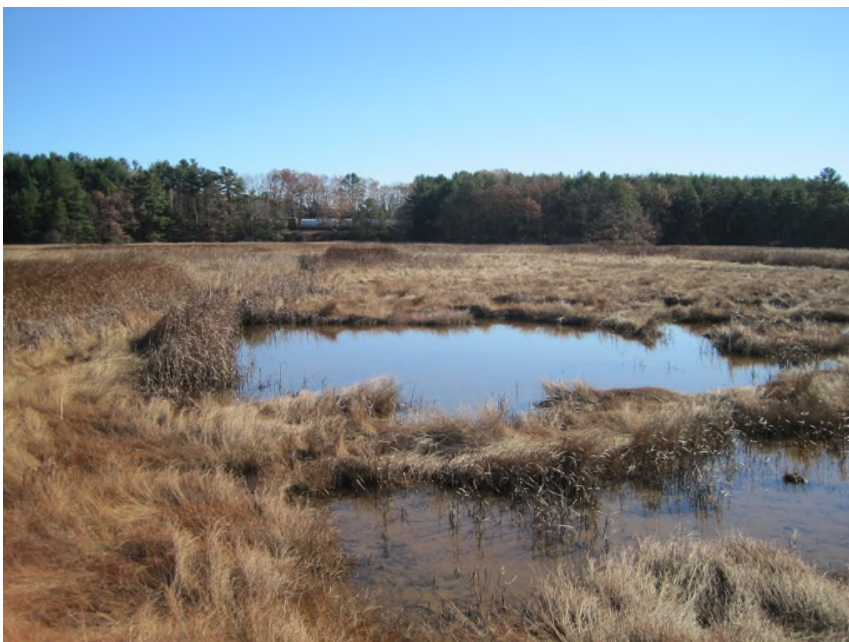
Photographer: S. Watts
Date: 11-12-10
Photo No.: 2-8
Direction: 130

Comments:
Panoramic series from Photo Station #2 at low tide during neap 1st quarter.

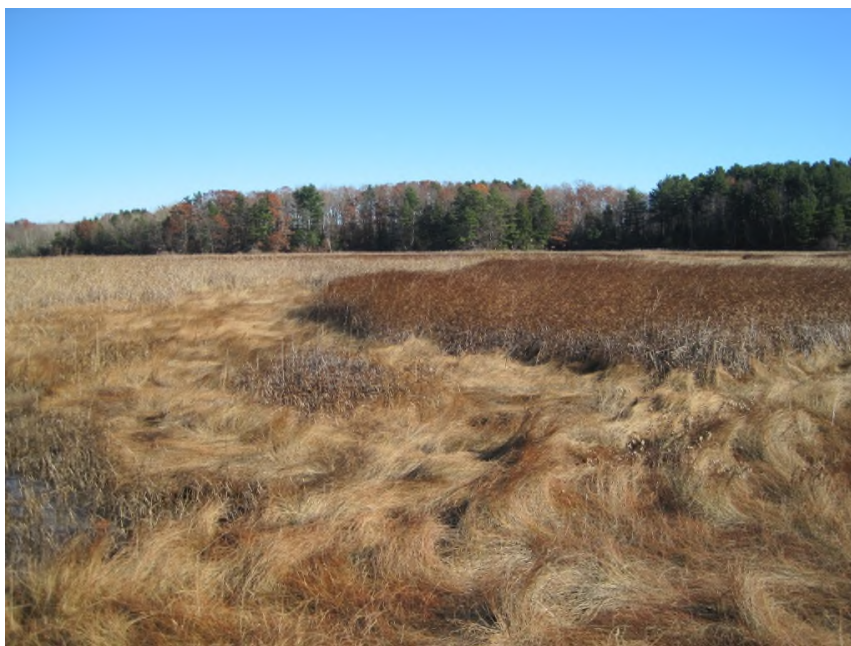
Photographer: S. Watts
Date: 11-12-10
Photo No.: 2-9
Direction: 90

Comments:
End of panoramic series from
Photo Station #2. *Phragmites*
removal area in distance to the
left of center.

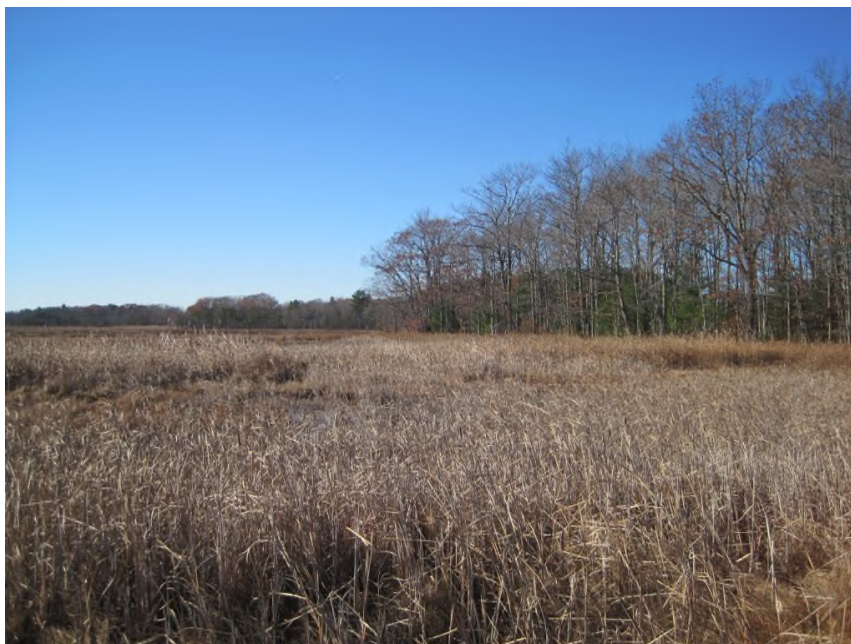
Photographer: S. Watts
Date: 11-12-10
Photo No.: 3-1
Direction: 260

Comments:
Start of panoramic series from
Photo Station #3 at low tide
during neap 1st quarter.
Phragmites removal area, at
center.

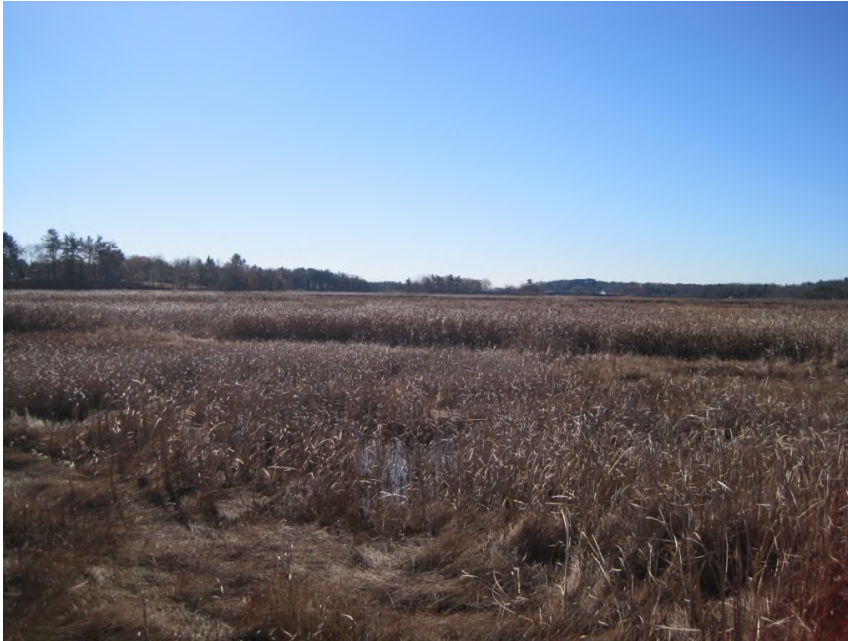
Photographer: S. Watts
Date: 11-12-10
Photo No.: 3-2
Direction: 210

Comments:
Panoramic series from Photo Station #3 at low tide during neap 1st quarter.

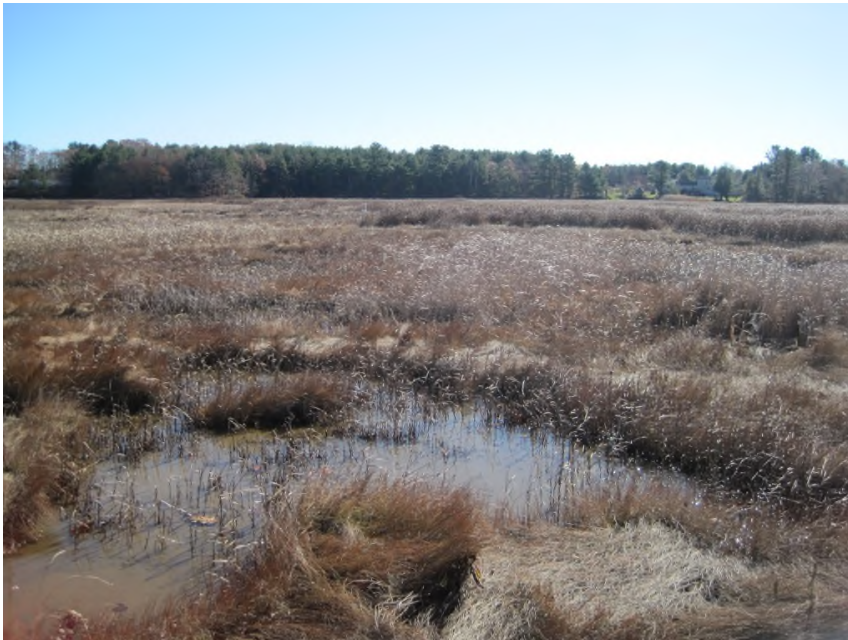
Photographer: S. Watts
Date: 11-12-10
Photo No.: 3-3
Direction: 160

Comments:
Panoramic series from Photo Station #3 at low tide during neap 1st quarter.

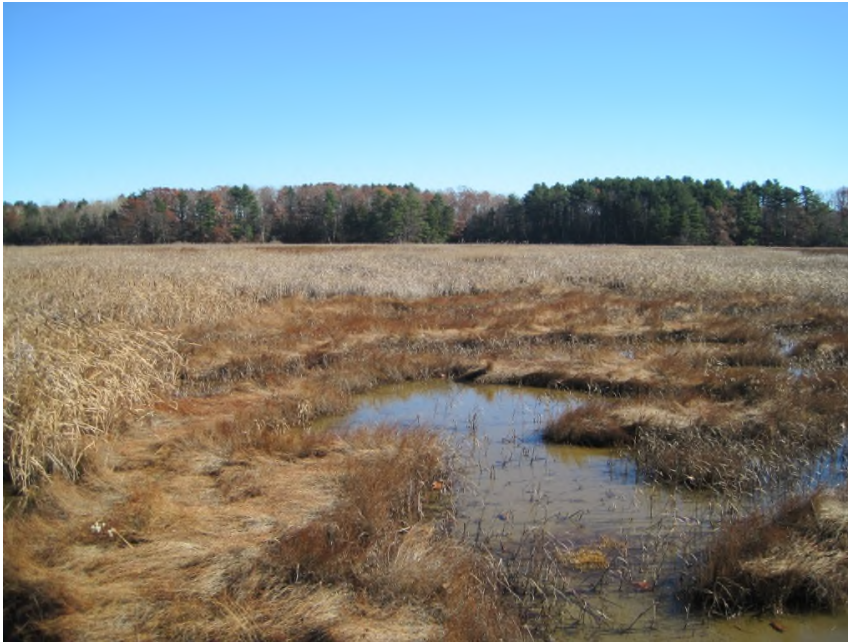
Photographer: S. Watts
Date: 11-12-10
Photo No.: 3-4
Direction: 110

Comments:
Panoramic series from Photo Station #3 at low tide during neap 1st quarter. *Phragmites* removal area in distance to right of center.

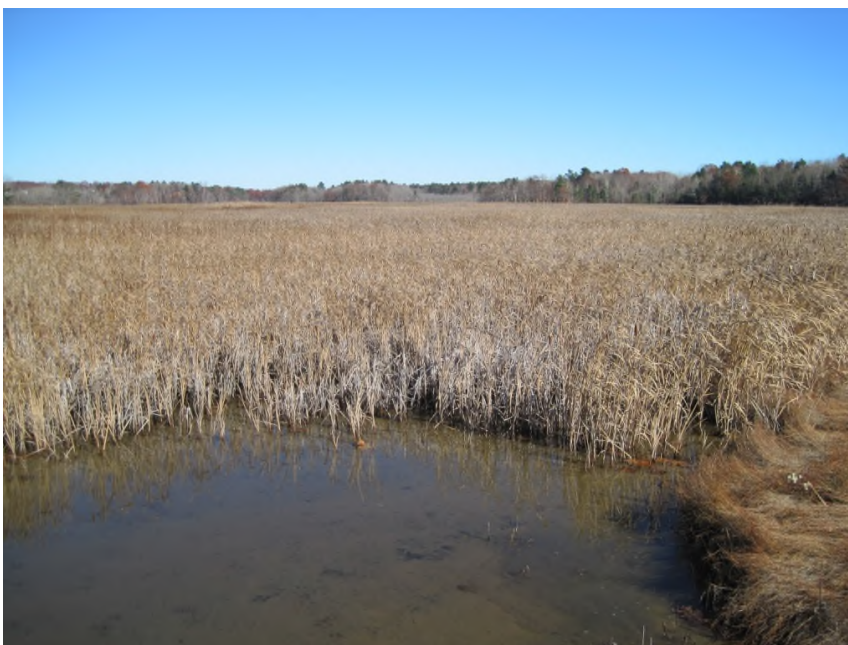
Photographer: S. Watts
Date: 11-12-10
Photo No.: 3-5
Direction: 180

Comments:
End of panoramic series from Photo Station #3. *Phragmites* removal area in distance.

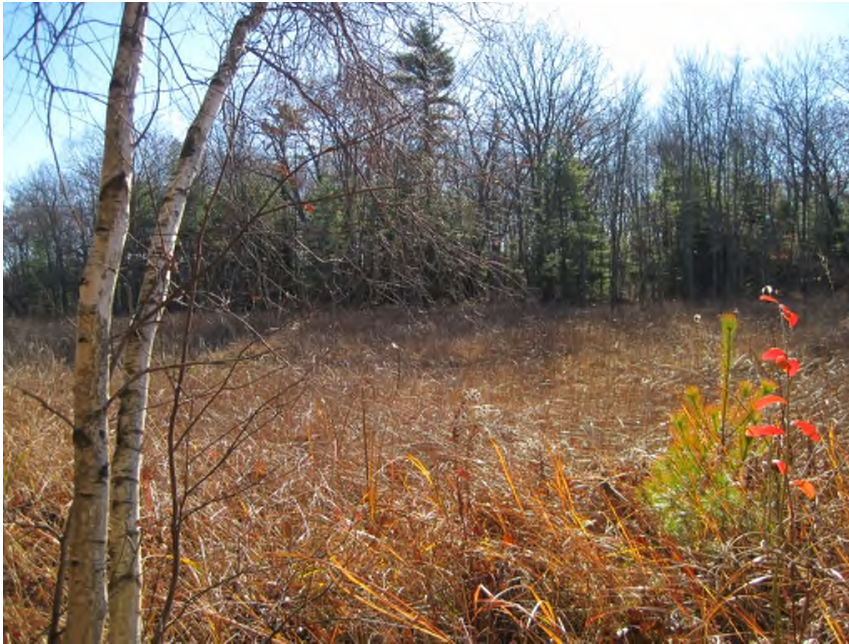
Photographer: S. Watts
Date: 11-12-10
Photo No.: 4-1
Direction: 110

Comments:
Start of panoramic series from Photo Station #4 at low tide during neap 1st quarter. Small *Phragmites* removal area at center.

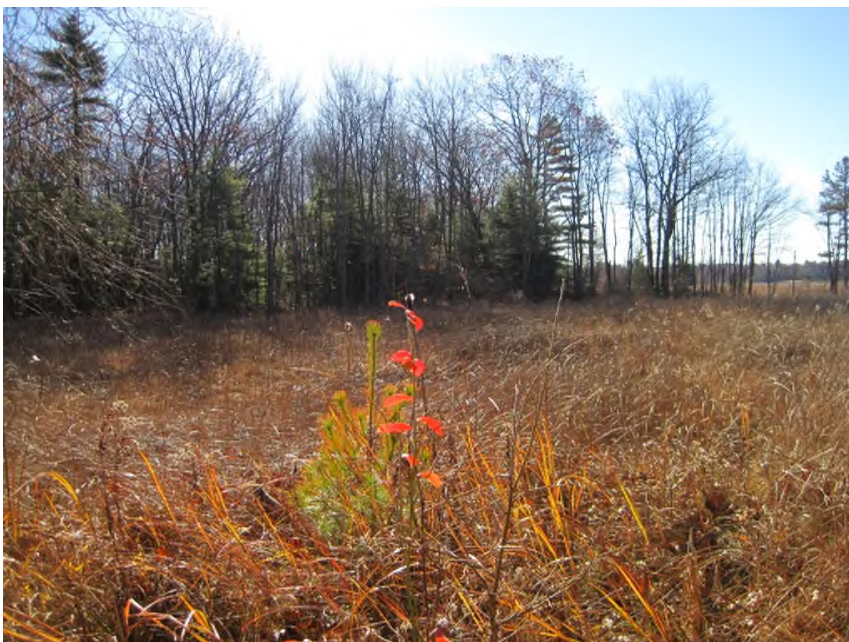
Photographer: S. Watts
Date: 11-12-10
Photo No.: 4-2
Direction: 150

Comments:
Panoramic series from Photo Station #4 during low tide during neap 1st quarter. *Phragmites* removal area at center.

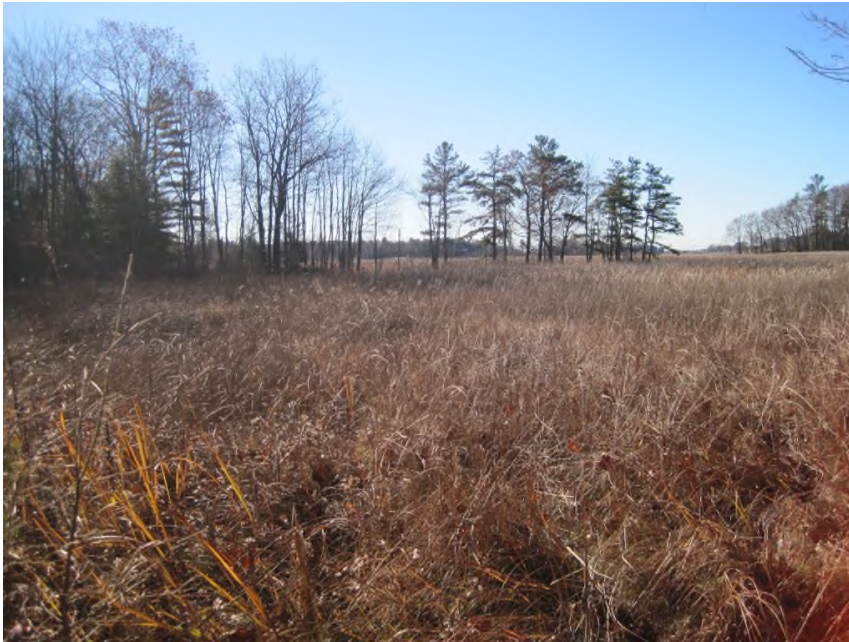
Photographer: S. Watts
Date: 11-12-10
Photo No.: 4-3
Direction: 190

Comments:
Panoramic series from Photo Station #4 at low tide during neap 1st quarter. *Phragmites* removal area to left and at center-right.

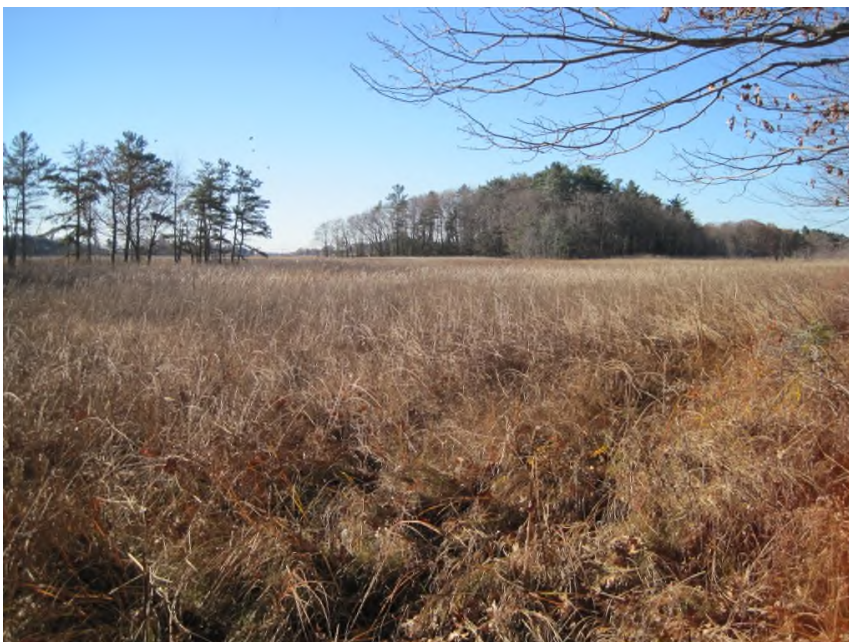
Photographer: S. Watts
Date: 11-12-10
Photo No.: 4-4
Direction: 230

Comments:
End of panoramic series from Photo Station #4. *Phragmites* removal area left of center.

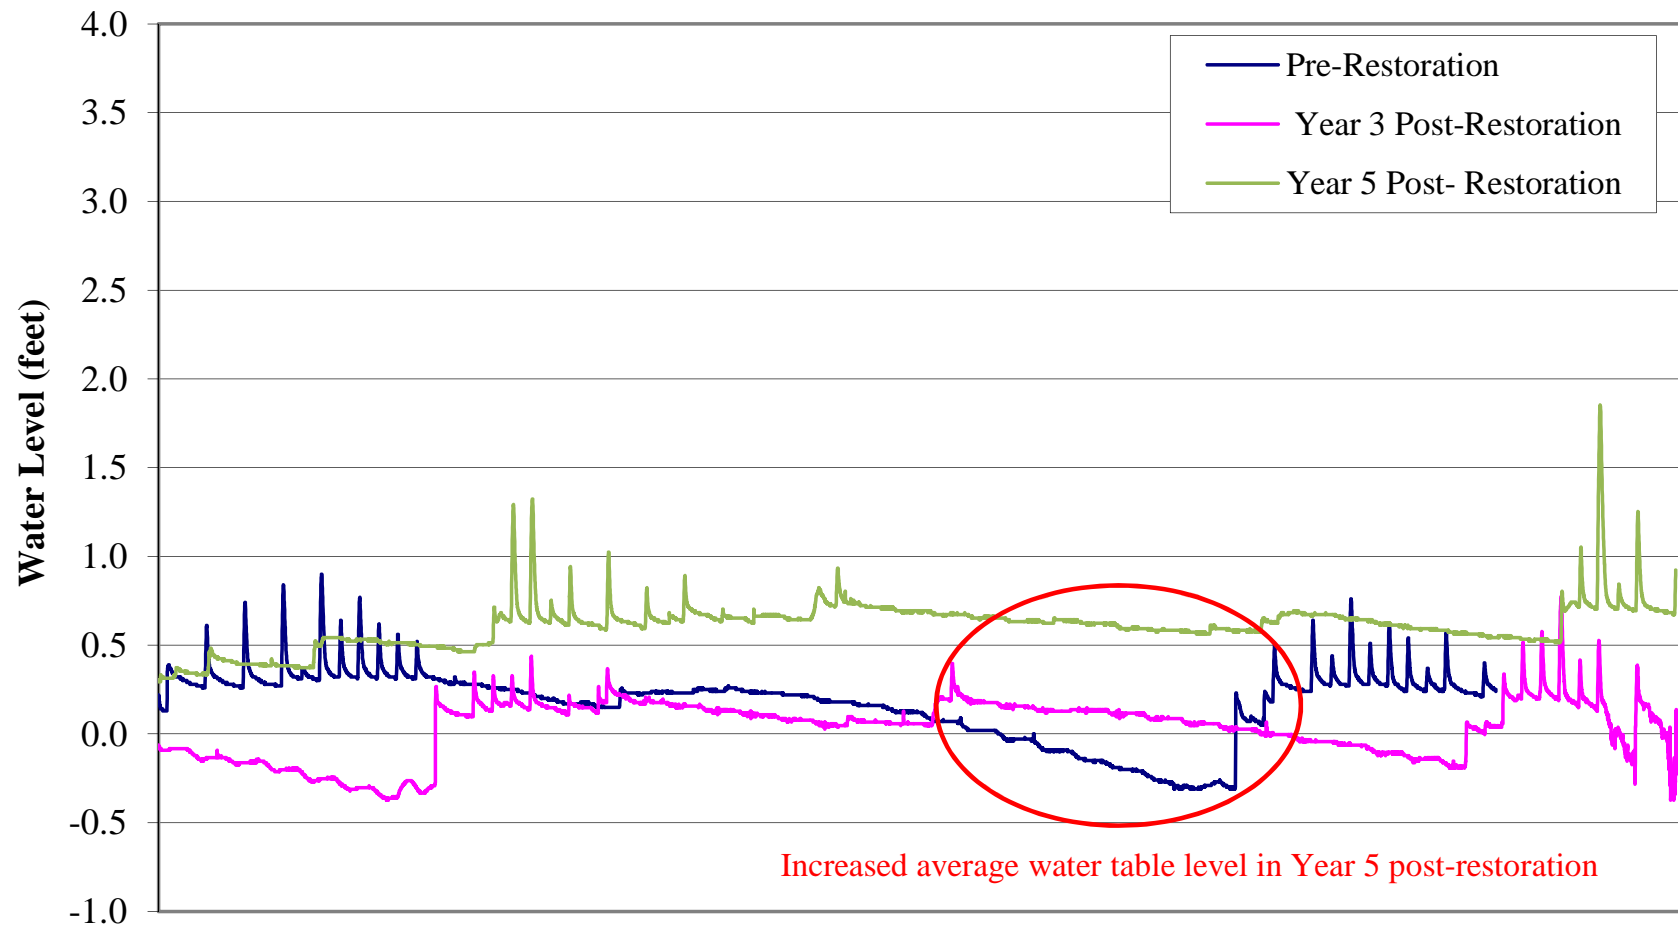
Water level data at Station #2, which is located in proximity to one of the berm removal areas (B7), suggest that the base water table level was higher at this station in year 5 post-restoration than it was pre-restoration. The data for Station #2 appear to show a substantial increase in the base water level at the station, and the groundwater levels remain elevated throughout the duration of the tidal cycle when compared to pre-restoration conditions.
