Scarborough Marsh:
*Historical Impacts, Current Conditions,
and Restoration Potential*

MAINE AUDUBON SOCIETY

June 1999

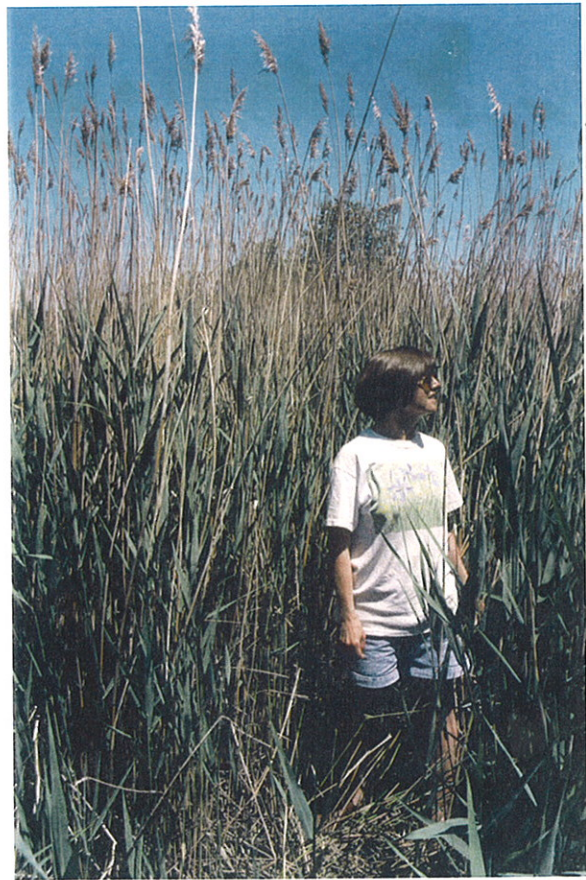
Phragmites is spreading rapidly in parts of Scarborough Marsh
