**SEAVEY LANDING SALT MARSH  
YEAR 5 POST-RESTORATION MONITORING  
PROJECT SUMMARY REPORT**

**SEAVEY LANDING, SCARBOROUGH, MAINE**

**January 2007**

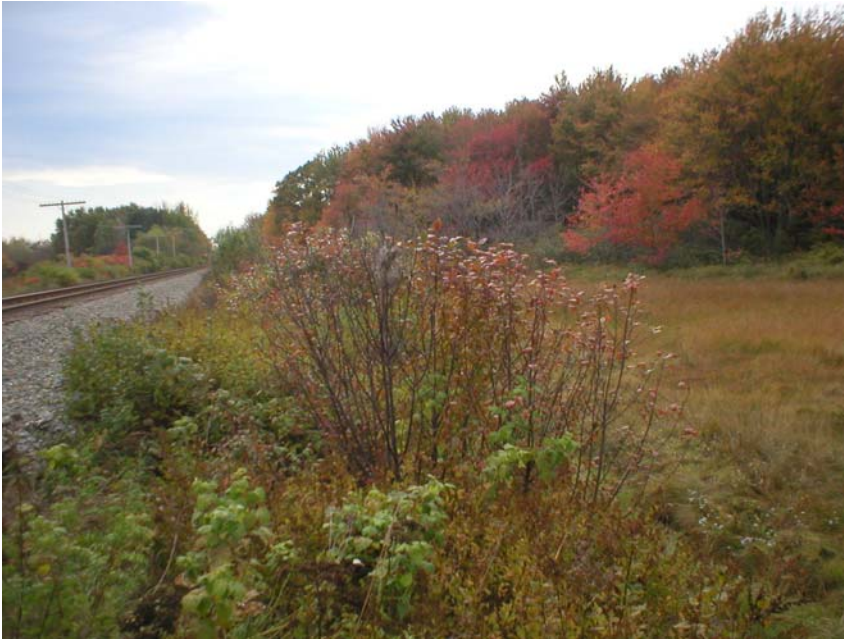
**Photographer:** S. Casto  
**Date:** 10-03-06  
**Photo No.:** 1(1)  
**Direction:** 240

Photo station # 1, looking southwest. Start of panoramic series. Photo shows the transition from marsh to upland along the eastern perimeter of project area. The railroad bed that runs parallel to the eastern perimeter of the marsh is visible in the upper left part of the photo.

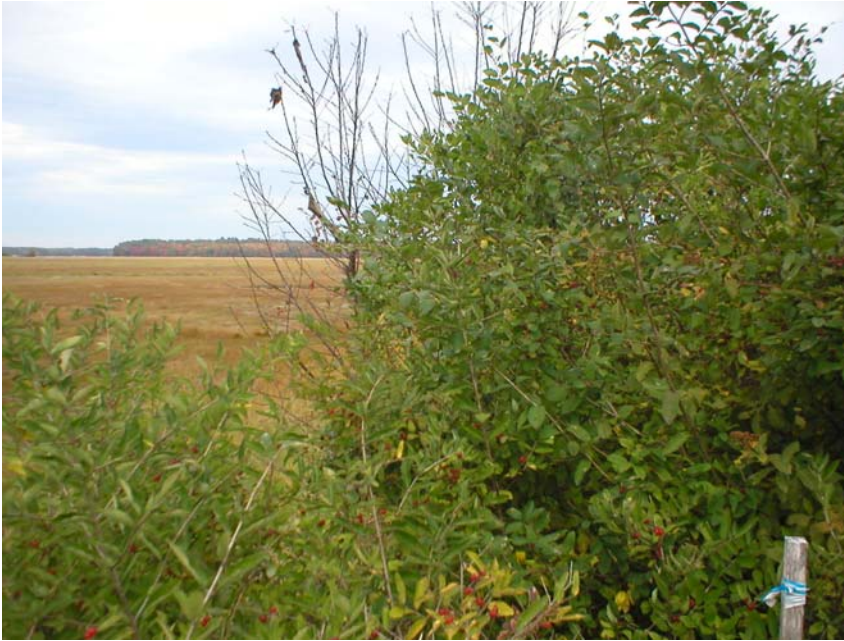
**Photographer:** S. Casto  
**Date:** 10-03-06  
**Photo No.:** 1(5)  
**Direction:** 10

Photo station # 1, looking north. Photo shows flourishing shrub next to railroad tracks at Photo Station 1.

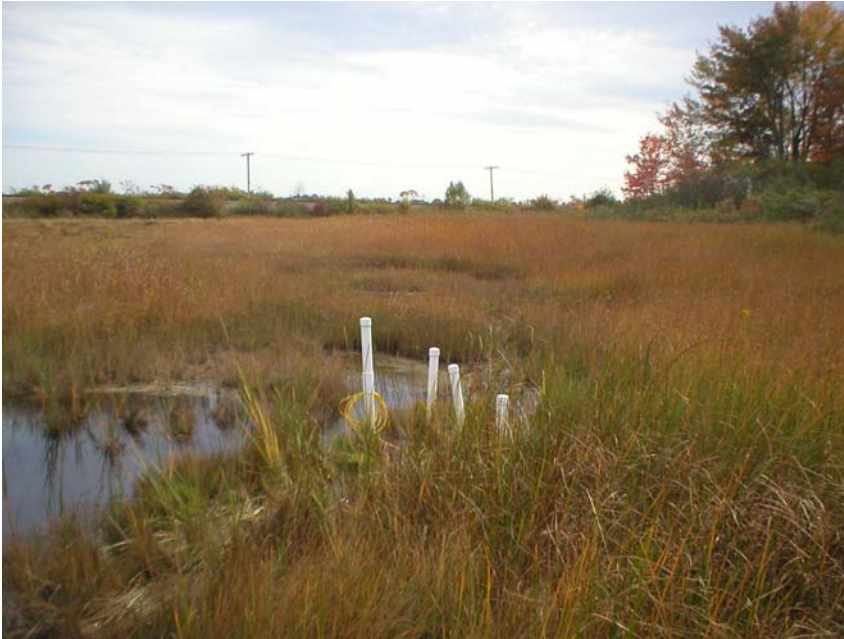
**Photographer:** S. Casto  
**Date:** 10-03-06  
**Photo No.:** 2(1)  
**Direction:** 160

Photo station # 2, looking south/southeast. Start of panoramic series. Photo shows marsh surface during average low tide condition. Pipe setup is water sample station # 1.

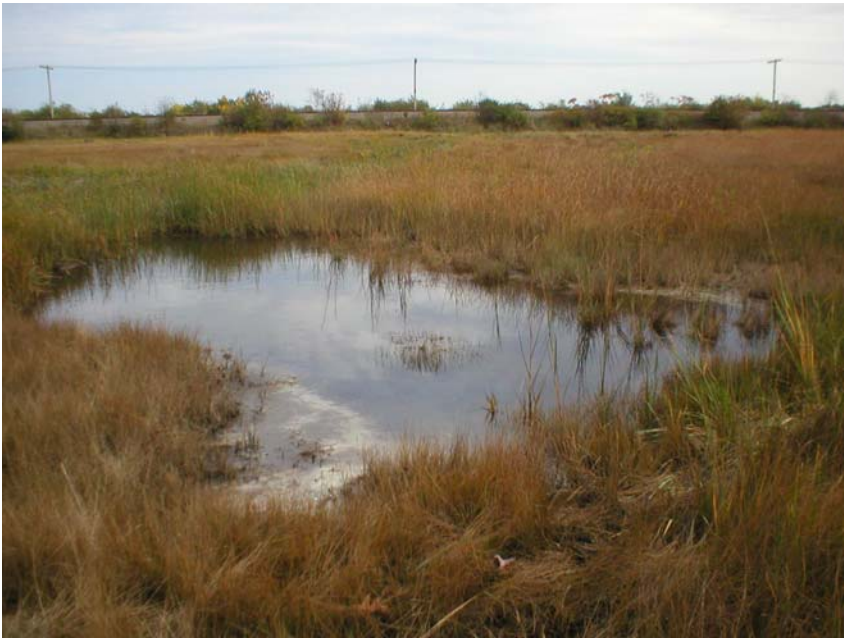
**Photographer:** S. Casto  
**Date:** 10-03-06  
**Photo No.:** 2(2)  
**Direction:** 130

areas, *Spartina patens* and/or *Spartina alterniflora* communities appear to be stressed and the communities appear to be transitioning toward pool or panne habitats (depending on the hydroperiod in each area). See photographs 2(2), 3(3), and 4(2) to 4(4) in Appendix C for examples. In other areas, the inundation appears to be less in the pool and panne habitats and the communities appear to be transitioning toward *Spartina patens* and/or *Spartina alterniflora* communities. See photographs 5(3) to 5(4) in Appendix C for examples. Additionally, an increase in *Typha* communities was observed during Year 4 and 5 (see photographs 4(1), 11, and 22 in Appendix C).

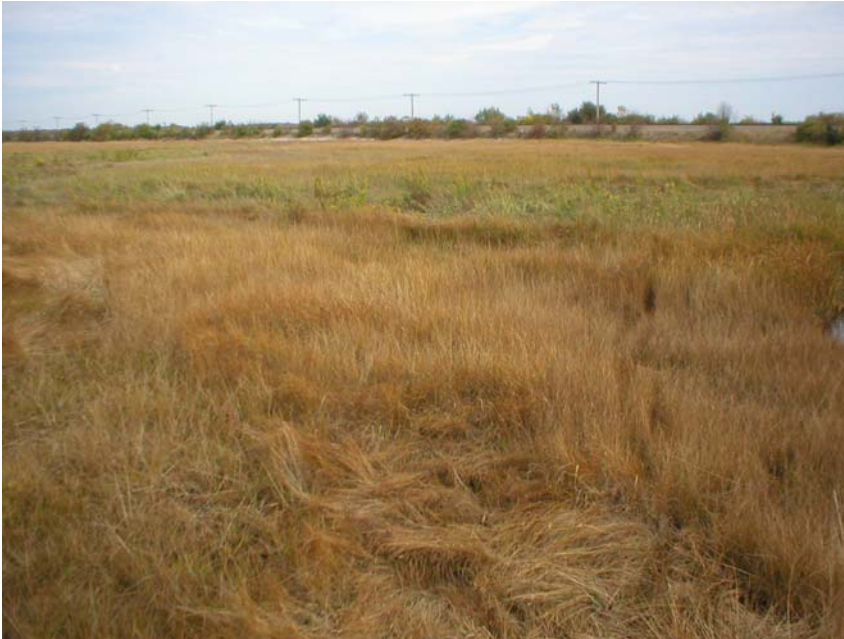
**Photographer:** S. Casto  
**Date:** 10-03-06  
**Photo No.:** 2(3)  
**Direction:** 100

Photo station # 2, looking east. Photo shows marsh surface during average low tide condition.

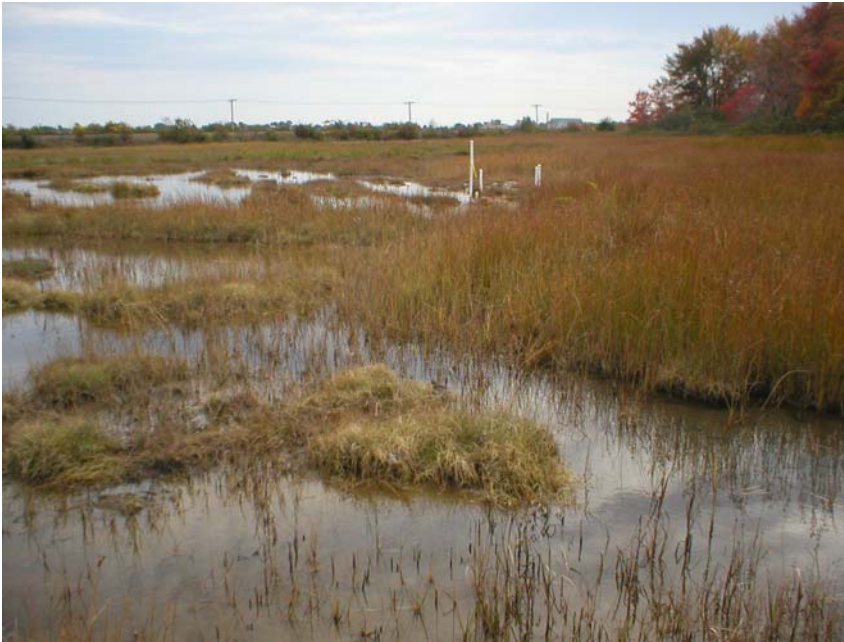
**Photographer:** S. Casto  
**Date:** 10-03-06  
**Photo No.:** 3(1)  
**Direction:** 180

Photo station # 3, looking south. Start of panoramic series. Photo shows flooded marsh surface near water sampling station # 2 during average low tide condition.

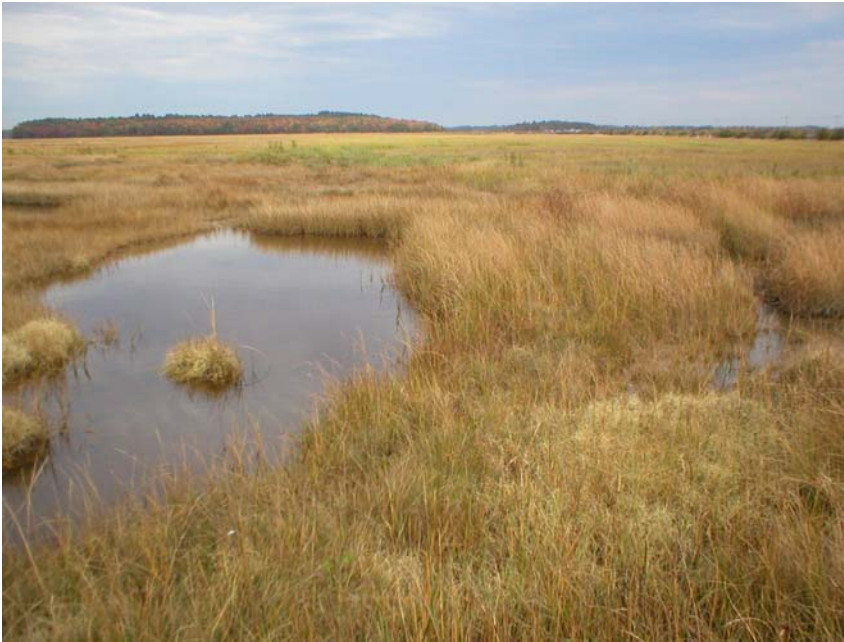
**Photographer:** S. Casto  
**Date:** 10-03-06  
**Photo No.:** 3(5)  
**Direction:** 50

Photo station # 3, looking northeast. Photo shows flooded marsh surface during average low tide condition.

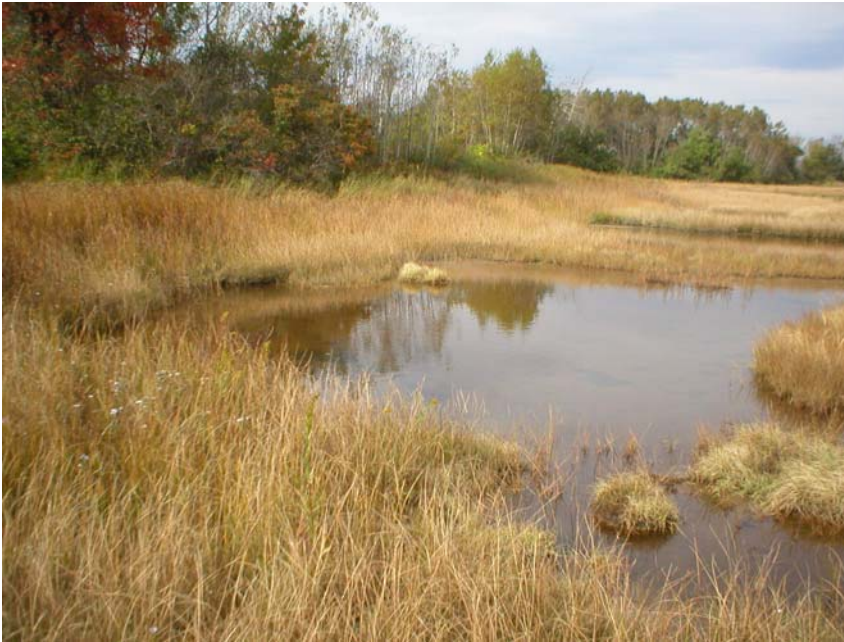
**Photographer:** S. Casto  
**Date:** 10-03-06  
**Photo No.:** 3(7)  
**Direction:** 330

**Comments:**  
Photo station # 3, looking northwest. Photo shows flooded marsh surface during average low tide condition. End of panoramic photo series # 3.

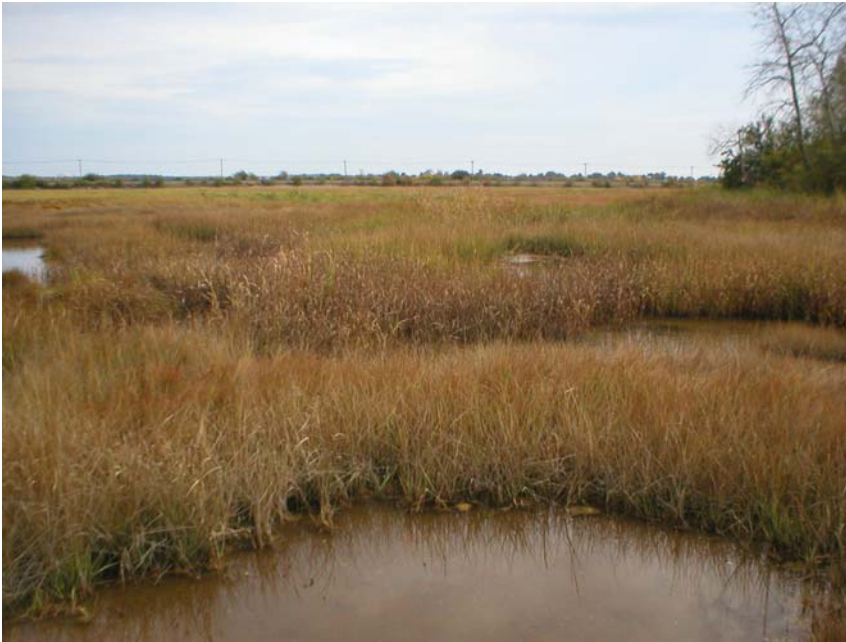
**Photographer:** S. Casto  
**Date:** 10-03-06  
**Photo No.:** 4(3)  
**Direction:** 165

Photo station # 4, looking south/southeast. Photo shows flooded marsh surface during average low tide condition.

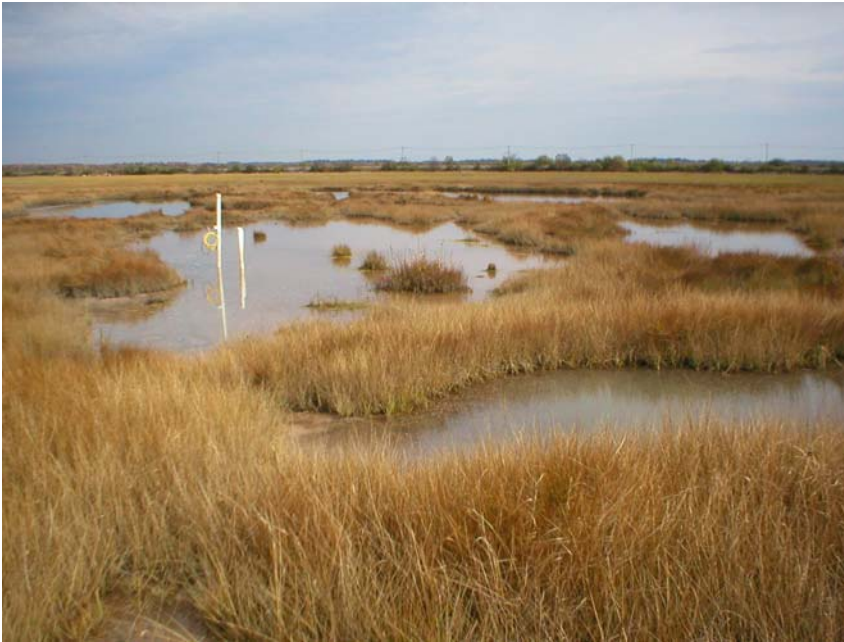
**Photographer:** S. Casto  
**Date:** 10-03-06  
**Photo No.:** 4(5)  
**Direction:** 115

Photo station # 4, looking east/southeast. Photo shows flooded marsh surface during average low tide condition. Water sampling station # 3 is to the left of the photo.

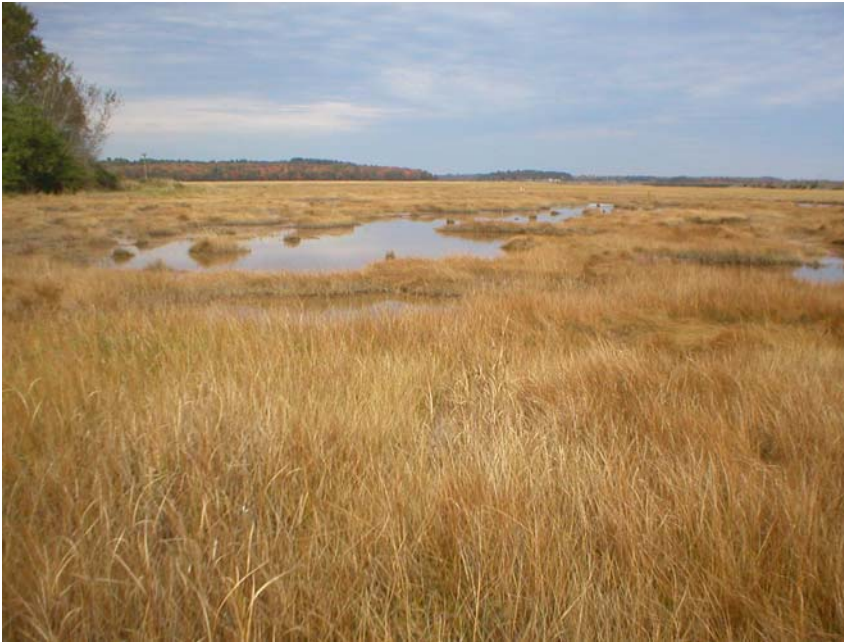
Photo station # 4, looking northeast. Photo shows flooded marsh surface during average low tide condition.

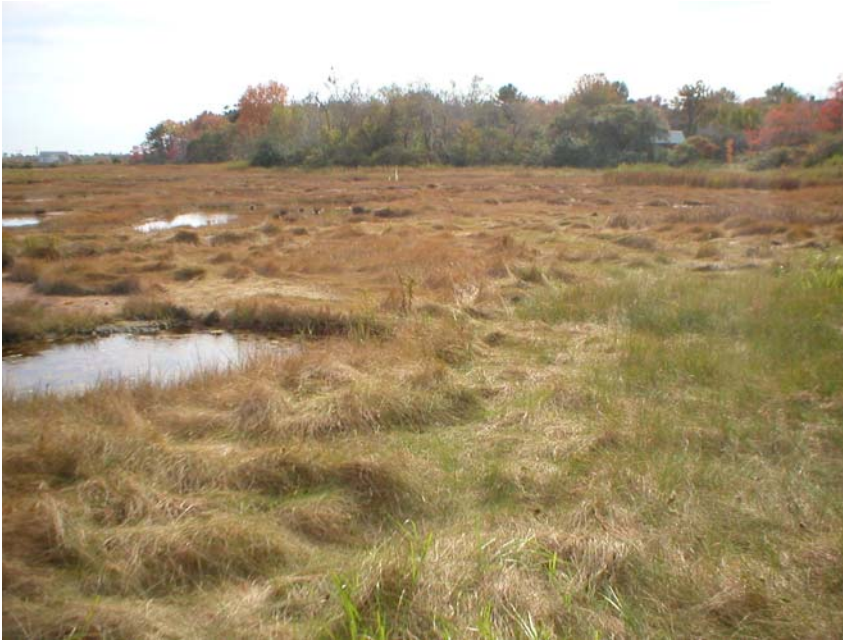
**Photographer:** S. Casto  
**Date:** 10-03-06  
**Photo No.:** 5(1)  
**Direction:** 210

Photo station # 5, looking southwest. Start of panoramic series. Photo shows flooded marsh surface during average low tide condition.

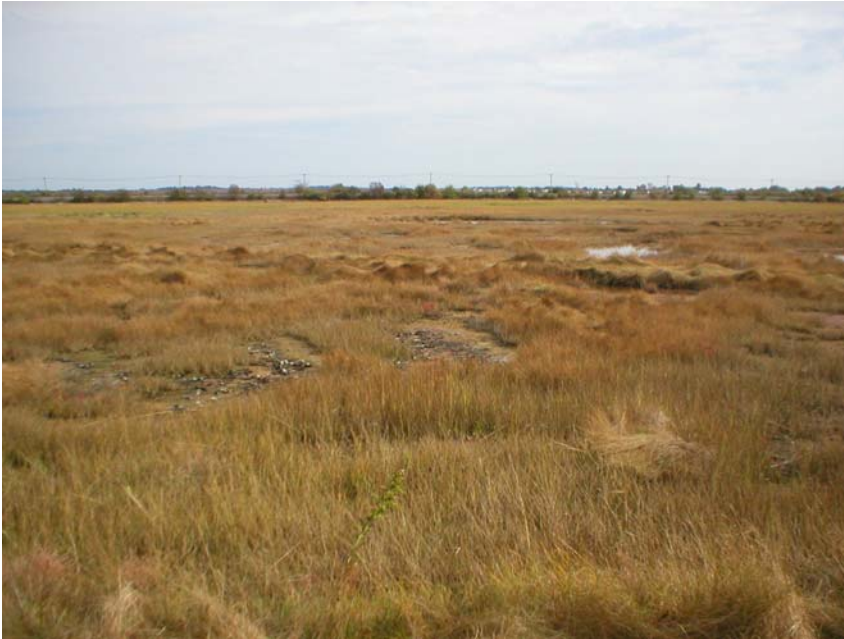
**Photographer:** S. Casto  
**Date:** 10-03-06  
**Photo No.:** 5(3)  
**Direction:** 135

Photo station # 5, looking southeast during average low tide conditions. Photo shows panne habitat in photo foreground.

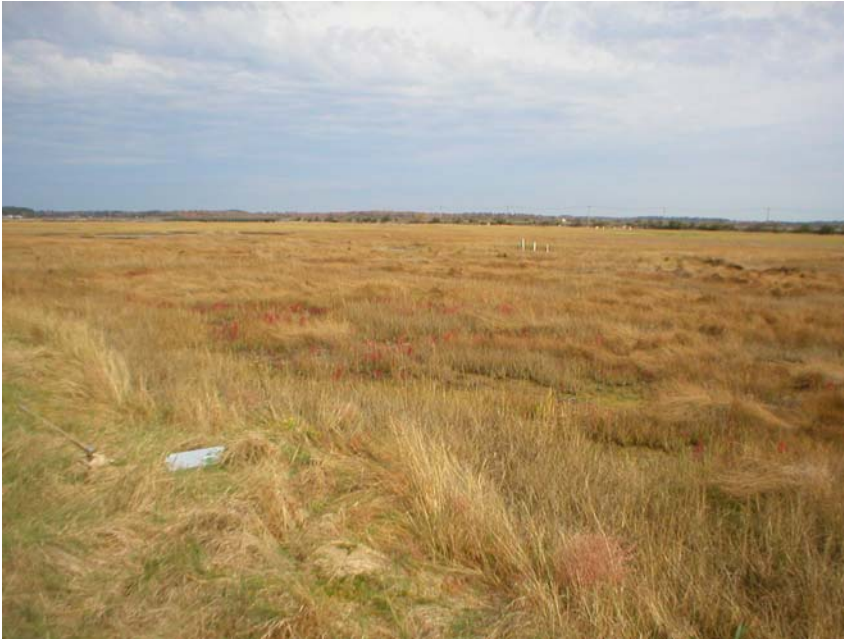
**Photographer:** S. Casto  
**Date:** 10-03-06  
**Photo No.:** 5(5)  
**Direction:** 65

Photo station # 5, looking northeast. Photo shows marsh surface/upland ecotone during average low tide condition.

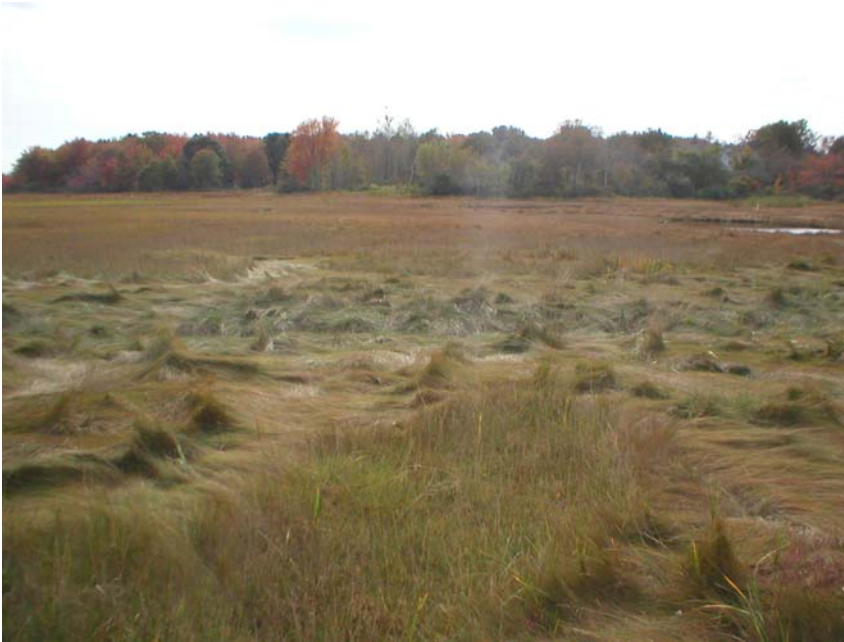
**Photographer:** S. Casto  
**Date:** 10-03-06  
**Photo No.:** 6(3)  
**Direction:** 220

Photo station # 6, looking south. Photo shows marsh surface during average low tide condition.

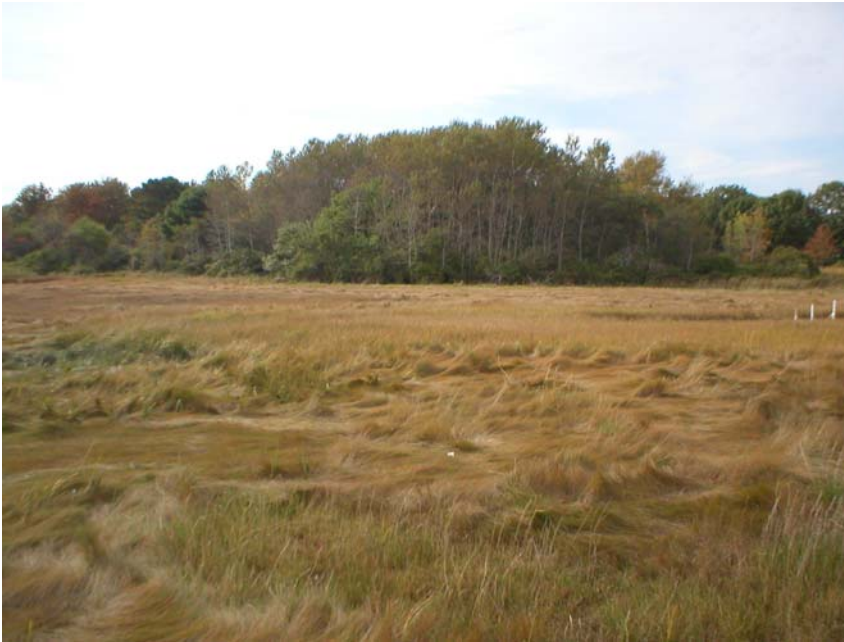
Photo station # 6, looking northwest. Photo shows marsh surface during average low tide condition.

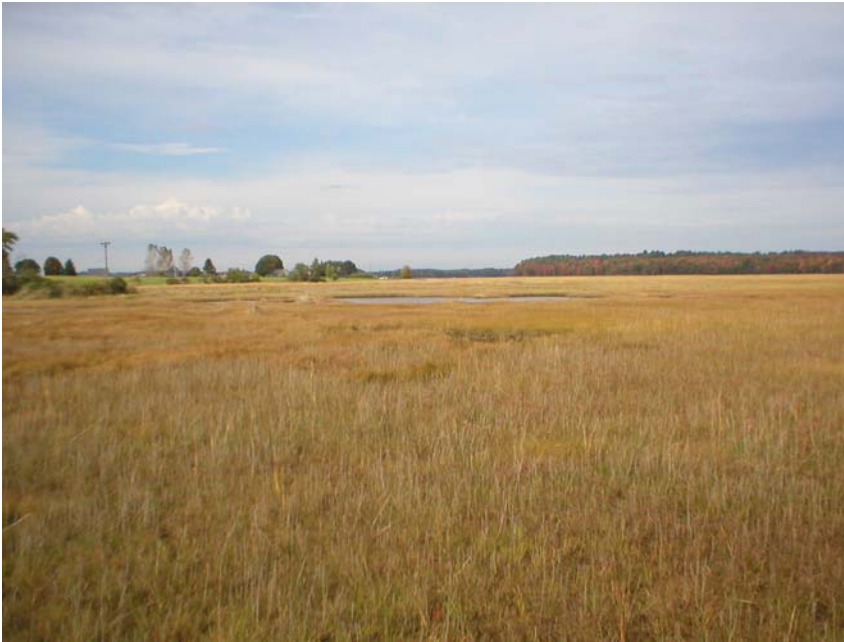
**Photographer:** S. Casto  
**Date:** 10-03-06  
**Photo No.:** 6(7)  
**Direction:** 300

**Comments:**  
Photo station # 6, looking northwest. Photo shows marsh surface during average low tide condition.

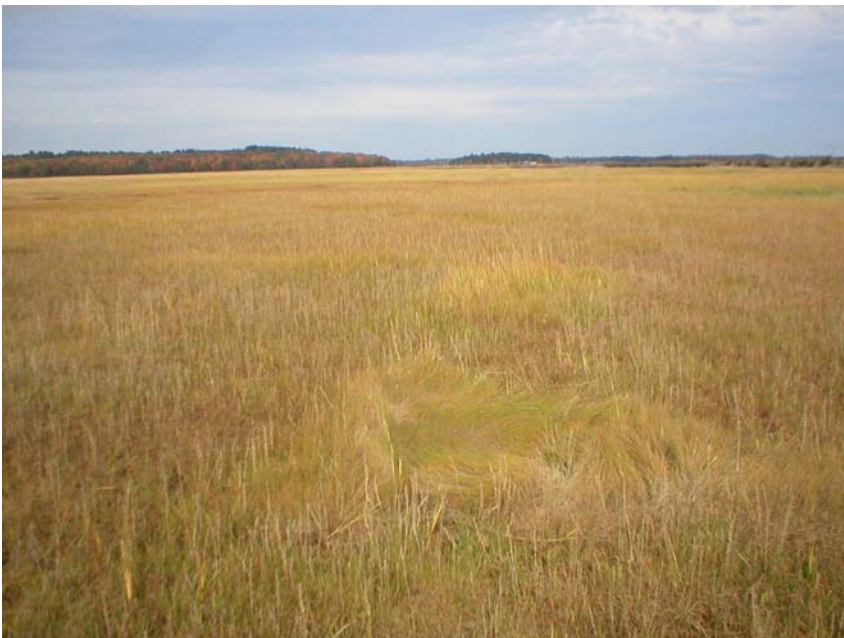
**Photographer:** S. Casto  
**Date:** 10-03-06  
**Photo No.:** 6(8)  
**Direction:** 340

**Comments:**  
Photo station # 6. Photo shows marsh surface during average low tide condition. End of panoramic photo series # 6.

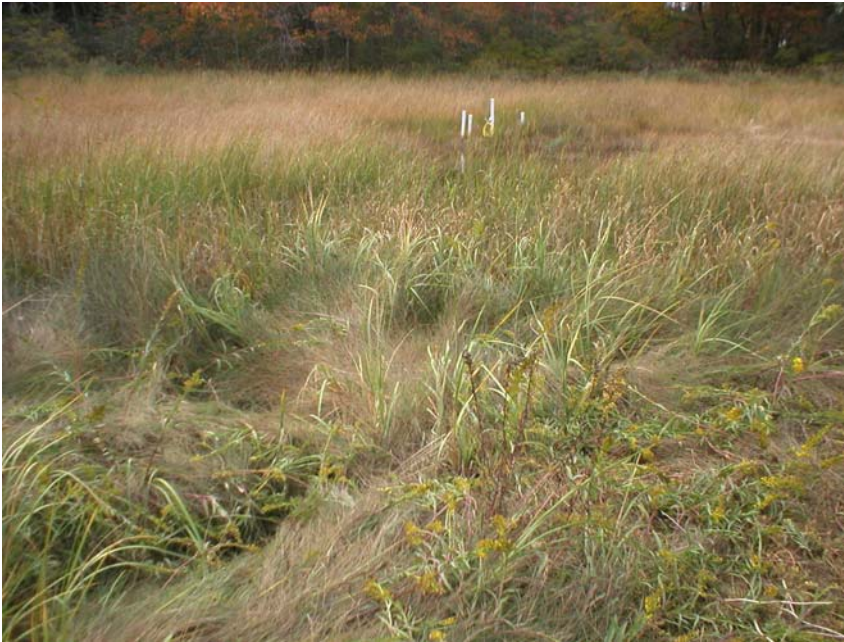
**Photographer:** S. Casto  
**Date:** 10-03-06  
**Photo No.:** 7  
**Direction:** 100

Ditch plug # 1 and associated pools. Photo shows ditch plug at a slightly higher elevation. Ditch plug has desirable vegetation growing and shows no evidence of erosion.

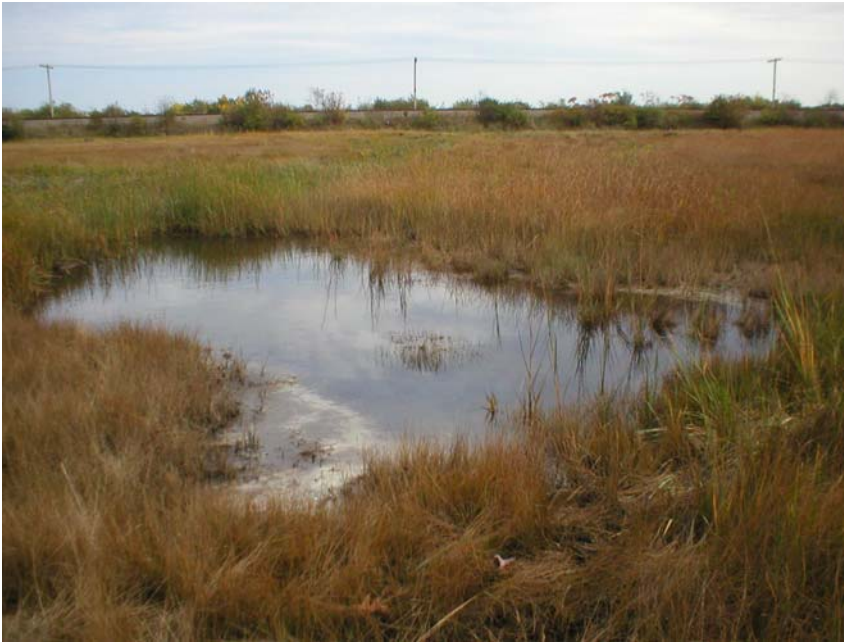
**Photographer:** S. Casto  
**Date:** 10-03-06  
**Photo No.:** 9  
**Direction:** 200

Ditch plug # 3 and associated pool. Water is pooling (approx. 6 in deep) behind the ditch plug. No evidence of erosion

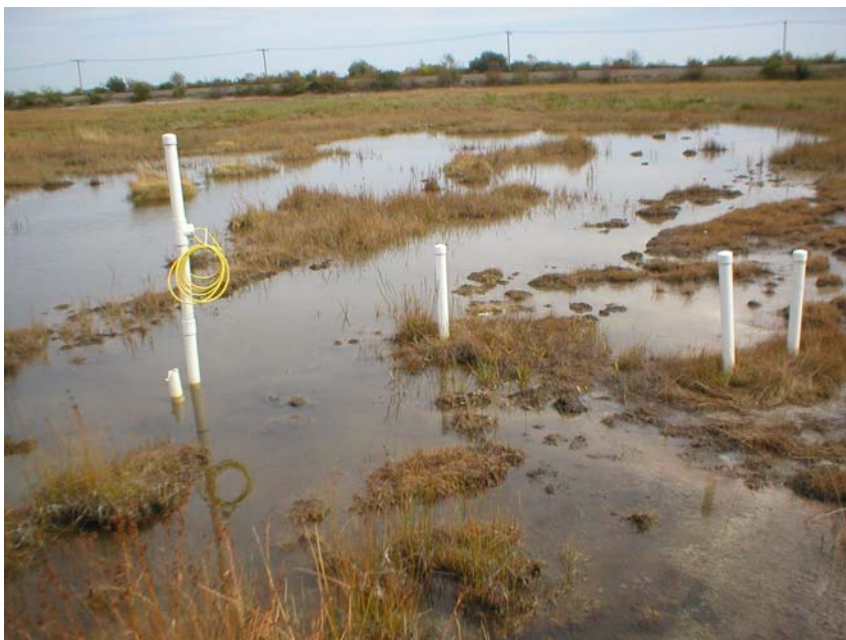
**Photographer:** S. Casto  
**Date:** 10-03-06  
**Photo No.:** 16  
**Direction:** 15

Water Quality Station # 2, looking northeast at average low tide conditions. Pool is about 6 inches deep with various nekton species. Note the water level recorder in place.

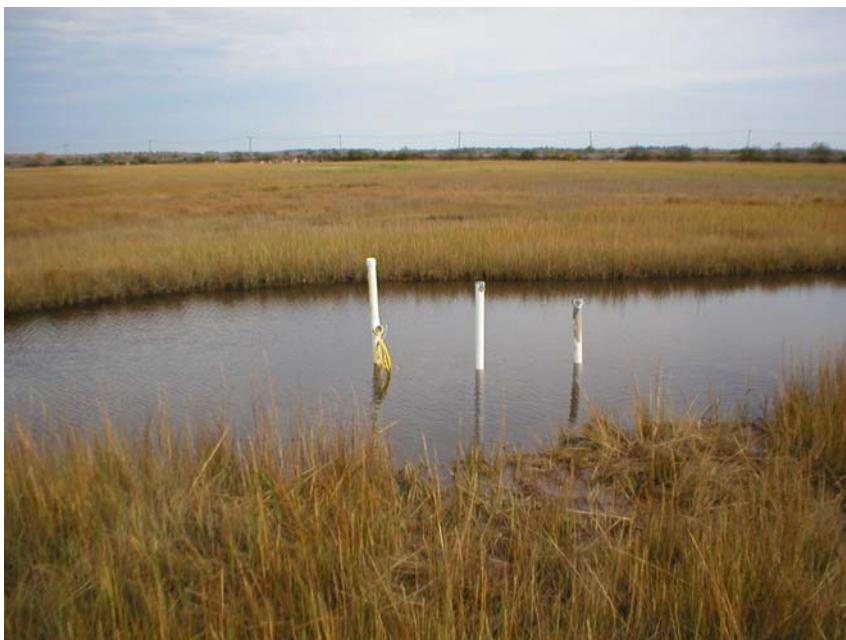
**Photographer:** S. Casto  
**Date:** 10-03-06  
**Photo No.:** 18  
**Direction:** 65

Water Quality Station # 4, looking east at average low tide conditions. Pool is about 36 inches deep with various nekton species. This Water Quality Station was repaired on 9-19-06. Note the water level recorder in place.

1100 - Water Quality station #4  
 pipe broken lying in pool (~2 1/2 ft)  
 deep. Lot of fish, crabs, large  
 American eel (~16" long).  
 brought back for repair

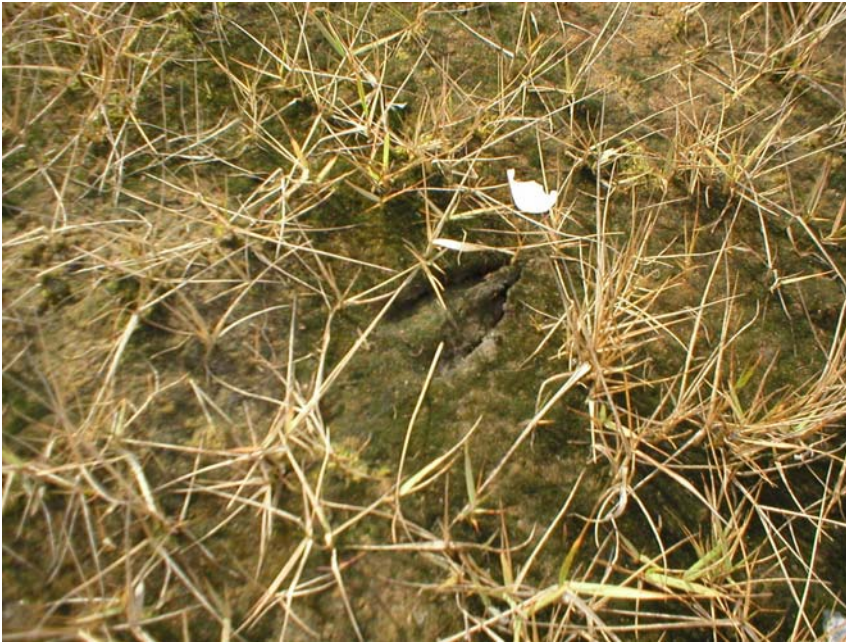
Photo shows deer tracks through a panne surface near Photo Station # 3.

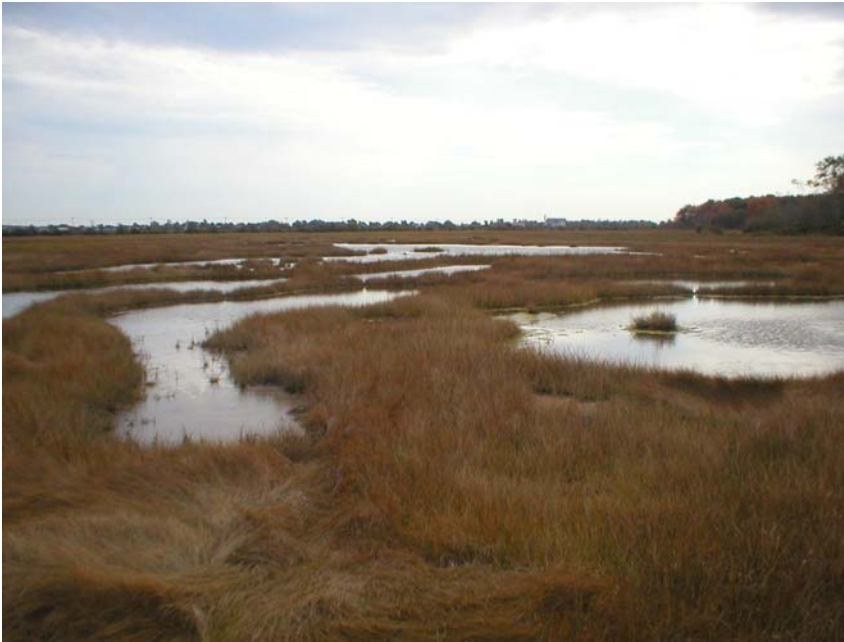
Overall marsh surface during average low tide conditions. Photo taken from northwestern area of marsh study area. Notice water levels of pools and pannes are generally high.
